Re: *Dredge Spoil Area Evaluation Report*  
Solutia Inc. Anniston, AL Facility  
EPA ID No. ALD 004 019 048

**DREDGE SPOIL AREA EVALUATION REPORT  
SNOW CREEK AND CHOCCOLOCCO CREEK  
CALHOUN AND TALLADEGA COUNTIES, ALABAMA**

**October 15, 1998**

**ROUX ASSOCIATES, INC.  
1110 Nasa Road One, Suite 207  
Houston, Texas 77058  
(281) 335-4000**

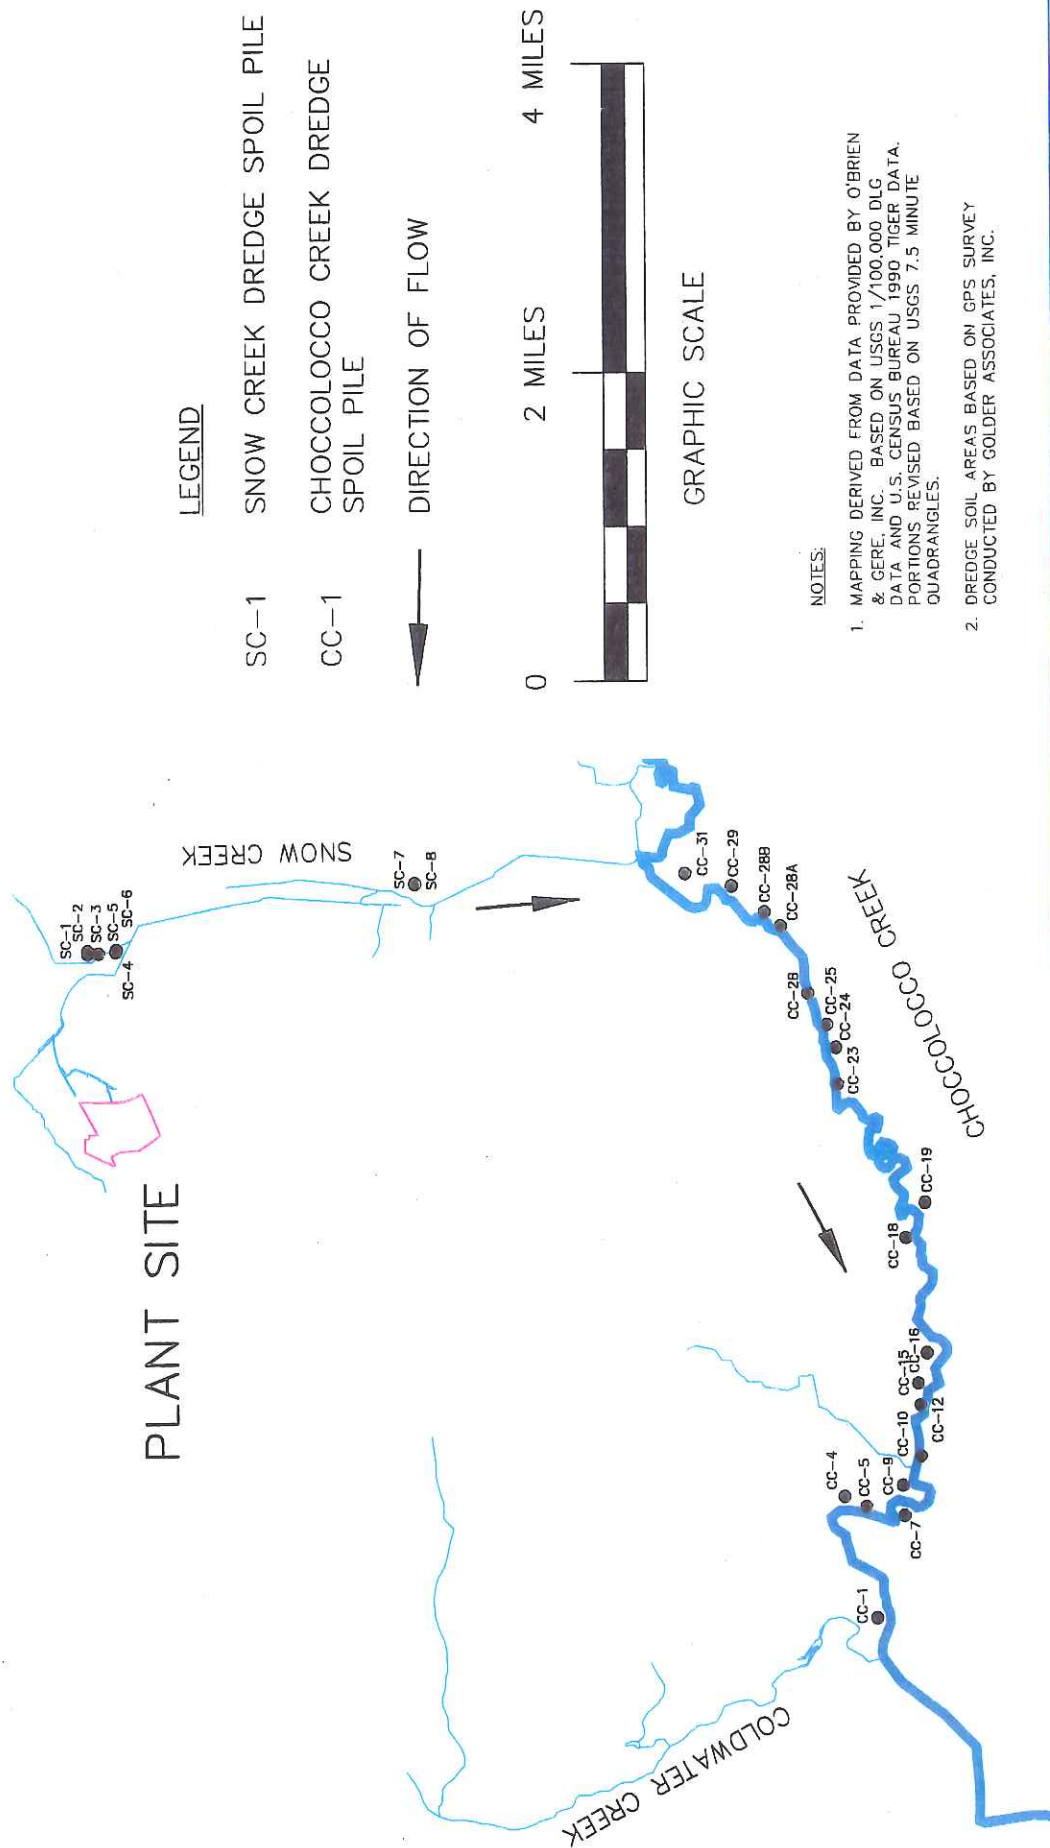
# Figure 2 - Locations of Dredge Spoil Areas

There are a total of eight dredge spoil areas located along the banks of Snow Creek between its confluence with the 11<sup>th</sup> Street Ditch and Choccolocco Creek, as shown on Figure 2. Physical data collected for each area are presented on data sheets in Appendix A and summarized in Table 2. The dredge spoil areas range in height from 3 to 7 feet and in areal extent from 225 square feet to 44,000 square feet. Six of the eight areas extend to the top of bank. One of the areas, Area No. 1, has a non-woven geotextile cover installed. The remaining areas have a well established vegetative cover comprised of trees, ivy, vines, weeds, brush, brier or kudzu. Four of the eight areas, Area Nos. 3 through 6, exhibit 1:1, near vertical slopes and show evidence of minor slumping. Two of the areas, Area Nos. 7 and 8, are flat, parallel to the creek and have near vertical slopes at the creek bank, making them susceptible to possible bank erosion.

There are a total of 19 dredge spoil areas located along the banks of Choccolocco Creek between its confluence with Snow Creek and Coldwater Creek, as shown on Figure 2. Physical data collected for each area are presented on data sheets in Appendix A and summarized in Table 2. Seventeen (17) of the 19 areas were existing depressions or low areas requiring filling, e.g. gravel pits, borrow pits, old scour areas or other low areas. Area No. 16 was placed along an existing side slope, and Area No. 24 was deposited on the back side of an existing flood berm (road dike). The areas range in height or depth from a maximum of 10 feet high to 7 feet deep, and in areal extent from 2,500 square feet to 46,200 square feet. Only three areas extend laterally to within 10 feet of the creek bank (Area Nos. 9, 24 and 29). The remaining areas are located at distances ranging from 20 feet to 500 feet away from the adjacent creek bank. There was no evidence of slumping, erosion or other stability problems at any of the areas. The majority of the area slopes are flat as would be expected for filled-in, low-lying areas. The steepest slope measured was for Area No. 24 which exhibited an average slope of 3:1 (H:V). All of the areas have a well established vegetative cover (grass and weeds) with the exception of Area Nos. 7, 9 and 26. Area No. 7 is located in a washed-in area in a

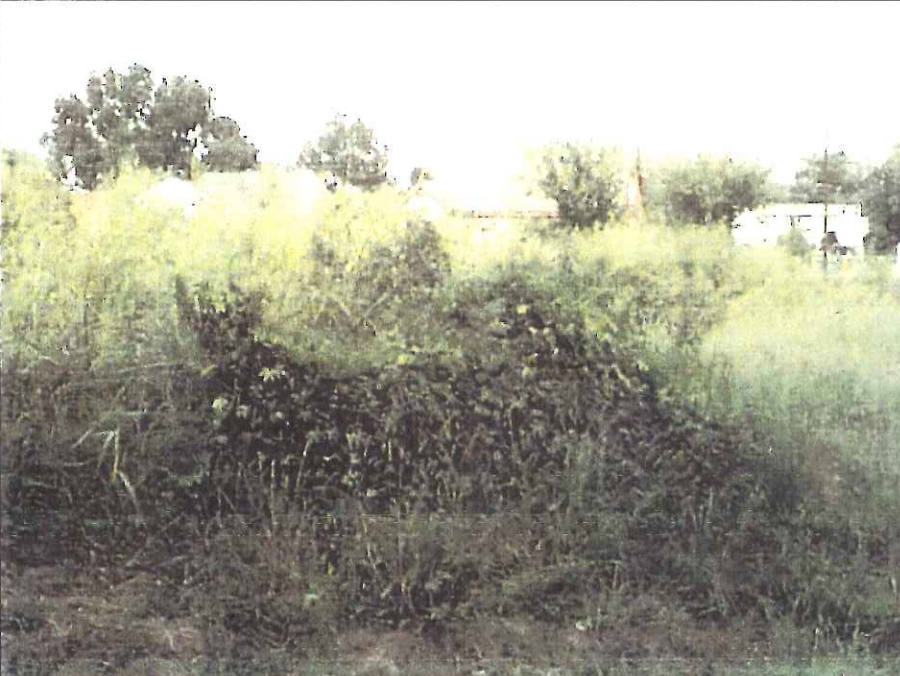
PHYSICAL DESCRIPTION	(#13)	(#14)	(#15)	(#16)	(#17)		(#18)
	Length (ft)	Width (ft)	Height (ft)	Soil Type in Area	Cover Type and Description		Is Vegetation Well Estab. ?
	15	15	5	Sand Silt Gravel	Weeds, brush		Yes
AREA SLOPE DATA	(#19)	(#20)	(#21)	(#22)	(#23)	(#24)	
	Average Slope Along Length (H) : (V)	Slope Length (Along Length) (ft)	Average Slope Along Width (H) : (V)	Slope Length (Along Width) (ft)	Steepest Slope (H) : (V)	Is There Evidence of Slump, Erosion or Area Stability Problem(s) ?	
	uneven, 1 : 1	4	uneven, 1 : 1	4	Portions near vertical	Some minor slumping	
SKETCH OF AREA			AREA PHOTOGRAPH

SIDE VIEW			Photo Caption:    Area 6, view to the east.

Dredge spoil Area Nos. 3 through 6 extend to the Creek bank and exhibit average slopes of 1:1 (H:V). Vegetation is well established at each area; however, each area exhibits some evidence of minor slumping. In order to prevent further slumping of these areas, it is recommended that permanent turf reinforcement mats be installed and seeded. Preparation of these areas will require the removal of large rocks, soil clods and existing vegetation to ground level to ensure intimate contact between the mats and subgrade. A turf reinforcement mat would then be installed, and the areas would be hydro-seeded to establish a good stand of grass. The turf reinforcement mats will stimulate rapid vegetative growth and provide permanent resistance to elevated hydraulic forces. The mats will permanently anchor the vegetative cover to the soil surface and provide twice the erosion protection of unreinforced vegetation. Typical specifications for turf reinforcement mats are provided in Appendix B. The mats are composed of a dense, three-dimensional web of polypropylene fibers, placed between two high strength nets and stitched together. The mats are installed in overlapping rolls and secured with ground-anchoring devices.

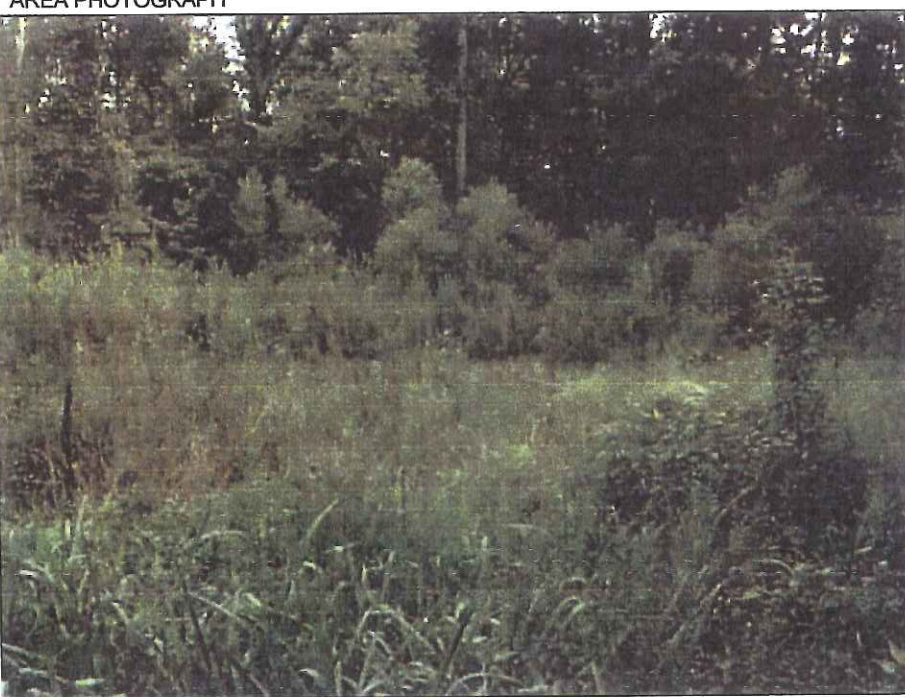
PHYSICAL DESCRIPTION	(#13) Length (ft)  130	(#14) Width (ft)  100	(#15) Height (ft)  -NA- Depth = 4 per NRCS	(#16) Soil Type in Area  Sand Silt	(#17) Cover Type and Description  Grass and tall weeds		(#18) Is Vegetation Well Estab. ?  Yes	
AREA SLOPE DATA	(#19) Average Slope Along Length (H) : (V)	(#20) Slope Length (Along Length) (ft)	(#21) Average Slope Along Width (H) : (V)	(#22) Slope Length (Along Width) (ft)	(#23) Steepest Slope (H) : (V)	(#24) Is There Evidence of Slump, Erosion or Area Stability Problem(s) ?		
	Flat	-NA-	Flat	-NA-	Flat	No		
SKETCH OF AREA

Photo Caption: Area 1, view to the west.
