Pharmacia Corporation and Solutia Inc.

**OU-4 Sediment Stability Technical
Memorandum**

June 2010

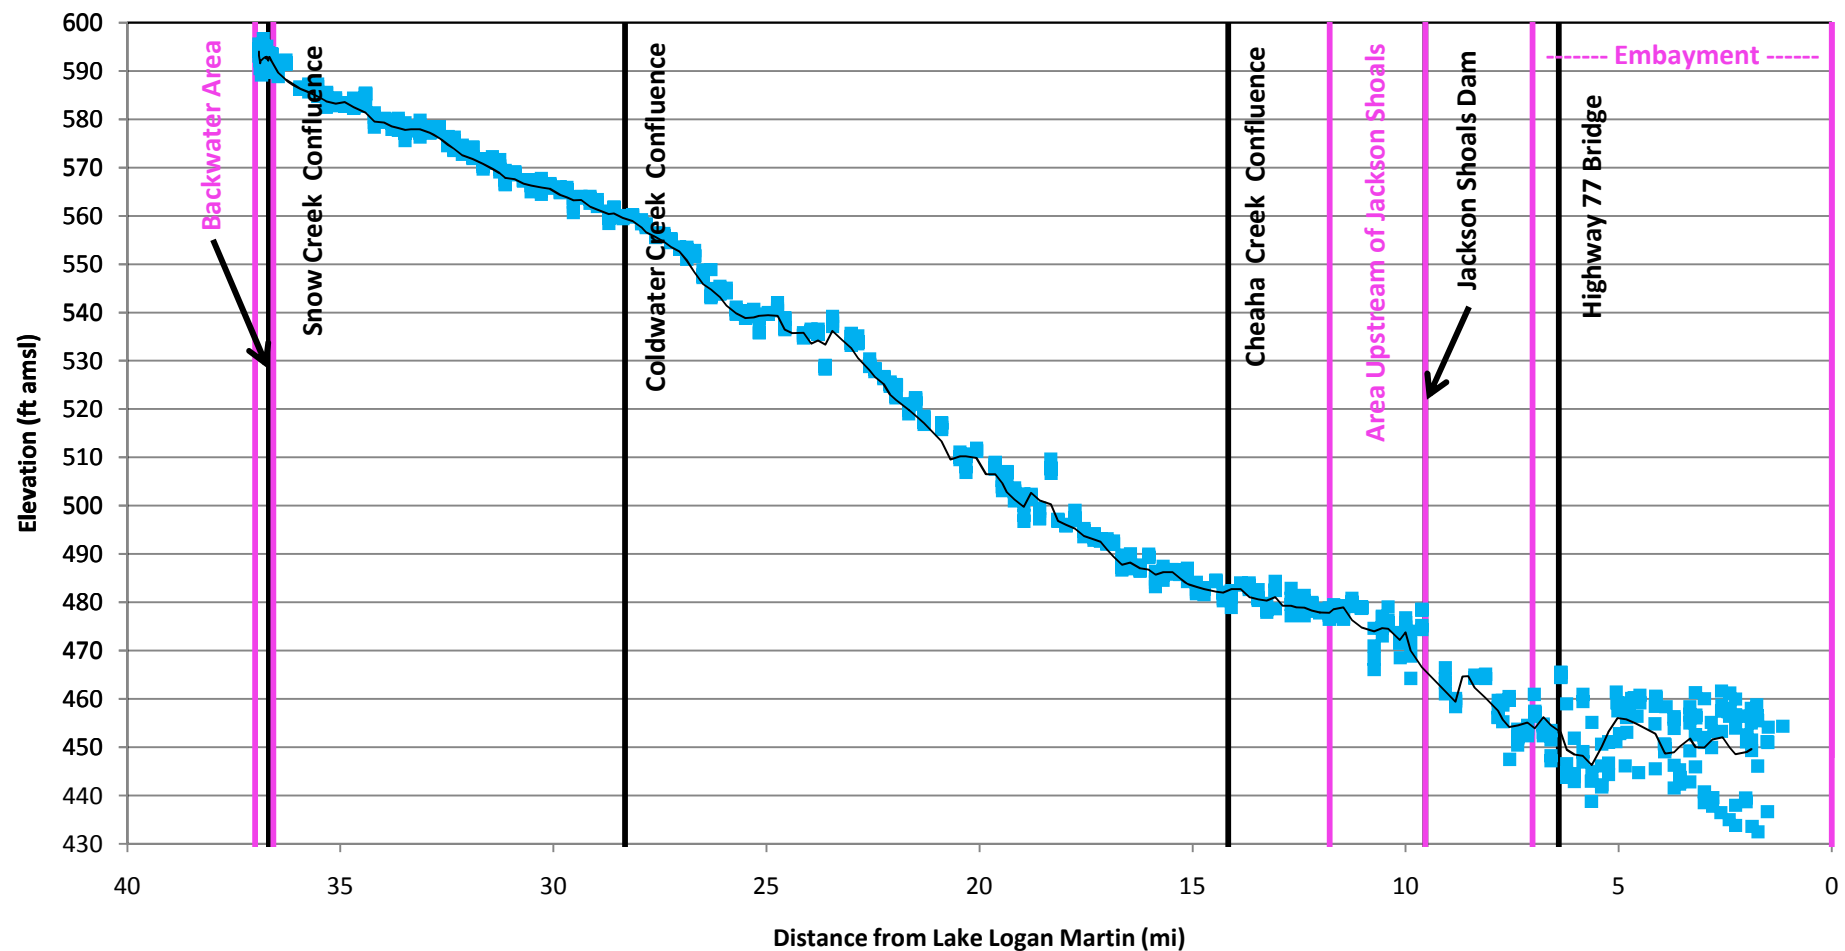
FIGURE 2

1. Based on probing data from 769 locations

ANNISTON PCB SITE ANNISTON, ALABAMA	
OU-4 SEDIMENT STABILITY TECHNICAL MEMORANDUM	
BOTTOM ELEVATION IN CHOCTAWHACHEE CREEK SEDIMENT WITH DISTANCE FROM LAKE LOGAN MARTIN

Bathymetry and gradient: Water depths and spatial changes in sediment and water surface elevations were considered in assessing sediment stability. In general, deeper water is an indication of depositional areas where the sediment is expected to be more stable than in shallower areas. The sediment in deeper water areas is less likely to be disturbed during typical flows and periodic high flows. Spatial changes in sediment and surface water elevations were also considered in assessing stability. Areas with rapid changes in bed and water surface elevations (steeper slopes) tend to correlate with areas of higher velocities and lower bed friction and, consequently, are most likely to be areas of less stable sediment. Areas with little change in bed and water surface elevations (shallow slopes and, thus, lower water velocities) are an indication of potential deposition and sediment is expected to be more stable in these areas. Available bathymetry data were reviewed to assess potential sediment stability. The results of this assessment are summarized in Table 1. In addition, sediment bed elevation data for Choccolocco Creek are plotted on Figure 2, water surface elevation data are plotted on Figure 3, and water depths are plotted on Figure 4.

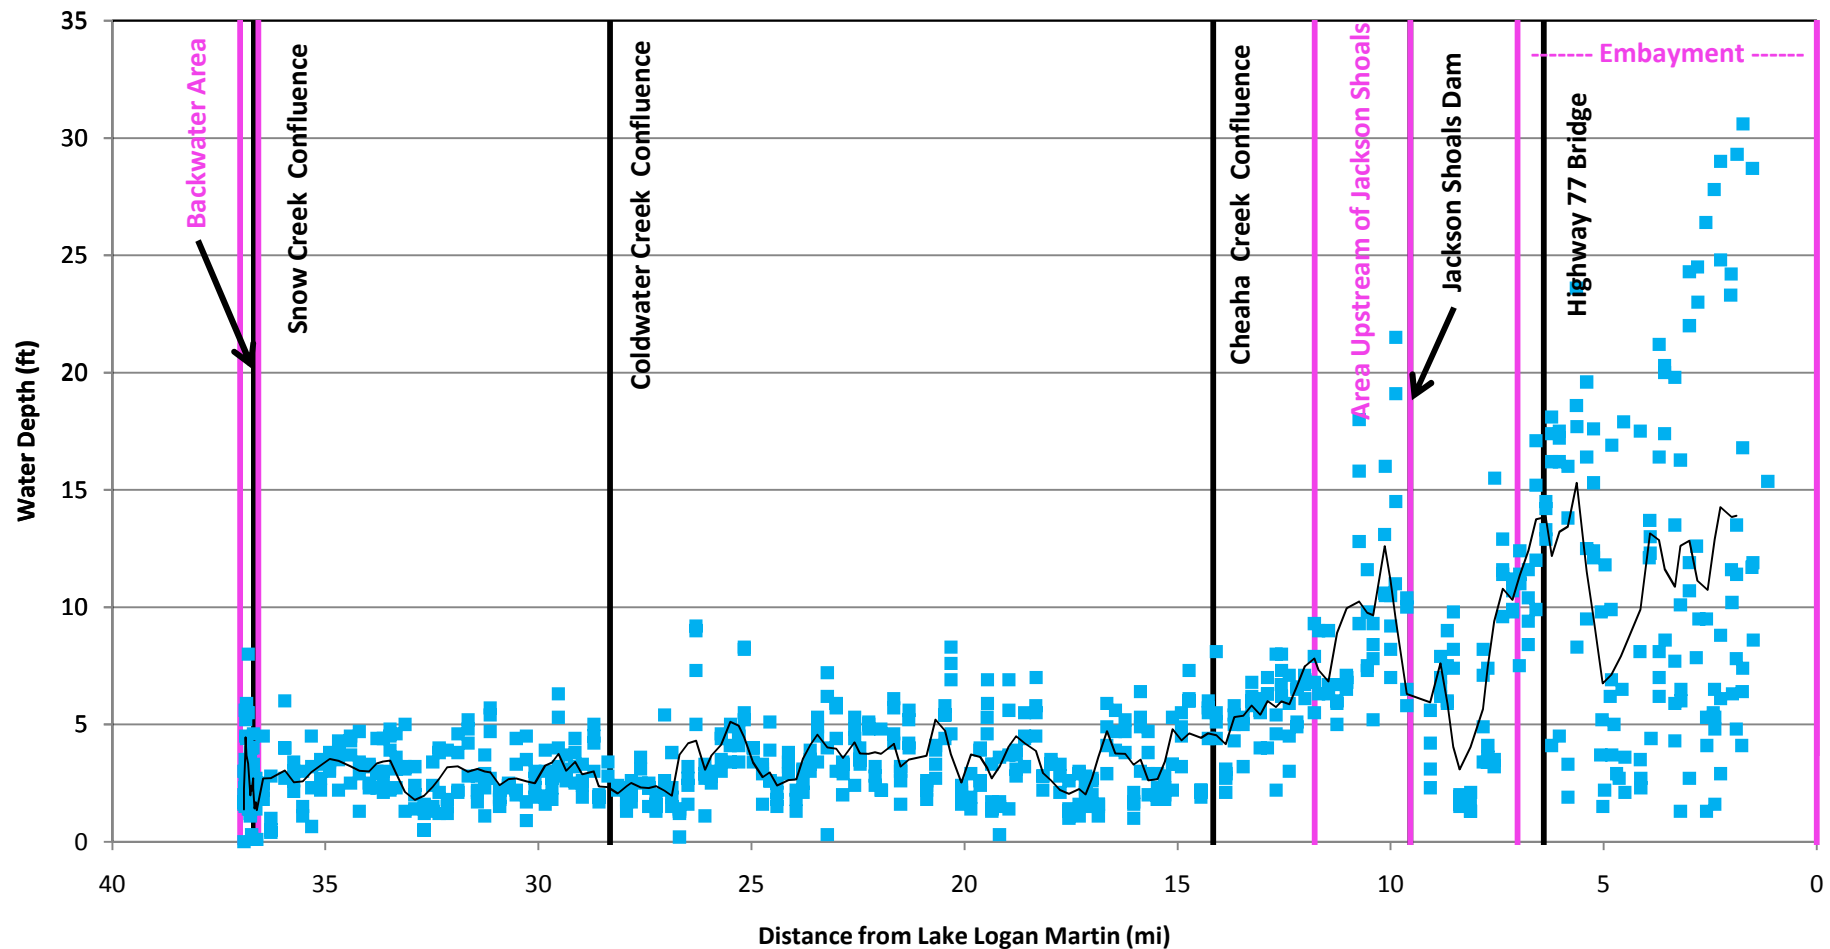
1. Based on probing data from 769 locations

WATER DEPTH IN CHOCCOLOCCO CREEK WITH DISTANCE
FROM LAKE LOGAN MARTIN

As discussed above, the overall stream gradient in this area is very low at 0.35 feet/mile (Figure 3) and water depths are significantly deeper than the rest of the creek (9.6 feet vs. 3.7 feet for the rest of the creek, Figures 4 and 11). As expected with the deeper waters, the water velocities measured during the Off-Site RFI, under base flow conditions, were lower than those measured in the rest of the creek. In general, PCB concentrations in this area were less than 3 mg/kg with an average concentration below approximately 1 mg/kg (0.73 mg/kg).

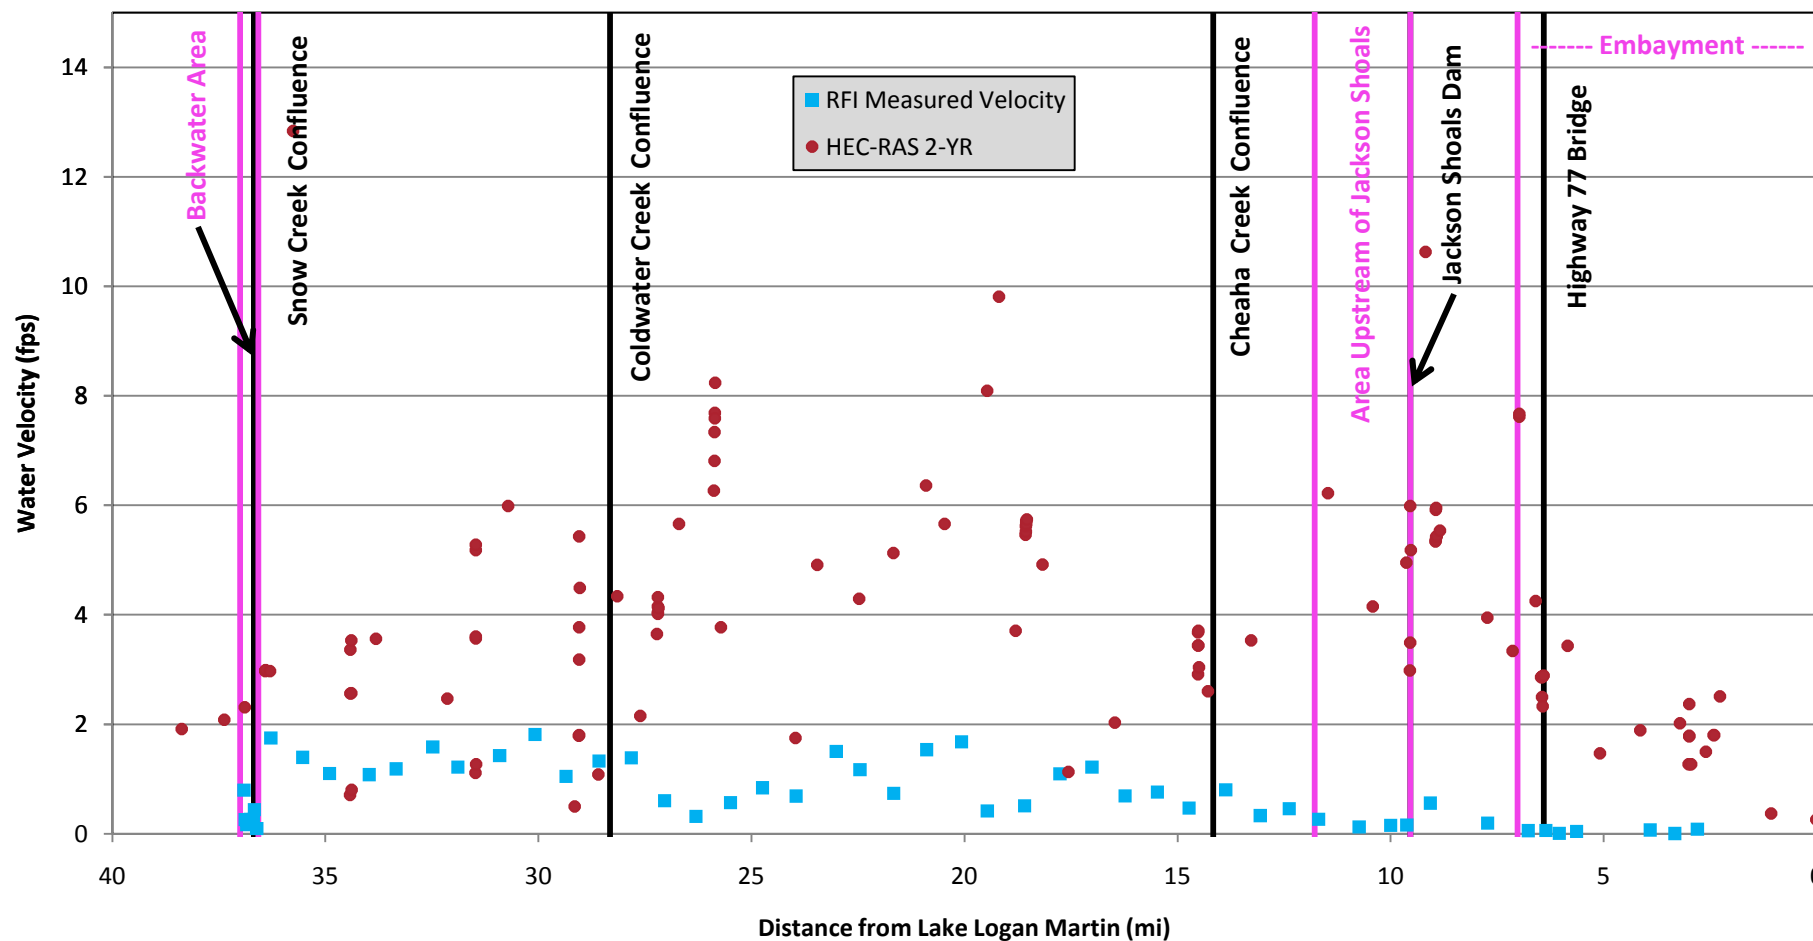
5

1. Measured data collected during off-site RFI base flow conditions
2. Model data based on the Off-Site RFI HEC-RAS model for a 2-yr flow event

WATER VELOCITY IN CHOCCOLOCCO CREEK WITH
DISTANCE FROM LAKE LOGAN MARTIN

Water Velocity and Flow Events: Areas with higher water velocities and high velocities during high flow events increase the potential for sediment to be less stable. Water velocities were measured during base flow conditions as part of the Off-Site RFI program and are shown on Figure 5. Flows were also modeled for a 2-year flow event as a part of the Off-Site RFI using the Hydrologic Engineering Centers River Analysis System (HEC-RAS) model (U.S. Army Corps of Engineers 1998). The 2-year flow event was selected for this evaluation as out-of-bank flow typically occurs during this event and, at higher flows, much of the additional surface water conveyance occurs outside of the defined channel. During these higher flow conditions, the in-creek surface water velocities are generally on the same order as the 2-year event. The estimated water velocities for the modeled 2-year flow event are also shown on Figure 5. The measured and modeled water velocities for Choccolocco Creek are summarized in Table 1. In addition, actual flow data and measured peak flow events from United States Geological Survey (USGS) gauging stations in Lincoln, AL and at Jackson Shoals were reviewed and are shown on Figure 6. As shown on Figure 6, flows in the Choccolocco Creek are highly variable and several flow events have been documented exceeding 2-year and 10-year return intervals which indicate that the creek has been subject to several events at flows with the potential to cause erosion.

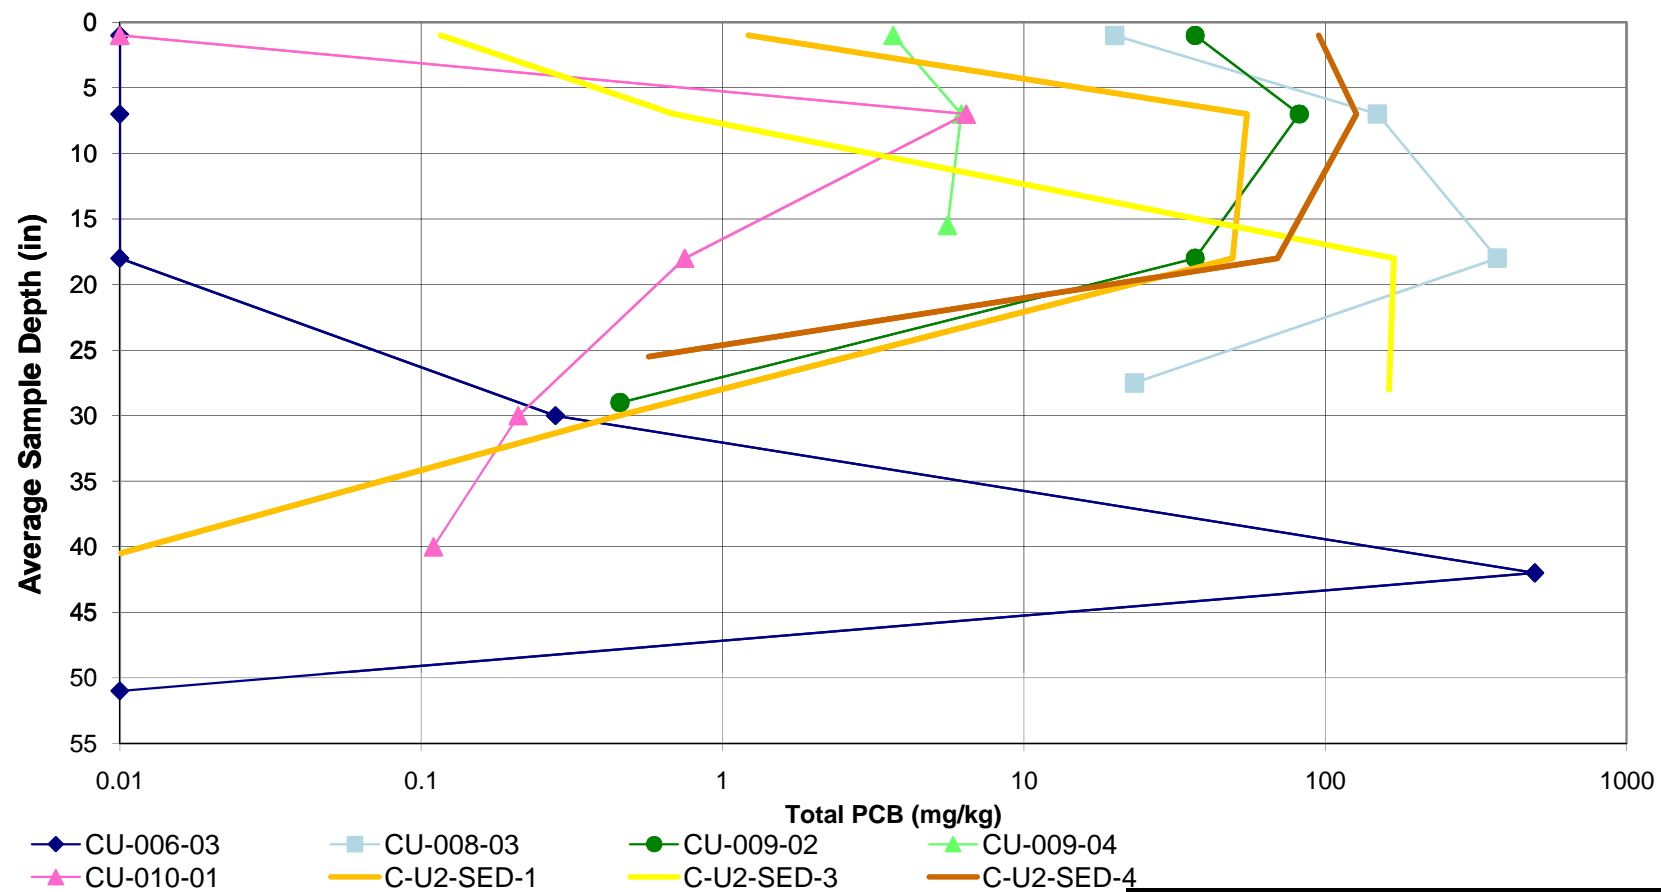
FIGURE 14

1. Based on core locations with maximum PCB concentrations greater than 5 milligrams per kilogram.
2. RFI locations include: C-U2-SED-1, C-U2-SED-3, and C-U2-SED-4.

ANNISTON PCB SITE ANNISTON, ALABAMA	
OU-4 SEDIMENT STABILITY TECHNICAL MEMORANDUM	
BACKWATER AREA SEDIMENT PCB PROFILES

PCB Data: PCB data and overall sediment thickness (discussed above) were also assessed to evaluate sediment stability. Based on our knowledge of the site and distribution patterns in OU-4 as described in the CSM, a simplistic approach is to expect that older, deeper deposits of finer grained material will correlate with higher PCB concentrations. More recently deposited material closer to the surface would generally be expected to have lower concentrations of PCBs. This simplistic approach is important in evaluating sediment stability in areas upstream and closer to the source. However, it does not fully recognize the complex dynamics of transport downstream. In actuality, constituents are transported downstream in conjunction with sediment particles, and more with finer grained particles, in a continuous and gradual process of desorption, dissolution, and re-adsorption. This process may contribute to different sediment profiles farther downstream from the source area than upstream areas closer to the source area. PCB profiles are summarized in Table 1 and are discussed in more detail in Section 4.

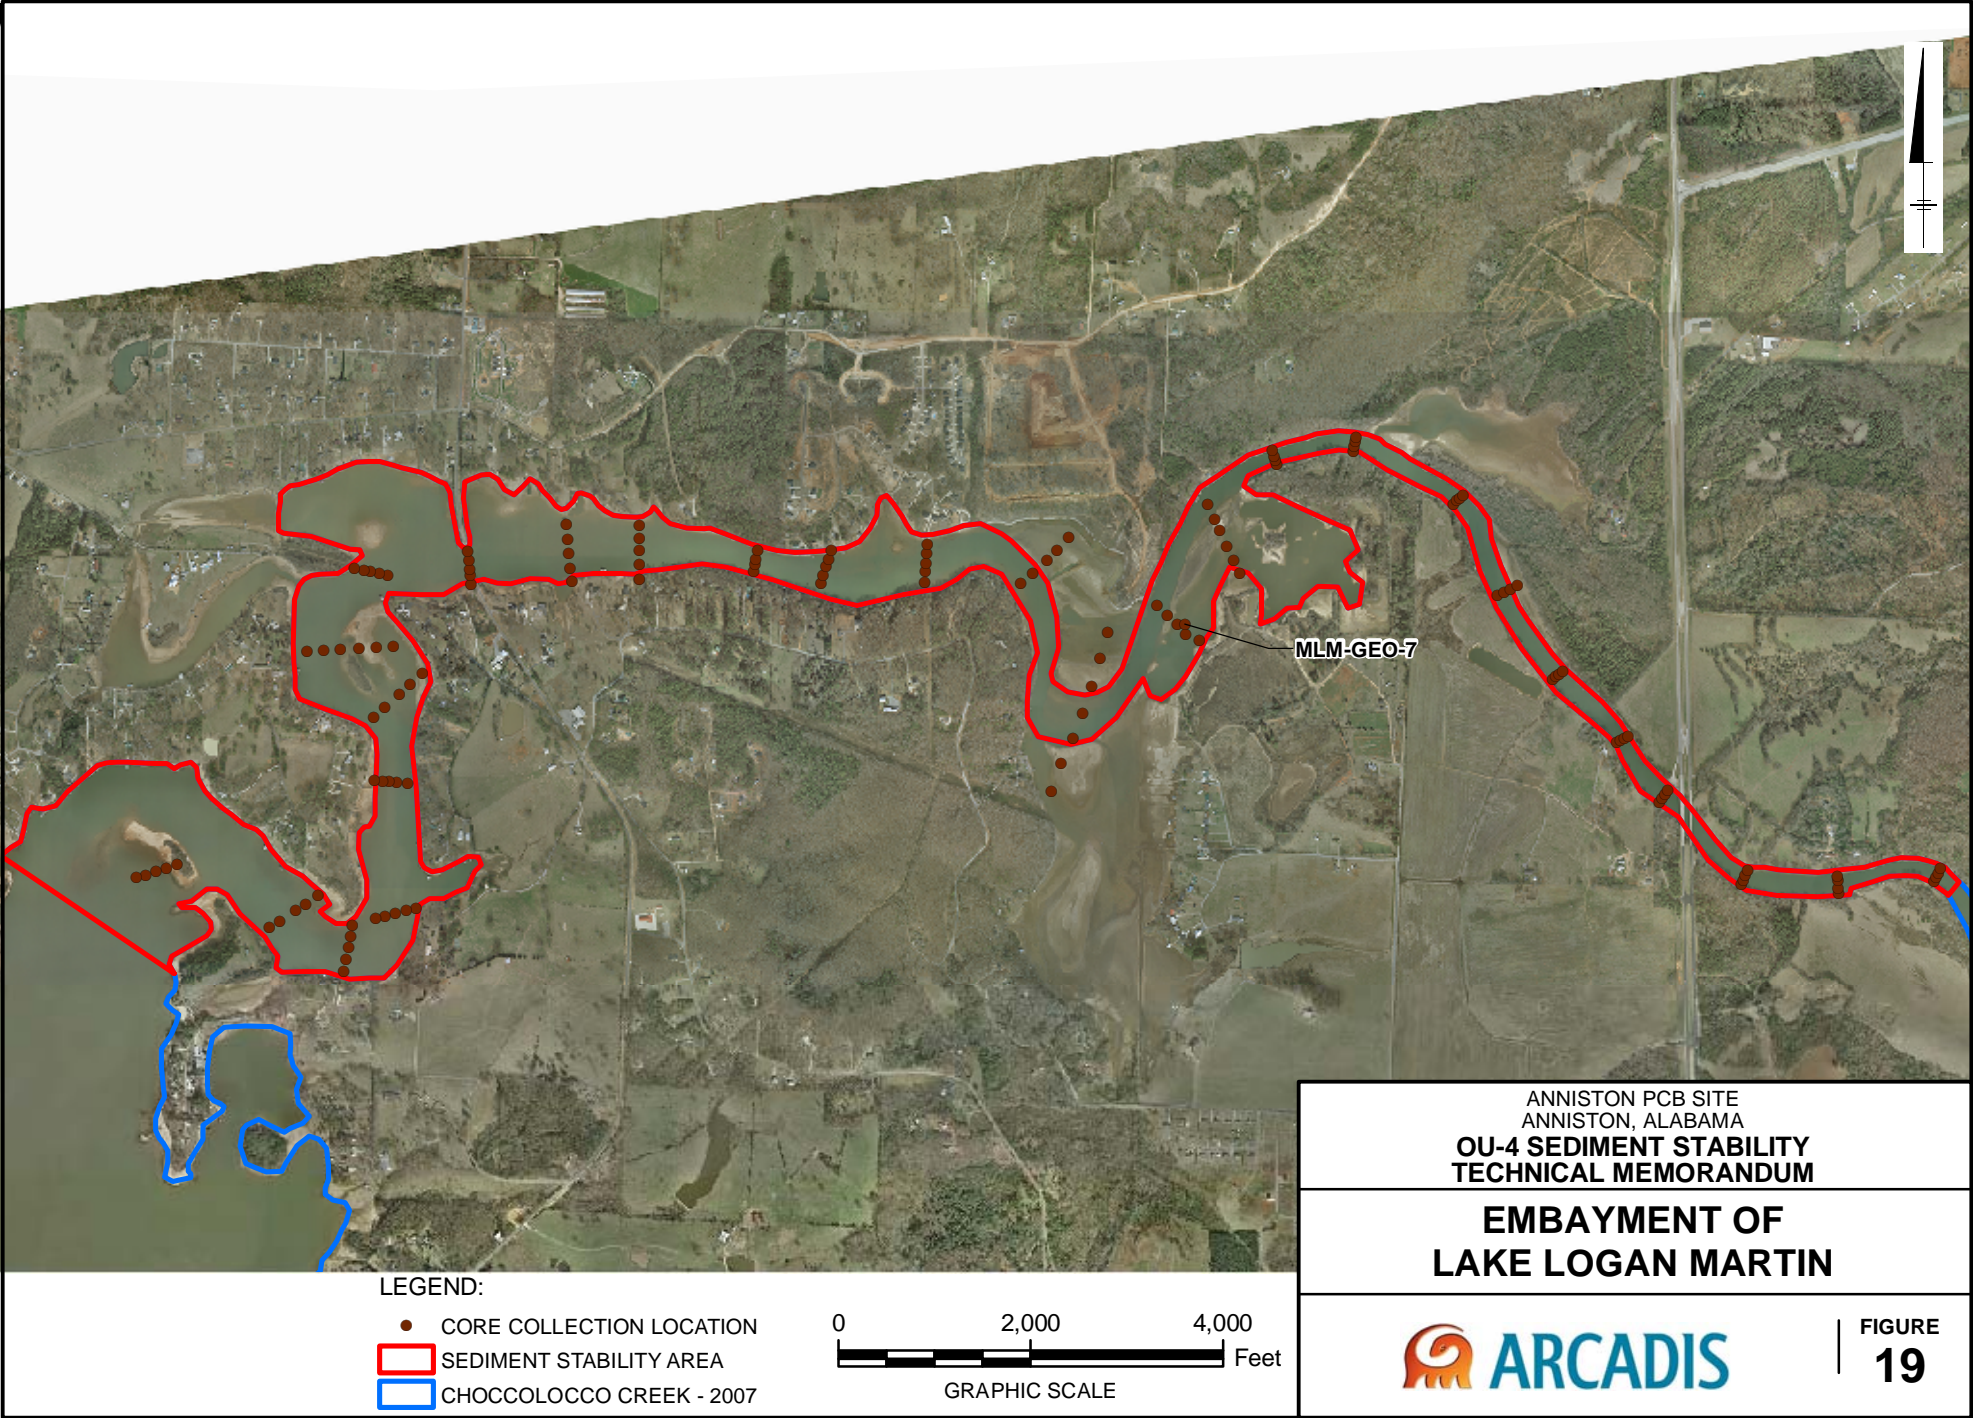
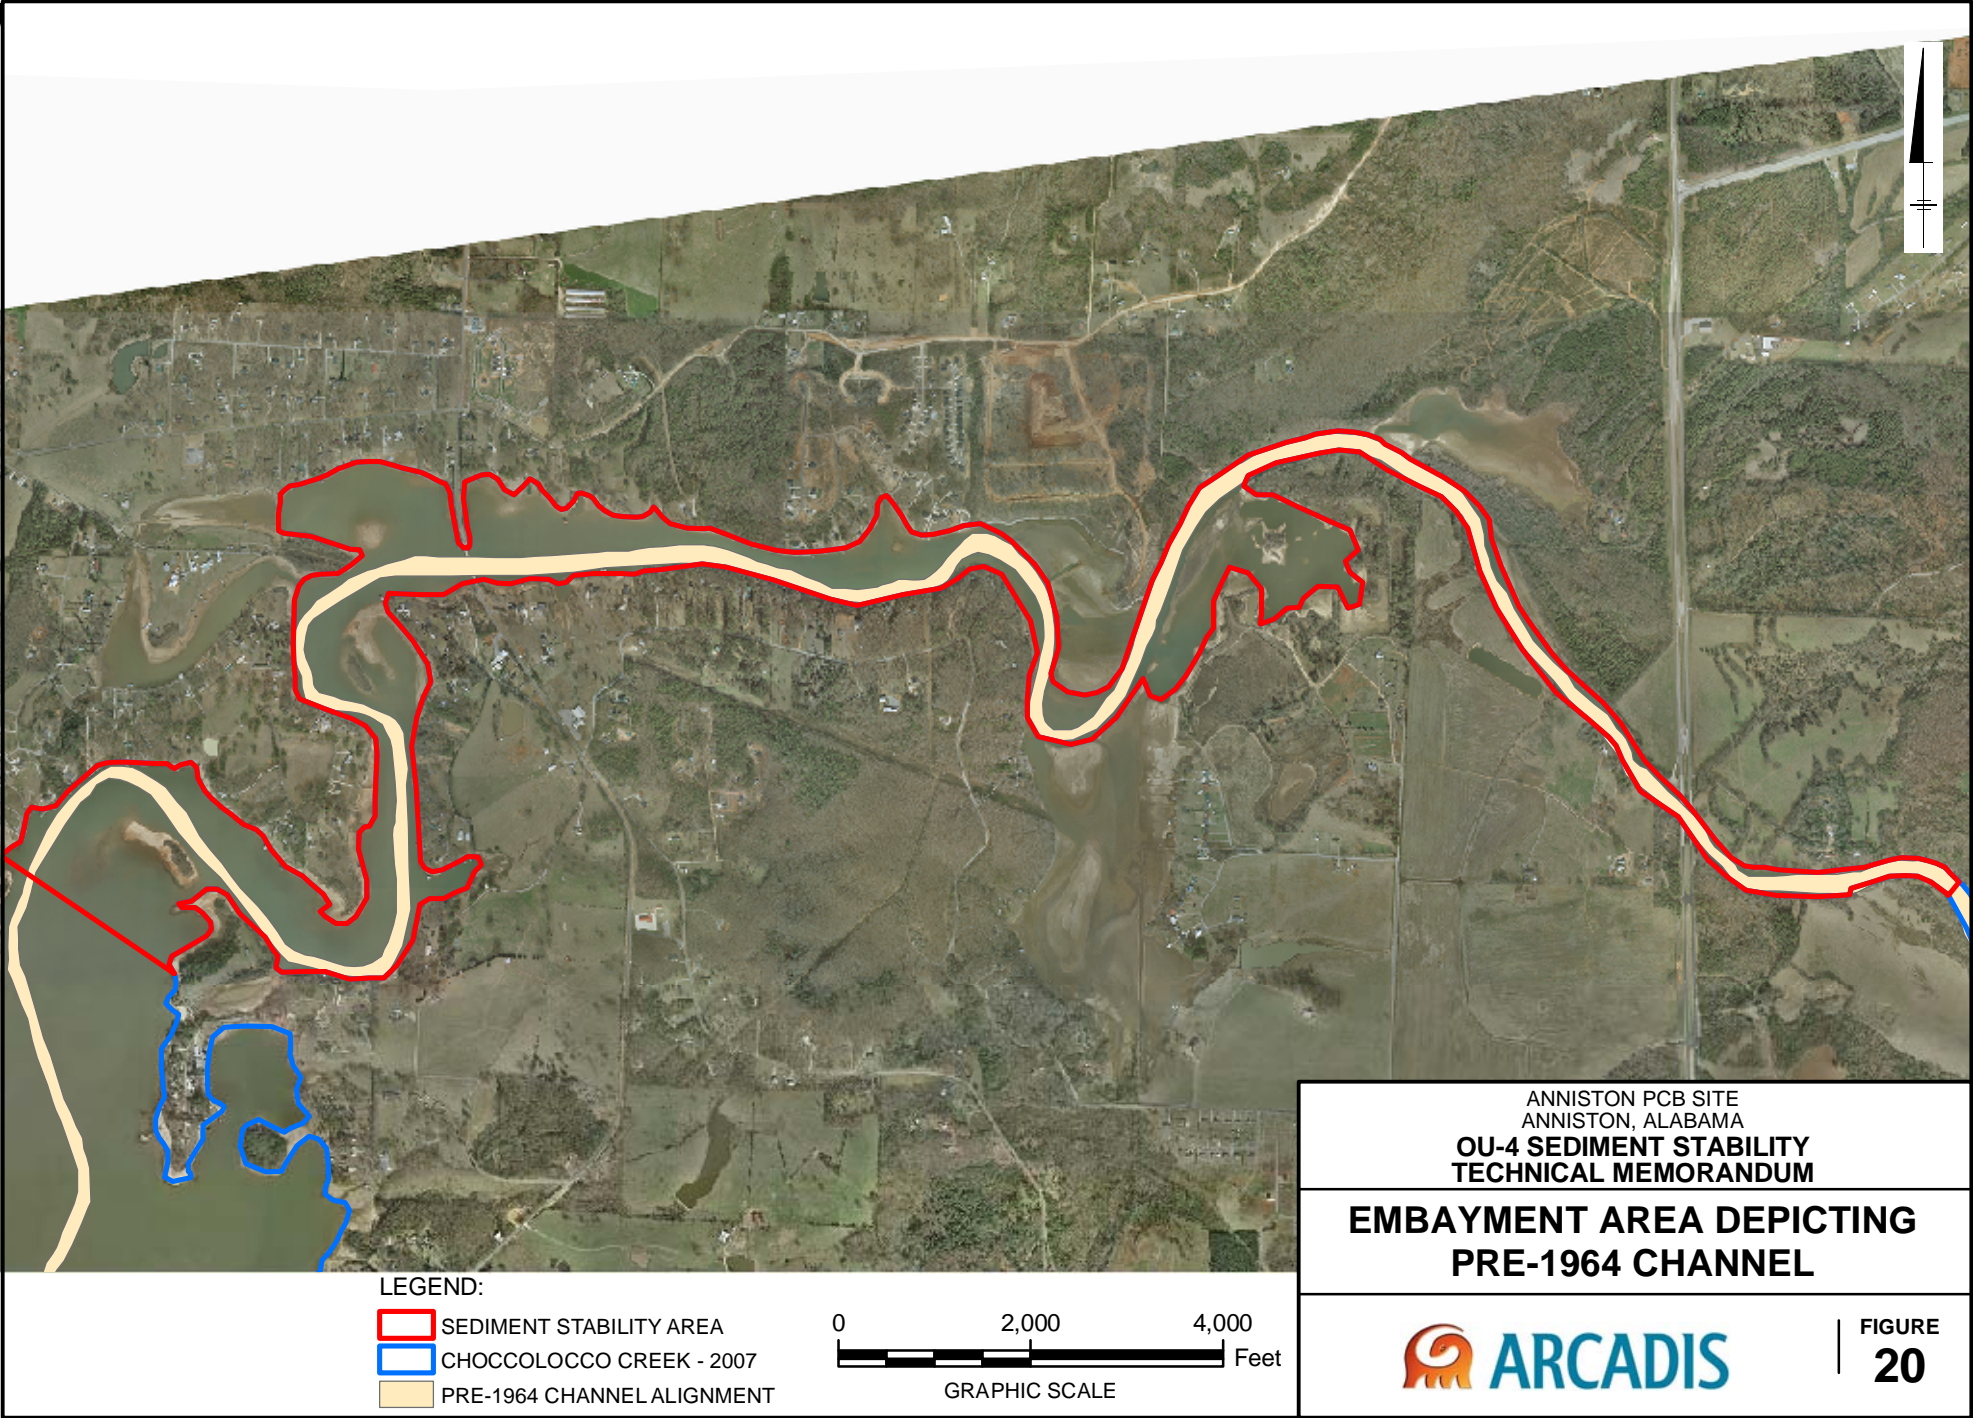
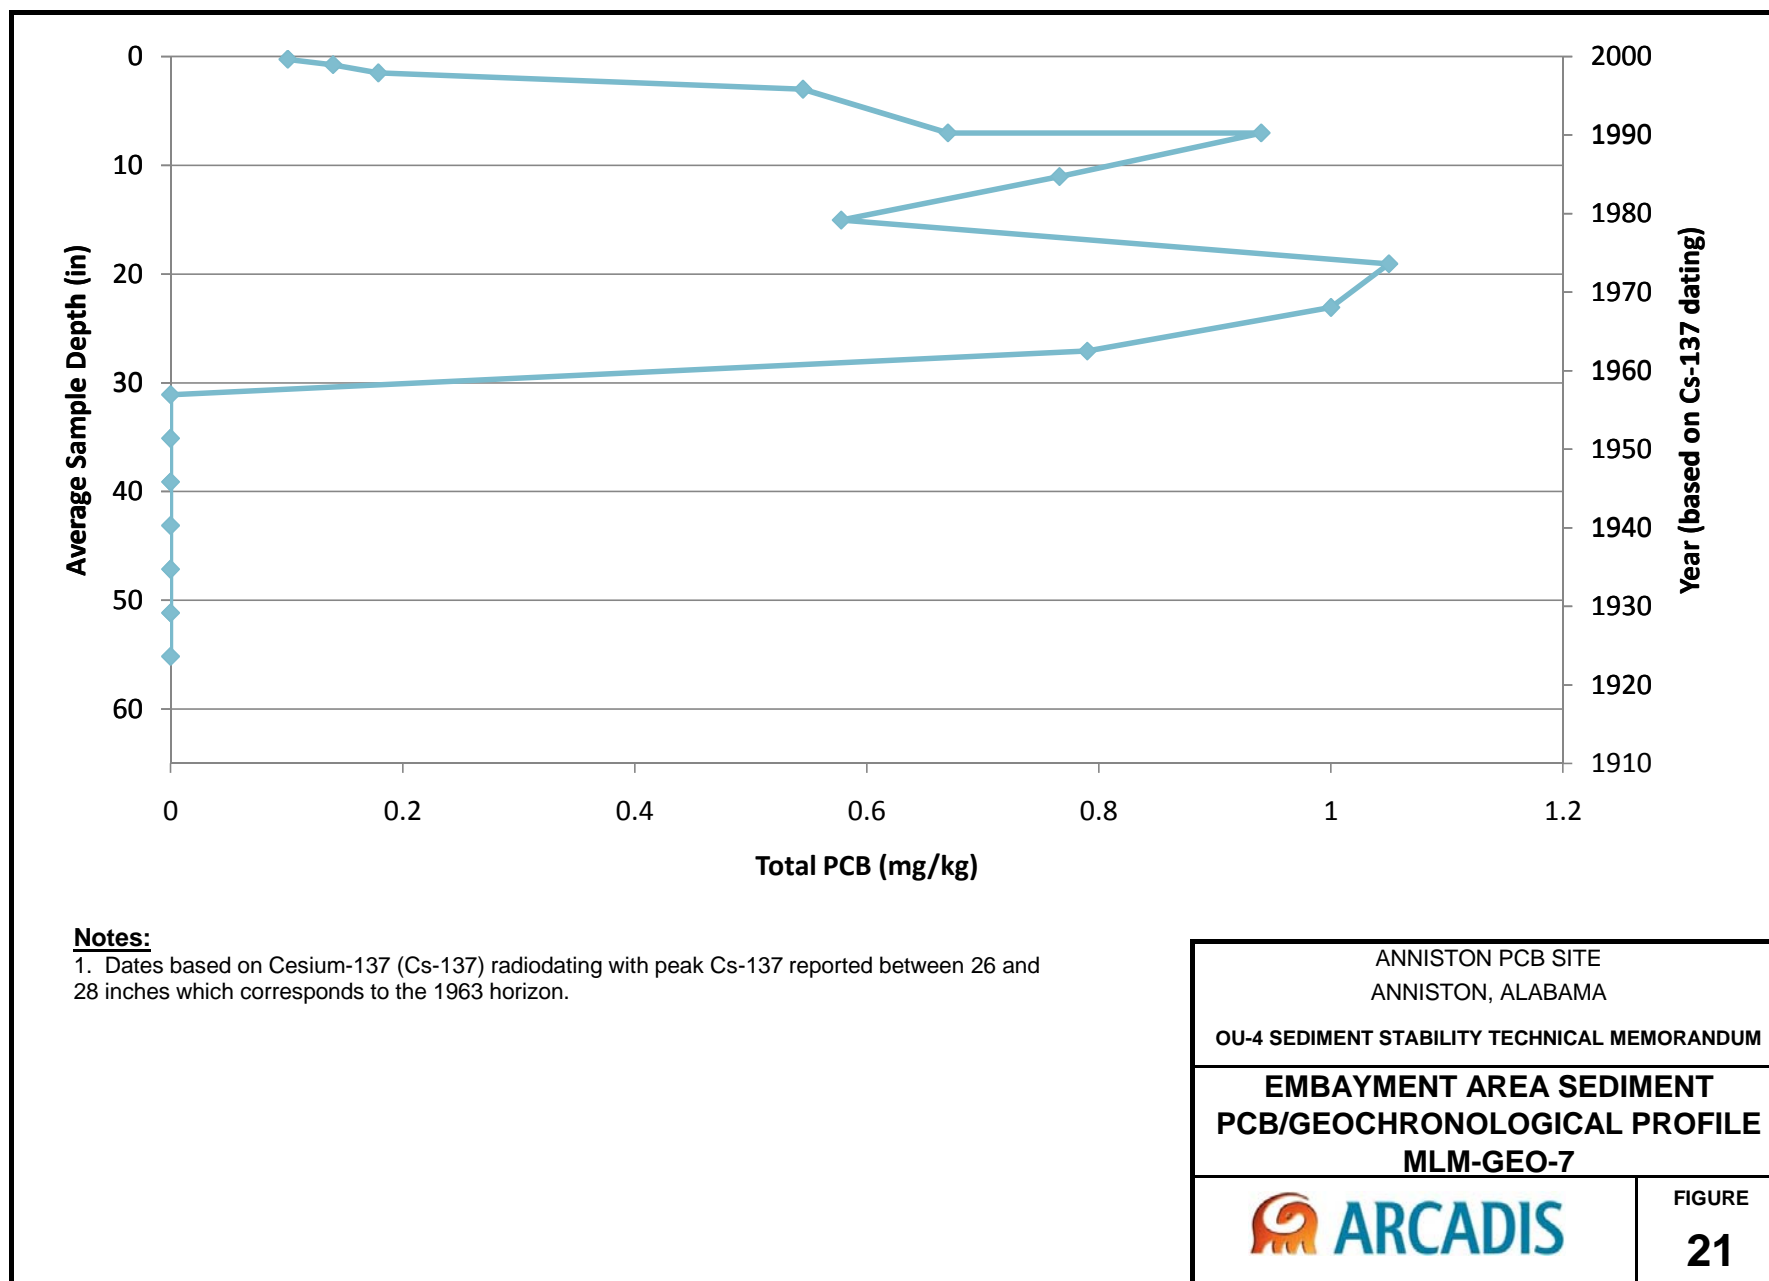
FIGURE
18

Despite the relatively low surface water velocities, sediment thickness in this portion of the creek is approximately 1 foot (Figures 7 and 11). Only two cores from this section of creek had at least 1 foot of recovered sediment and PCB concentrations over 1 mg/kg. These two cores are depicted on Figure 18, which shows that the maximum PCB concentrations are less than 1.5 mg/kg and the higher PCB concentrations are near the surface. Given that PCBs have not been manufactured at the Facility for nearly 40 years, these data indicate relatively low sediment deposition rates over time for this portion of the creek. A low sediment deposition rate is also consistent with the relatively thin sediment deposits measured in this portion of the creek. The thin sediment deposits, in combination with the low sediment PCB concentrations, result in relatively low total PCB mass for this section of the creek (approximately 3% of the total PCB mass for Choccolocco Creek).

PCB Profiles	14, 15, 18, 21	Peak PCB levels found below surface with highest detected concentration deeper than 3 ft below sediment surface	Highest PCB at surface decreases with depth - Average PCB concentrations ~ 1 mg/kg	Average PCB concentration well below 1 mg/kg (average = 0.34 mg/kg)	Profiles not evaluated
Radioisotope Dating	15, 21	Peak PCB concentrations correspond to late 1940s, PCB concentrations decrease since then	No isotope data collected	Peak PCB concentration corresponds to early 1970s, secondary peak around 1990	No isotope data collected
Changes in Channel Alignment Historic Photos, Manmade Changes	13, 17, 20	Some channel shifting due to human activity	No change in channel alignment over 70 years	Section impounded in 1964 - increase in cross sectional area enhances deposition	NRCS Channel Cutoffs - photo comparison not evaluated
