Re: Anniston PCB Site
Revision 1 of the *Screening Level Ecological Risk Assessment for Operable Units 1, 2, and 3*

*Screening Level Ecological Risk
Assessment (SLERA)
for Operable Units 1, 2, and 3
of the Anniston PCB Site*

**Anniston PCB Site
Anniston, Alabama**

**Revision 1
December 2005**

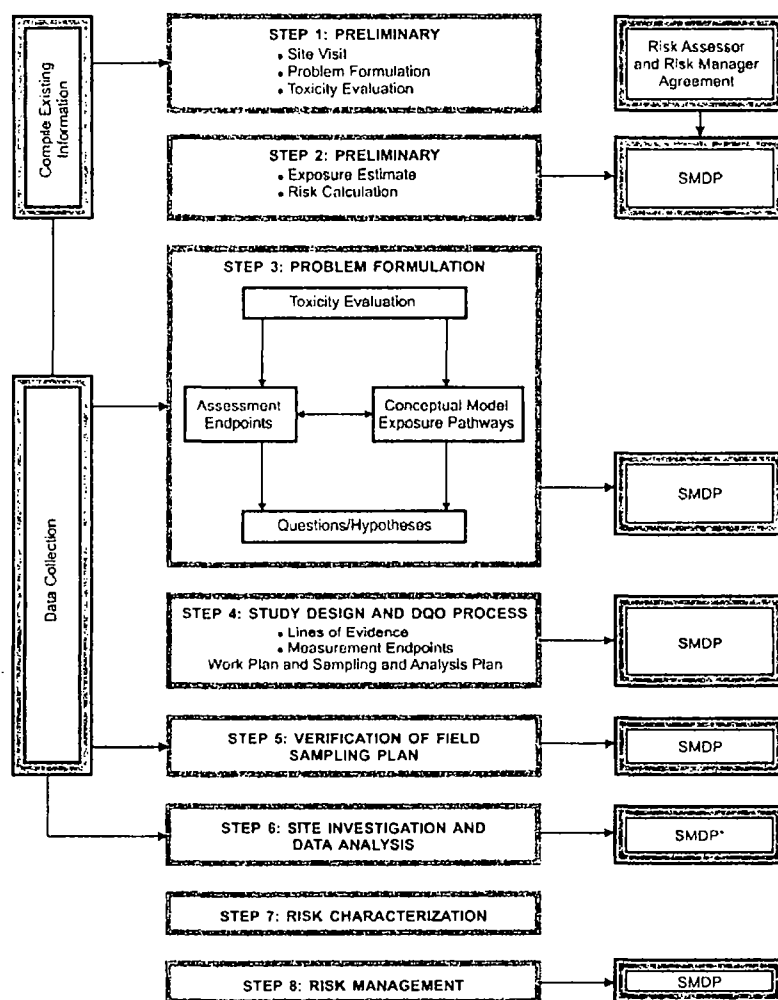
USEPA's Eight-Step Process for Conducting Ecological Risk Assessments

This report was developed in accordance with the CD and the eight-step process described by the USEPA in the *Ecological Risk Assessment Guidance for Superfund: Process for Designing and Conducting Ecological Risk Assessment* (see figure on next page, adapted from USEPA, 1997a) and follows the recommendations of the USEPA's supplemental guidance document, *Amended Guidance on Ecological Risk Assessment at Military Bases: Process Considerations, Timing of Activities, and Inclusion of Stakeholders* (USEPA, 2000). The methodology developed by the USEPA provides a rational, science-based approach for evaluating ecological risks for remedial decision making and the Site administrative record. This report describes the completion of the screening level portion of the ecological risk assessment process using readily available exposure media data (Steps 1 and 2 of the ecological risk assessment process).

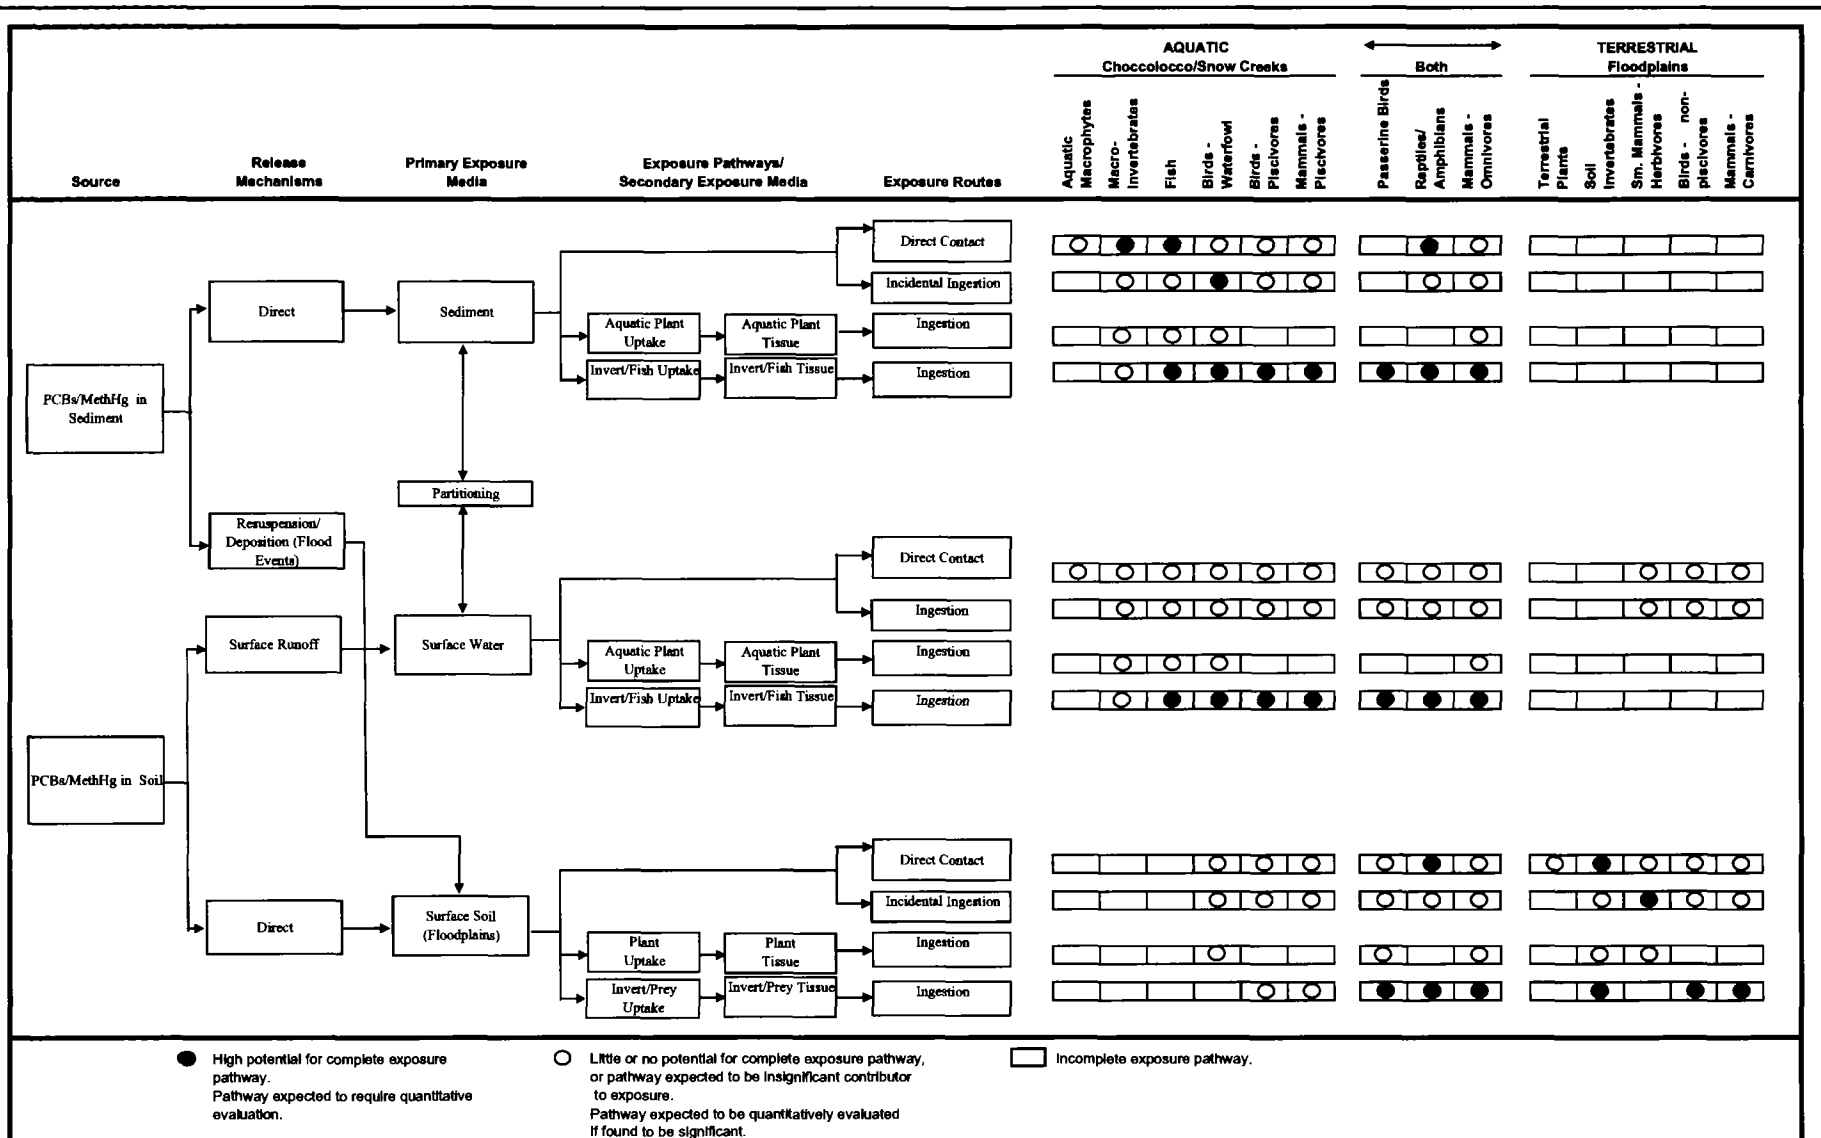
FIGURE
3

ANNISTON PCB SITE
ANNISTON, ALABAMA
**SCREENING LEVEL ECOLOGICAL RISK ASSESSMENT
FOR OPERABLE UNITS 1, 2, AND 3**
**CONCEPTUAL EXPOSURE MODEL FOR
ECOLOGICAL RECEPTORS: PCBs & METHYL
MERCURY**

The exposure pathway diagram on Figure 3 illustrates the hypothetical links between the stressors (PCBs and methyl mercury) in sediment, surface water, surface soil, and prey and the potential ecological receptors. In aquatic systems, PCBs and methyl mercury readily adsorb onto sediments and may be transferred to aquatic organisms and to higher trophic levels. Methyl mercury and, especially, PCBs are found only in a dissolved state within the water column at very low concentrations (MacKay et al., 1992); organic matter in sediments provides the primary reservoir (NRC, 2001). PCBs and methyl mercury accumulate in aquatic organisms because of their high lipid solubility and slow rate of metabolism and elimination (MacKay et al., 1992). Although the transformation of PCBs in aquatic systems can occur via microbial degradation in aerobic surficial sediments, reductive dechlorination in anaerobic sediments, and the metabolic action of organisms that uptake PCBs, these processes are relatively slow and congener-specific (NRC, 2001). For example, less-chlorinated congeners are more likely to biodegrade than those containing a higher number of chlorine atoms. This causes

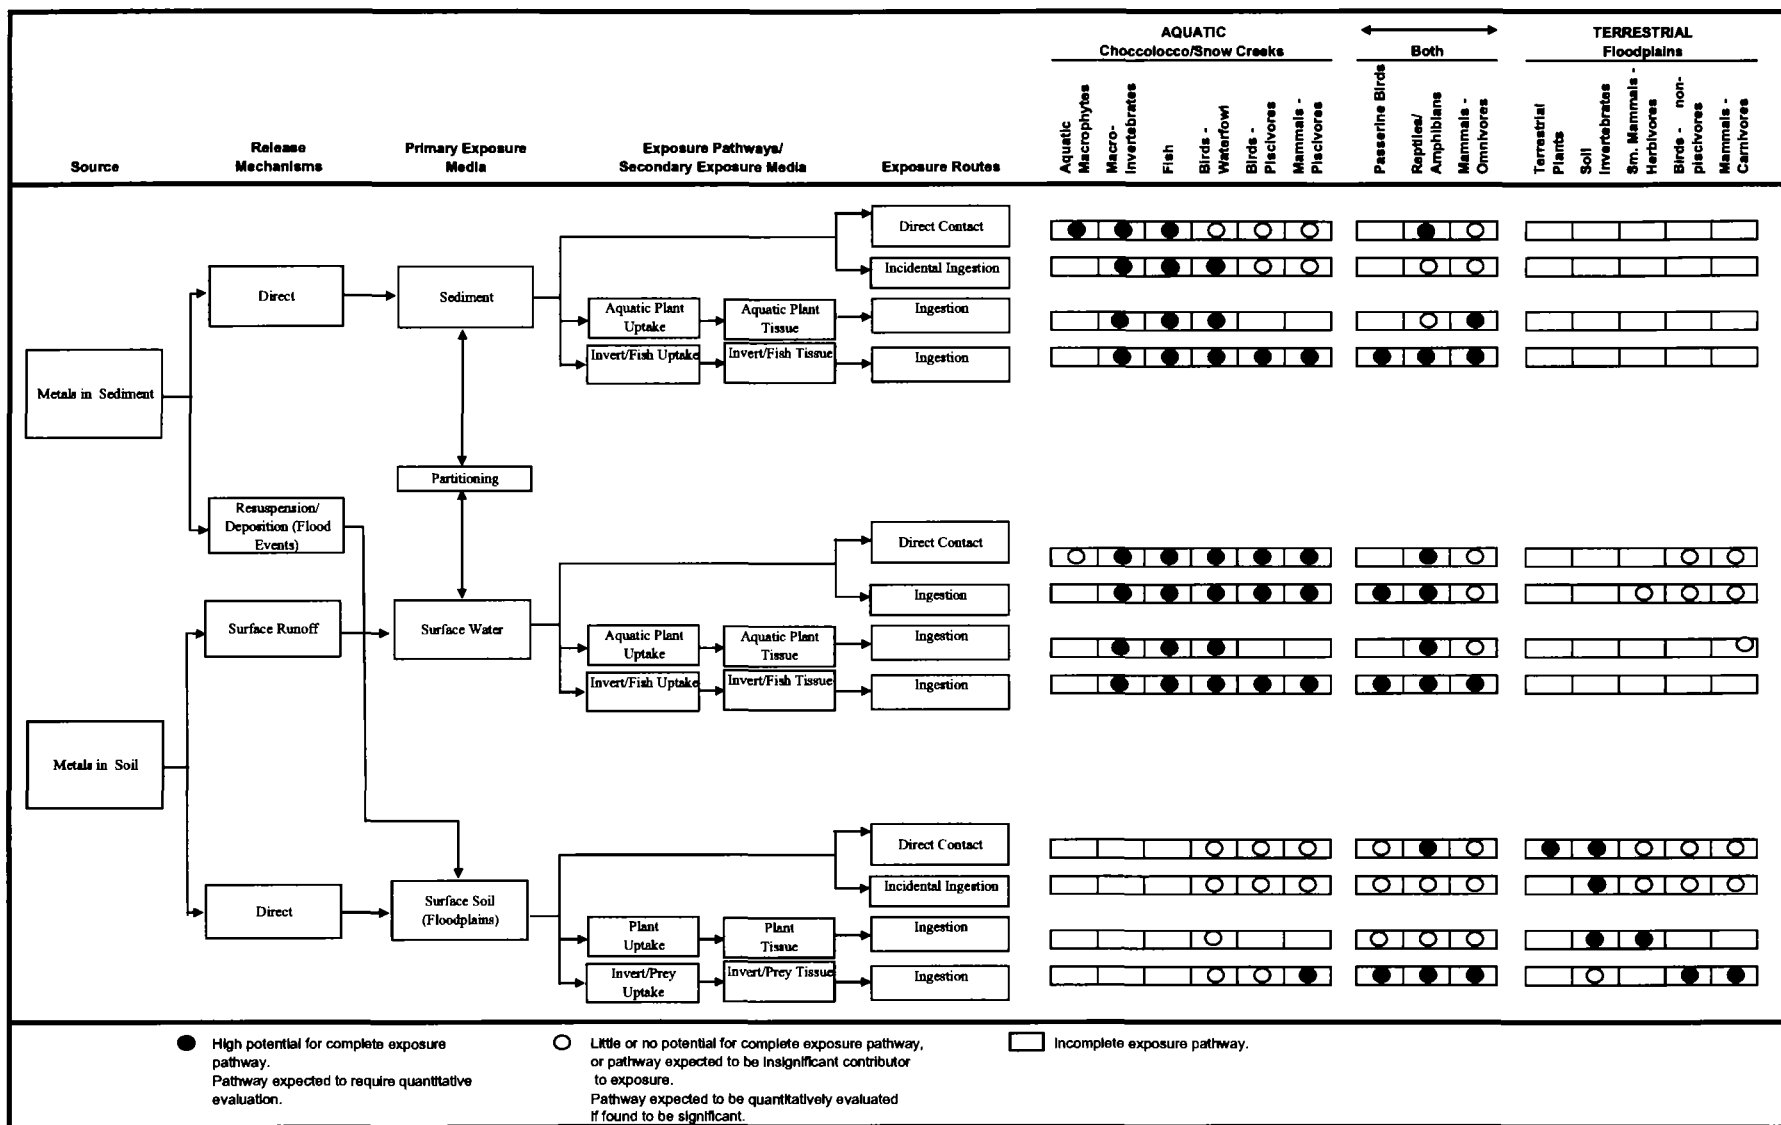
FIGURE
4

CONCEPTUAL EXPOSURE MODEL FOR
ECOLOGICAL RECEPTORS: METALS

direct uptake. Also, unlike PCBs, metals can sorb and desorb from soil and sediment with equal ease, depending on the physical and chemical conditions at a particular site or moment in time. Furthermore, although most metals may be absorbed into plant or animal tissues, they generally do not biomagnify in higher trophic levels. Using these general observations, the conclusions described below can be made about the complete pathways for ecological receptors in OUs 1, 2, and 3 that are potentially exposed to metals.

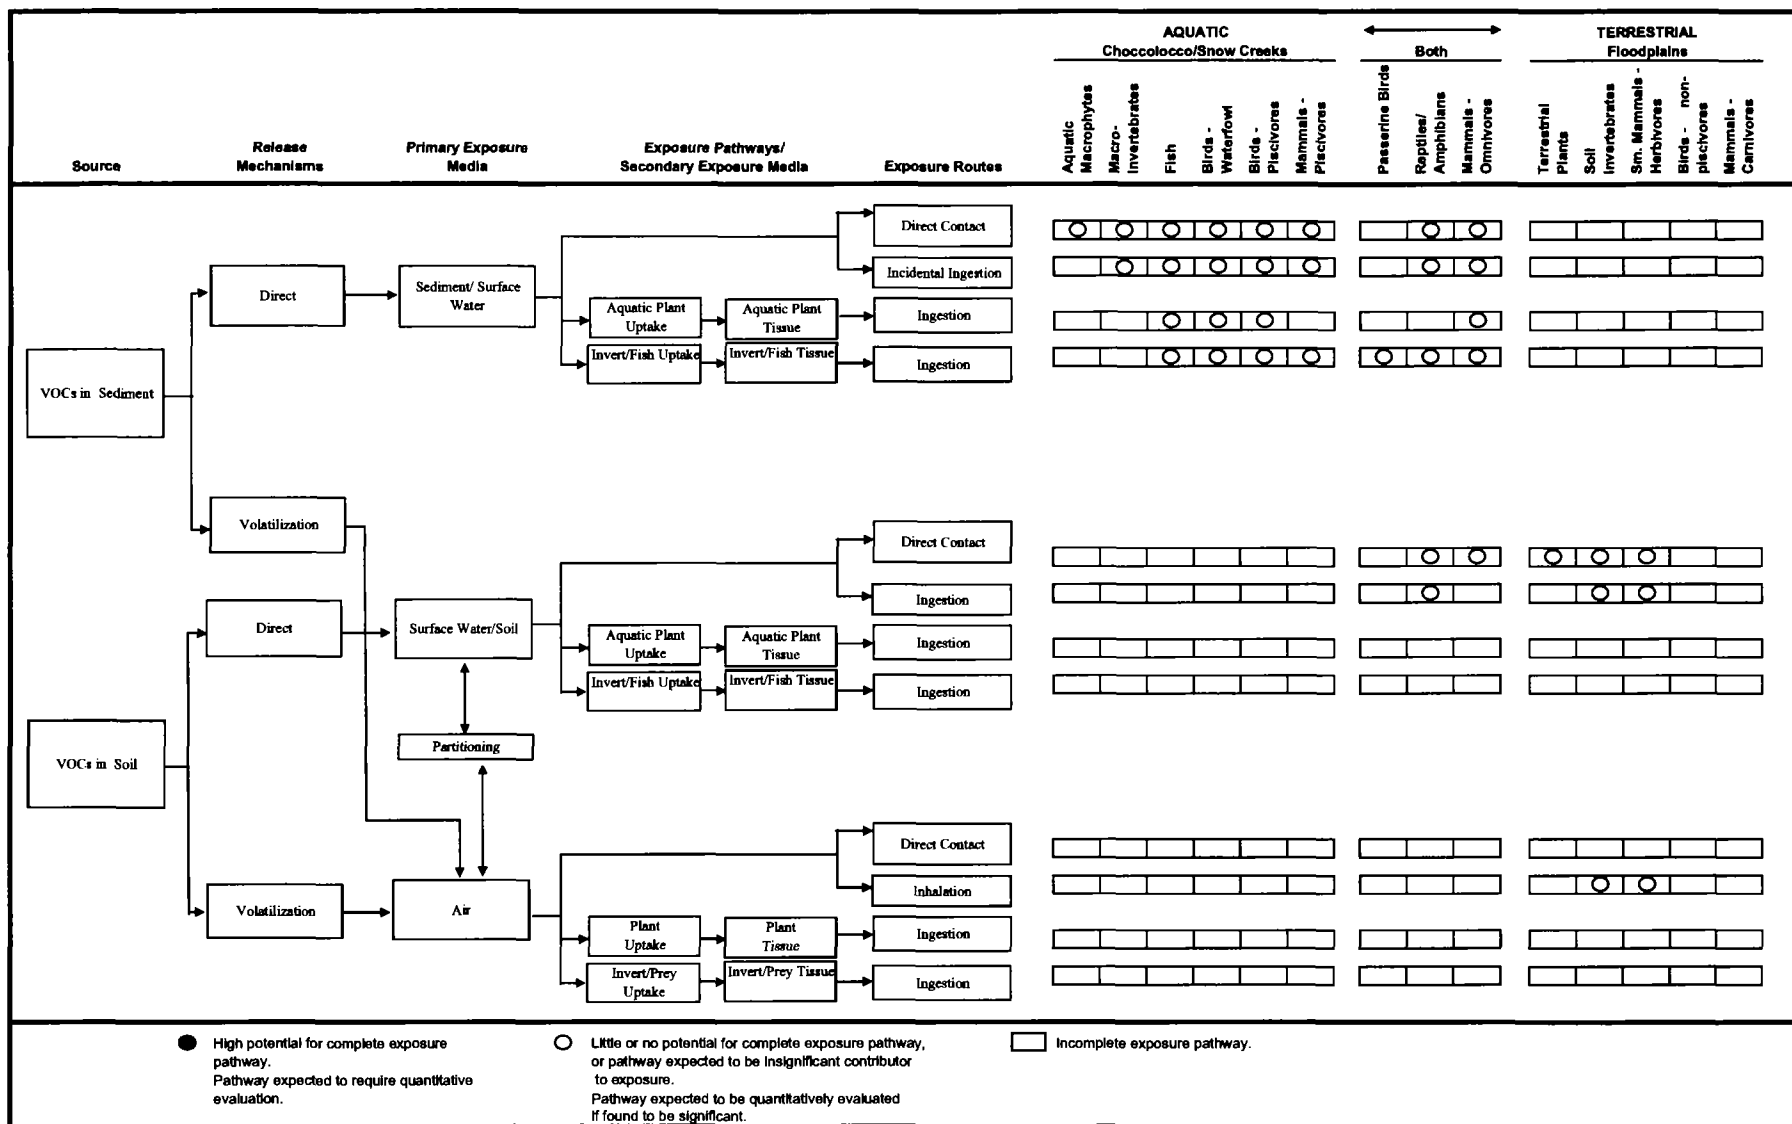
FIGURE
6

**CONCEPTUAL EXPOSURE MODEL FOR
ECOLOGICAL RECEPTORS: VOCs**

VOCs are characterized by a considerable propensity to escape from dense environmental media, such as sediment, soil, and water. Moreover, these short-chain molecules tend to degrade relatively quickly once released into the environment. Therefore, these media are usually associated with a low potential for complete or significant exposure pathways where sources are no longer active or are removed from the immediate location of a receptor. Accordingly, Figure 6 shows the potential receptors as having incomplete or insignificant exposure pathways for this group of chemicals.

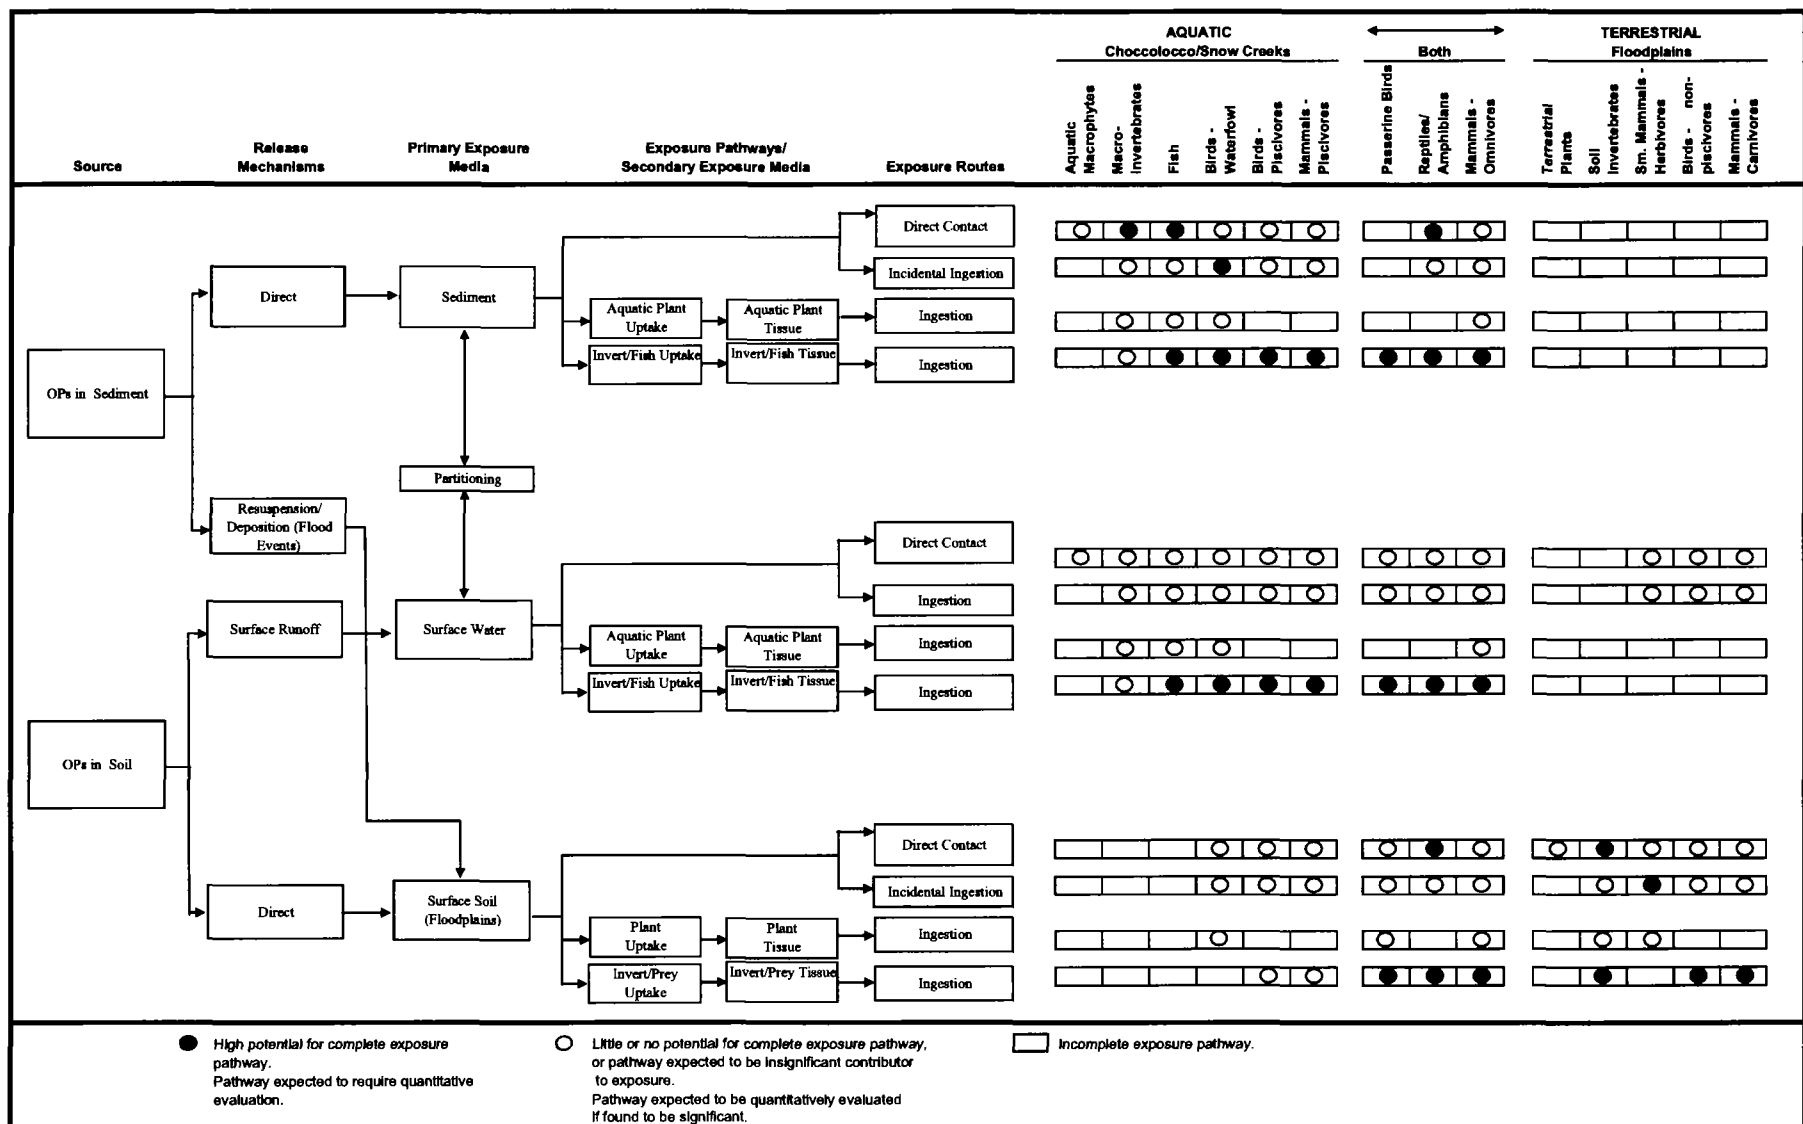
**FIGURE
7**

ANNISTON PCB SITE
ANNISTON, ALABAMA
**SCREENING LEVEL ECOLOGICAL RISK ASSESSMENT
FOR OPERABLE UNITS 1, 2, AND 3**
**CONCEPTUAL EXPOSURE MODEL FOR
ECOLOGICAL RECEPTORS:
ORGANOPHOSPHORUS PESTICIDES (OPs)**

OPs, such as parathion and sulfotepp, are less environmentally persistent than organochlorine insect control agents, such as dichlorodiphenyltrichloroethane (DDT). However, there is some potential for OPs to remain in various exposure media and to come into contact with ecological receptors. For example, methyl parathion tends to sorb to soil and may persist there for as long as two months (during fall, winter, and spring when sunlight levels are low). Persistence is measured in years in case of spills. OPs are soluble in water and, therefore, may be found in this exposure medium, as well as in soil and sediment. In aquatic systems, where the destructive action of sunlight (photolysis) may be limited, OPs may also persist long enough to affect receptors (although the absolute exposure period may be measured in days). Therefore, direct contact exposure pathways between sediment and aquatic receptors are potentially complete for those receptors that live in close proximity to sediment and tend to avoid direct sunlight (invertebrates, amphibians, and reptiles) (Figure 7). Because OPs are readily absorbed in biological tissues and subsequently stored in fat, some accumulation in prey may take place. For example, parathion is classified as having low to moderate bioaccumulation. As a result, there is a potential for complete exposure pathways between predators and prey (Figure 7). Breakdown of OPs in vegetation is rapid, so it is unlikely that herbivores would be exposed via the consumption of plants. For terrestrial systems, the species with potentially complete exposure pathways include soil invertebrates (e.g., earthworms) via direct contact, small burrowing mammals via ingestion of soil, and carnivorous mammals and birds via ingestion of prey. Volatilization of applied OPs is not considered extensive, so the air exposure medium was not included in the conceptual exposure model.

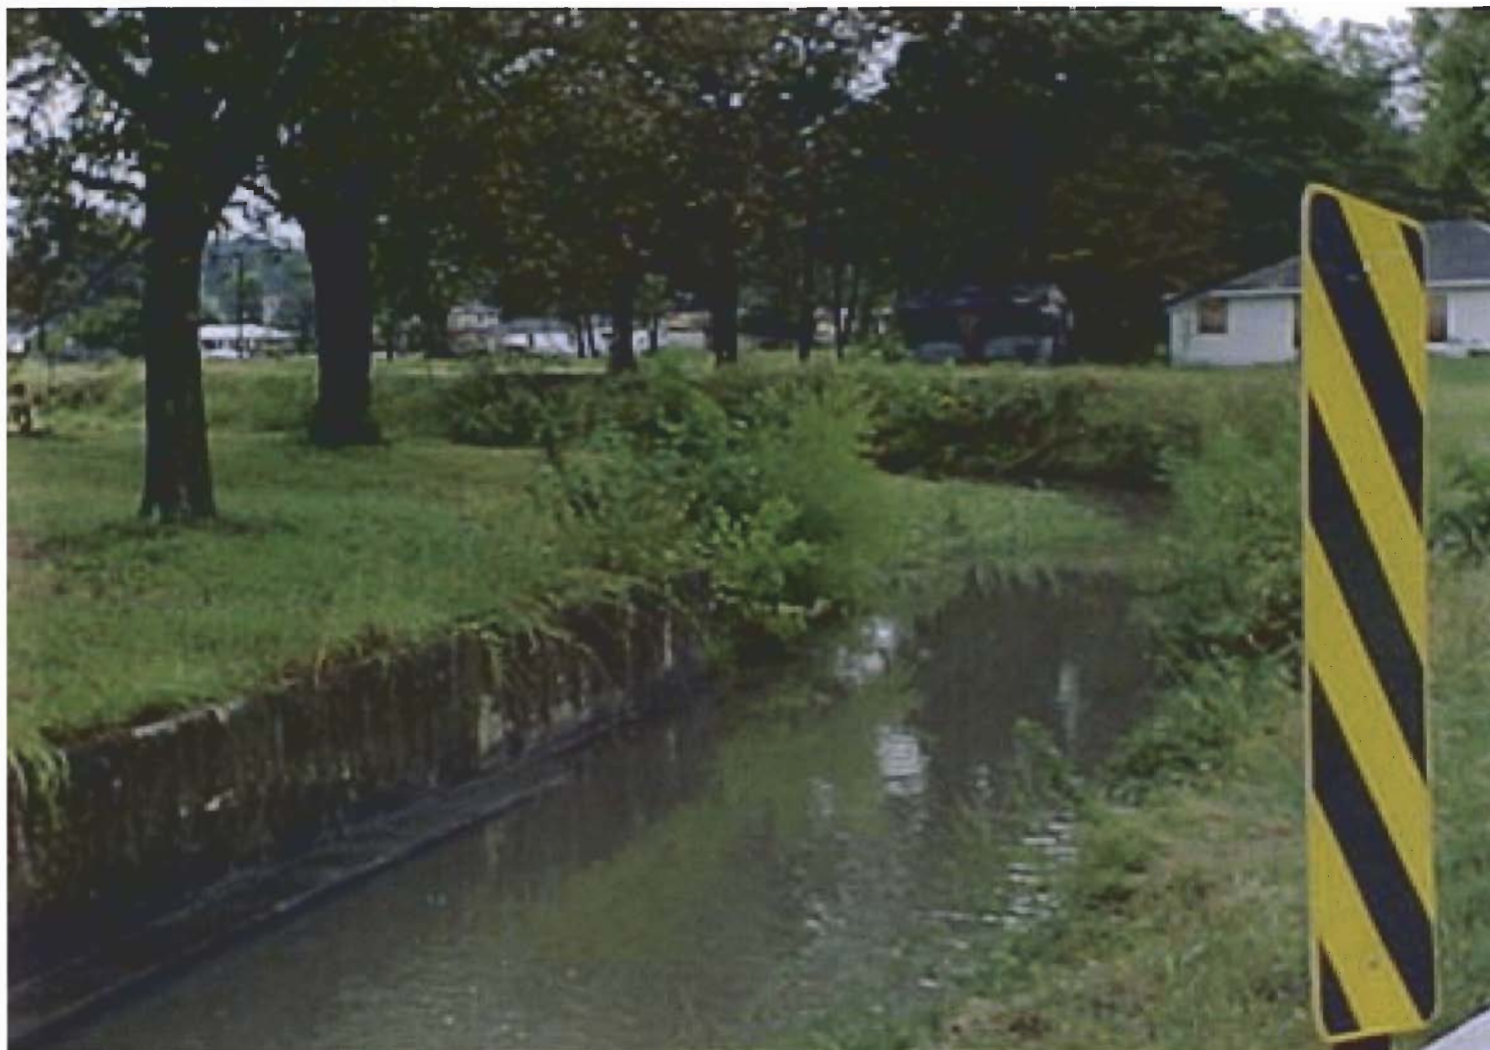
**SNOW CREEK FLOWING THROUGH A
RESIDENTIAL AREA (UPSTREAM VIEW)**

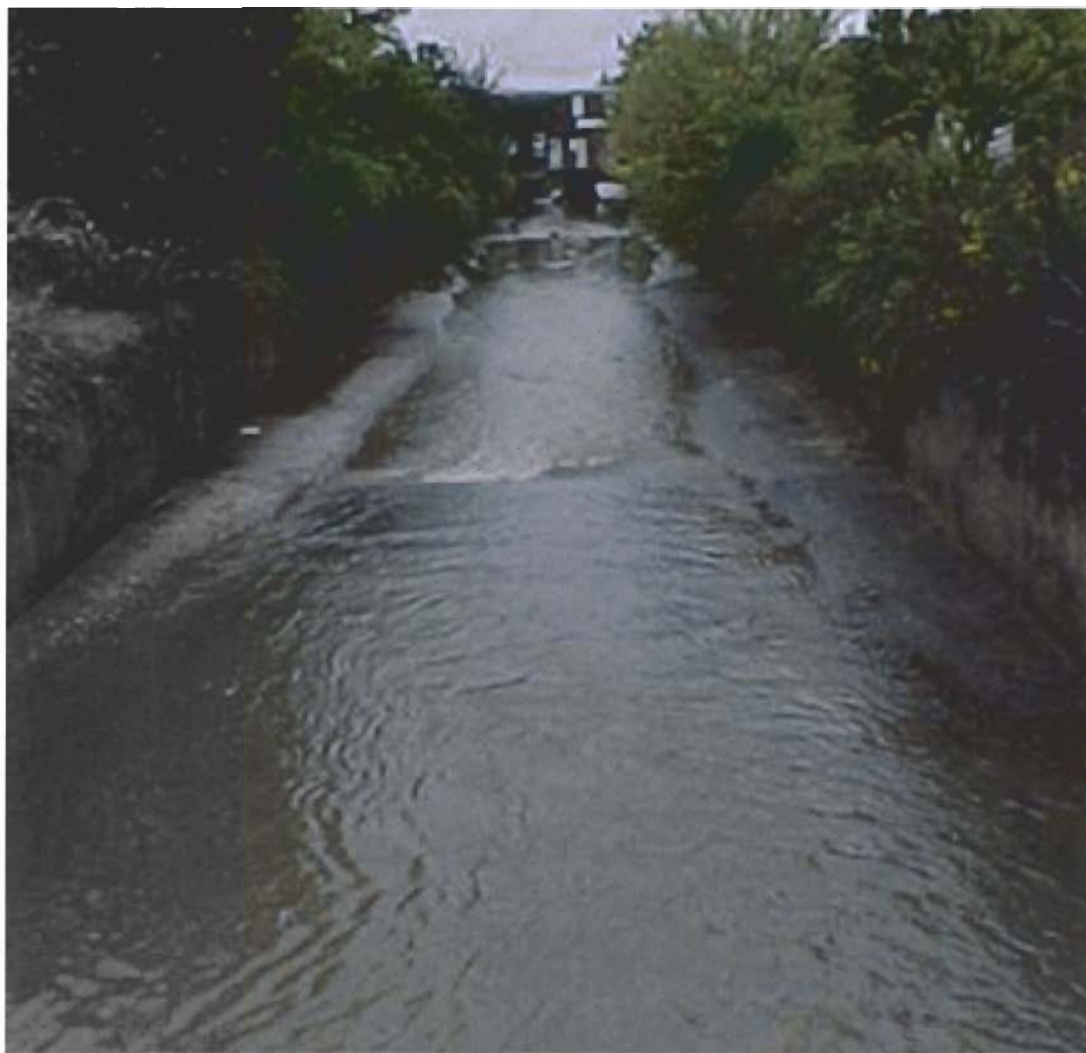
**FIGURE
8**

**SNOW CREEK FLOWING THROUGH A
RESIDENTIAL AREA (DOWNSTREAM VIEW)**

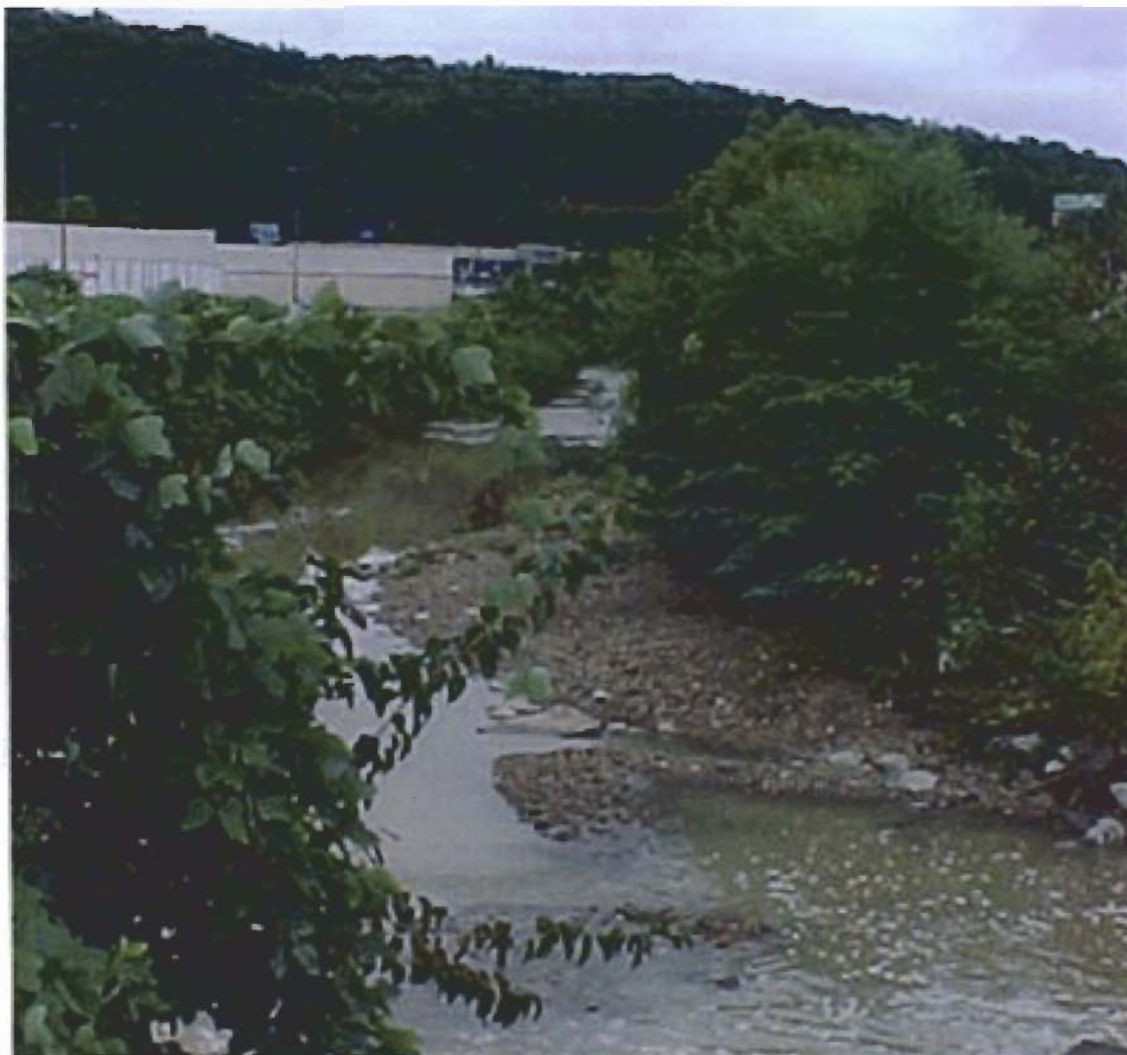
**FIGURE
9**

**RIPARIAN VEGETATION AND DEPOSITIONAL
BARS IN SNOW CREEK (BELOW NOBLE STREET)**

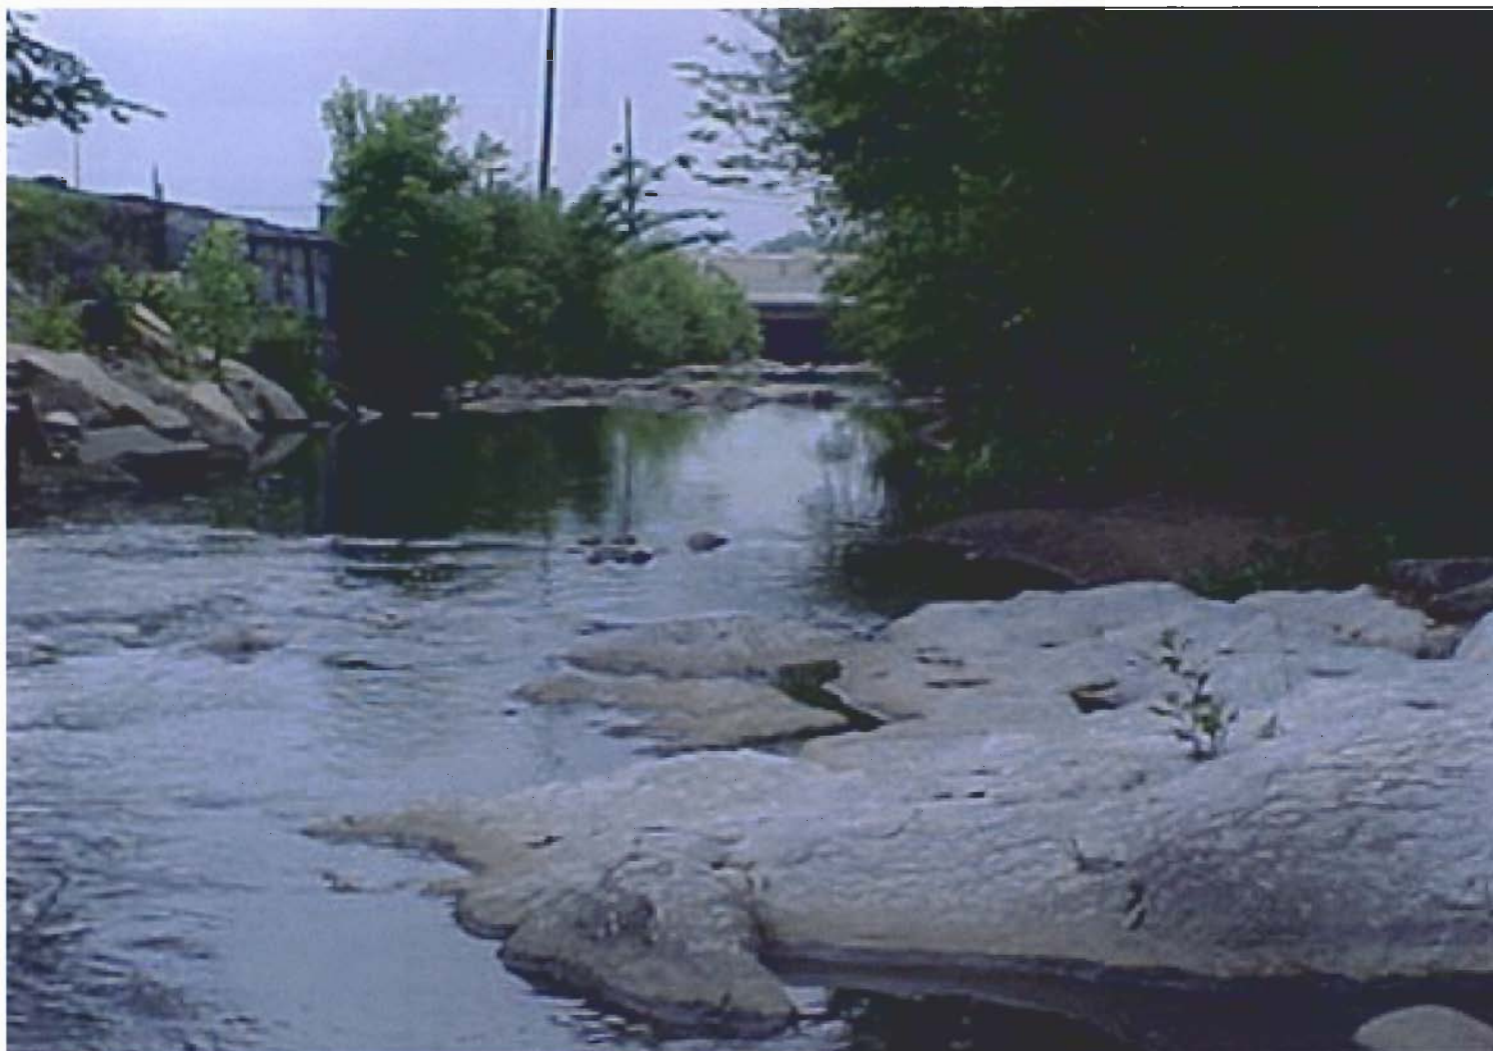
**FIGURE
10**

**SNOW CREEK BEFORE FLOWING INTO CULVERT
UNDER QUINTARD MALL (IN BACKGROUND)**

Snow Creek is a small urban drainage way that flows through the City of Anniston into the Town of Oxford, Alabama, before its confluence with Choccolocco Creek just south of Interstate 20 near the Choccolocco Creek Water Treatment Facility. Aquatic habitat in the upstream reaches of Snow Creek (north of U.S. Highway 78) is limited; there are drainage ditches along residential roads that flow into the Creek, and as it moves south it is heavily channelized through dense areas of residential, commercial, and industrial land use. In areas where concrete sluiceways channelize the Creek (Figures 8 and 9), substrate, aquatic vegetation, and bank features are lacking or are insufficient as habitat for aquatic organisms or wildlife. Previous studies have found that these areas, which are most prevalent above Noble Street, score low in habitat quality (BBL, 2000b). However, other areas of the Creek have not been altered to the same degree, specifically the portion of Snow Creek below Noble Street and above U.S. Highway 78. These areas have banks with riparian vegetation, a sandy-silt mix of substrate and depositional bars, and occasional riffle-run-pools (Figure 10). During heavy rains the surface water levels rise considerably in the Creek, and turbidity is visibly evident. At the southern limit of Snow Creek in OU-1/OU-2, surface waters flow into a long underground culvert beneath the Quintard Mall (Figure 11), which is an area devoid of any quality ecological habitat.

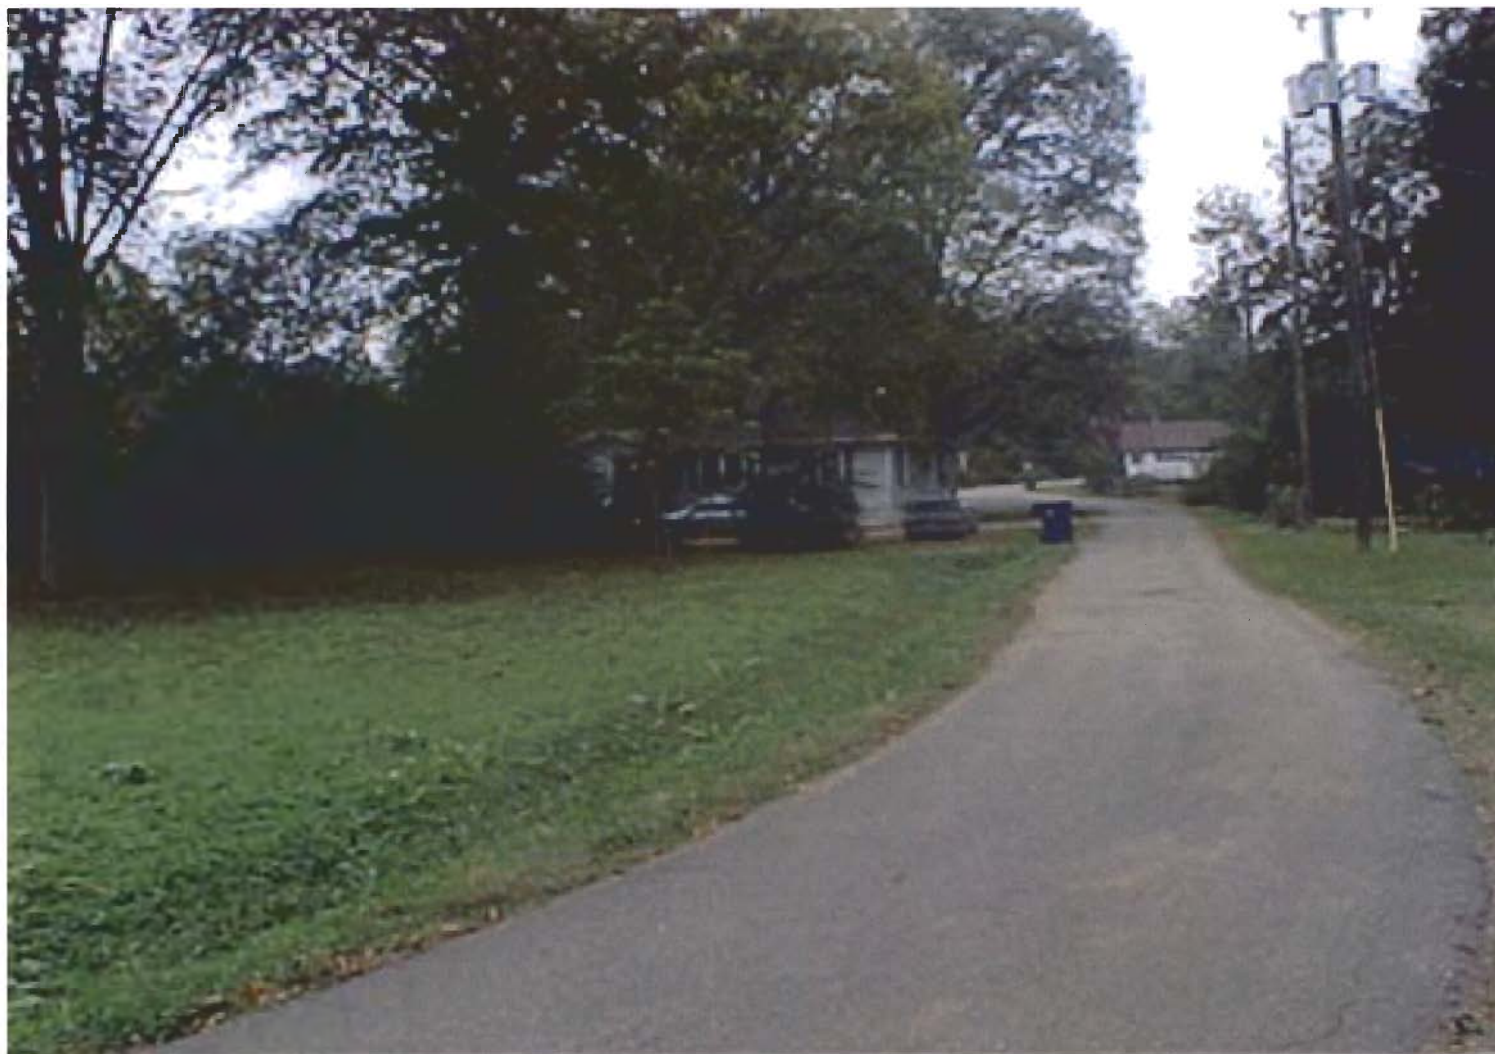
**FIGURE
11**

RESIDENTIAL MAINTAINED LAWNS AND SPARSE
ORNAMENTAL TREES

Residential. Most of the habitat available to ecological species in these areas is limited to maintained lawns with sparse and arranged ornamental (and often exotic/"non-native") trees and shrubs (Figures 12 and 13). Impervious layers, as represented by paved driveways, rooftops, streets, or large parking areas, are present throughout the residential communities and provide little, if any, significant habitat (Figure 14). Mowed lawns of some residential properties are maintained right up to the edge of Snow Creek (Figure 15). In these cases, there is little habitat in the form of cover or forage for terrestrial wildlife. In other locations where residential properties do not border the Creek, riparian habitat along the top of the creek bank (although typically narrow) provides some habitat for species of songbirds and "urban" wildlife (e.g., skunks, raccoons, squirrels, etc.). However, these areas are somewhat isolated by surrounding dense, residential communities (and other land uses), and therefore access is likely constrained.

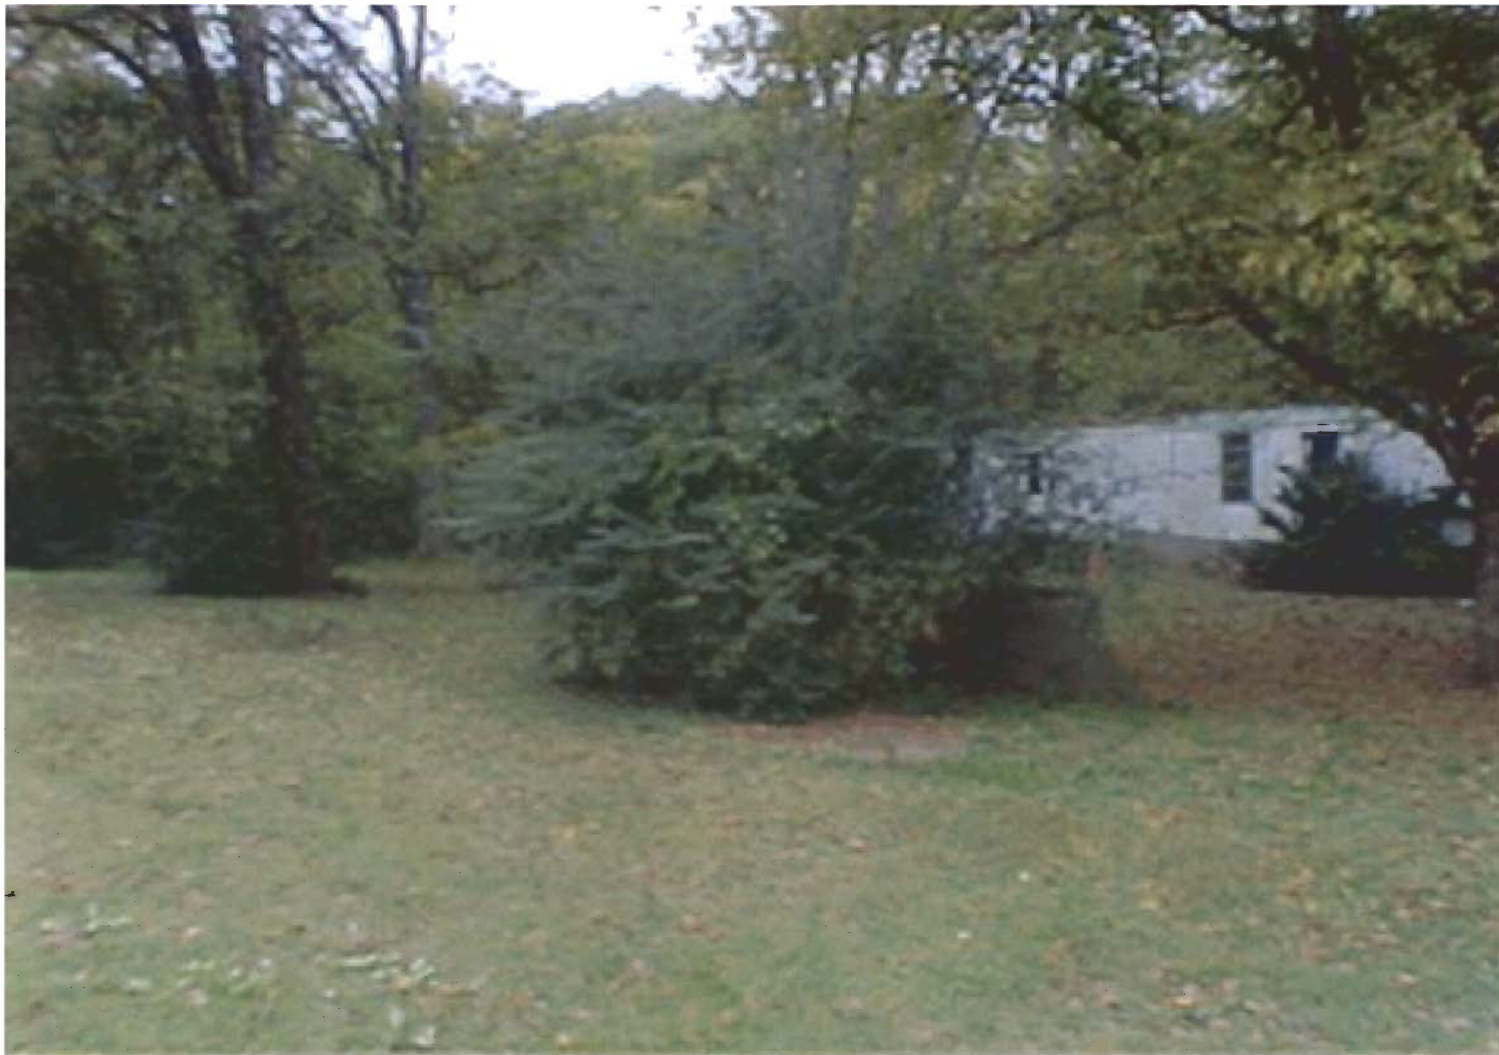
FIGURE
12

**RESIDENTIAL MAINTAINED LAWNS AND SPARSE
ORNAMENTAL TREES**

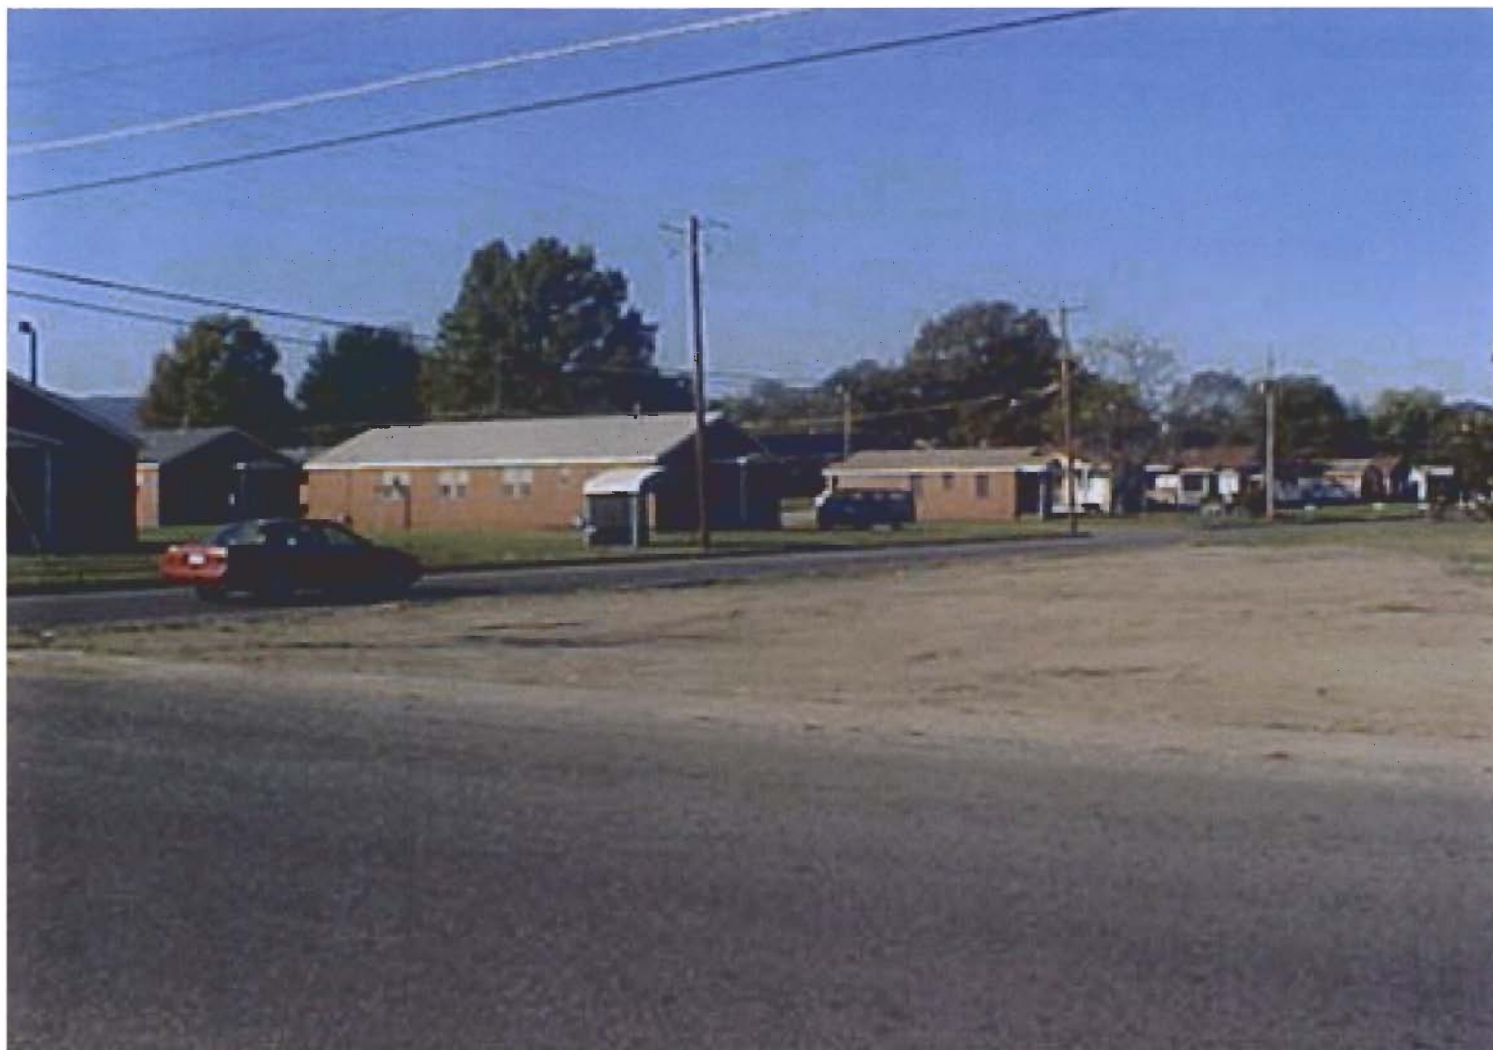
FIGURE
13

**EXAMPLE OF RESIDENTIAL AREAS WHERE
NETWORKS OF ROADS, ROOFTOPS AND
PARKING AREAS ELIMINATE HABITAT**
