Re: Anniston PCB Site
Revision 1 of the *Screening Level Ecological Risk Assessment for Operable Units 1, 2, and 3*

*Screening Level Ecological Risk
Assessment (SLERA)
for Operable Units 1, 2, and 3
of the Anniston PCB Site*

**Anniston PCB Site
Anniston, Alabama**

**Revision 1
December 2005**

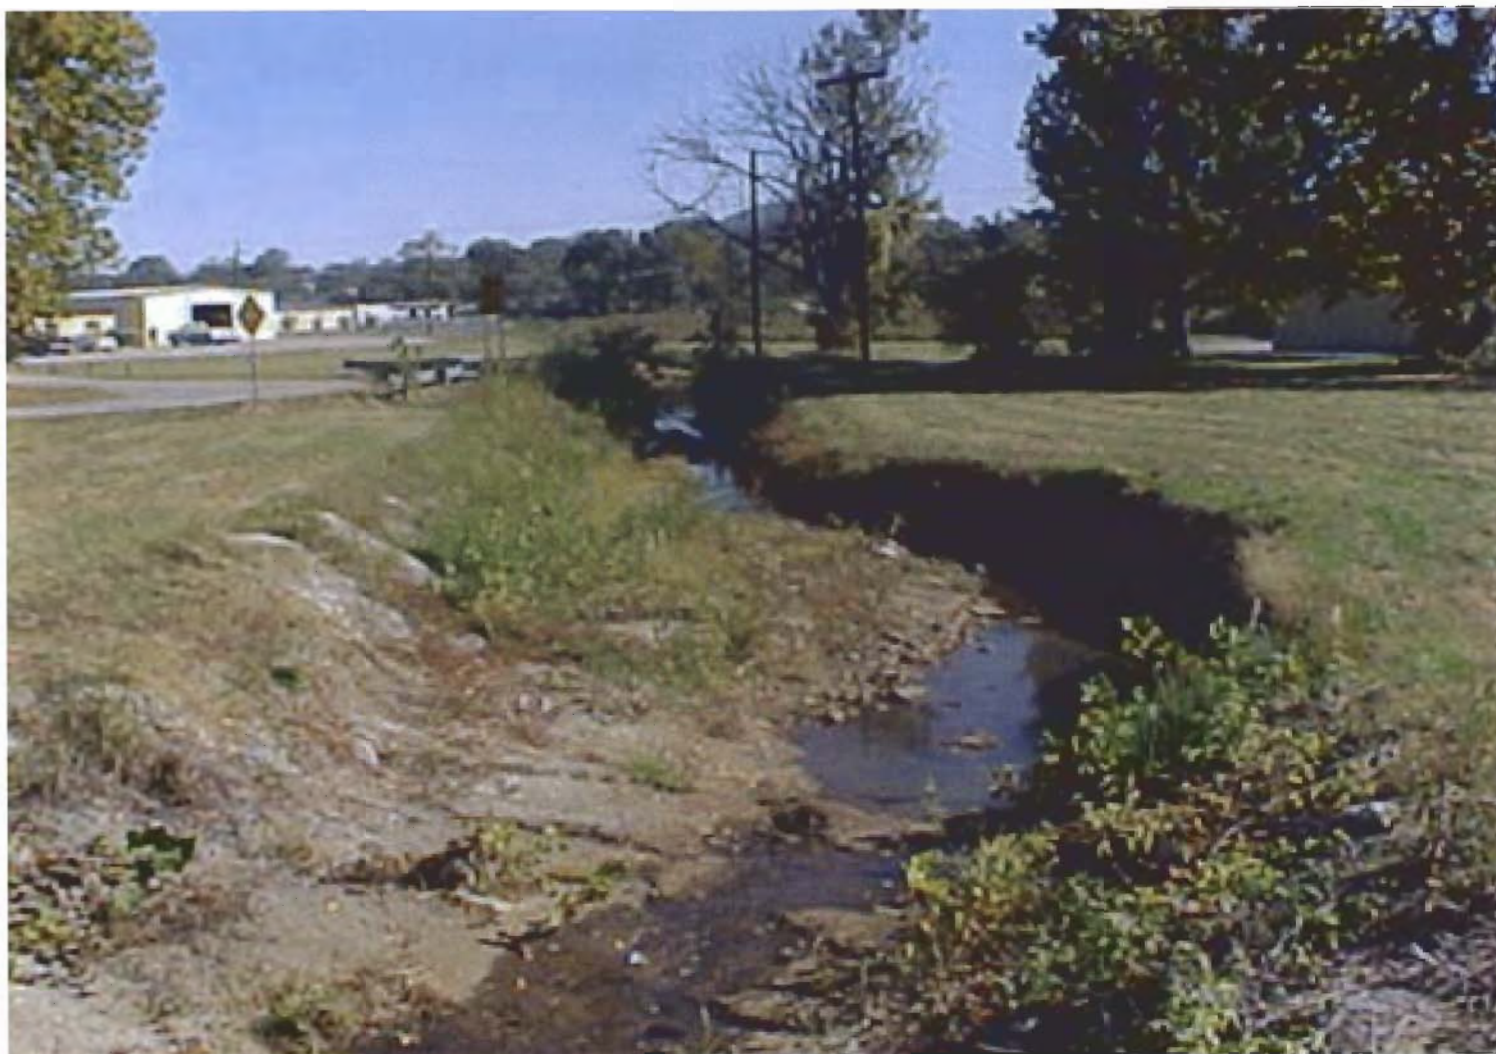
FIGURE
15

**MAINTAINED LAND USE TO EDGE OF SNOW
CREEK (UPSTREAM). NOTE: UNSTABLE BANKS
DUE TO EROSION AND SLOUGHING**

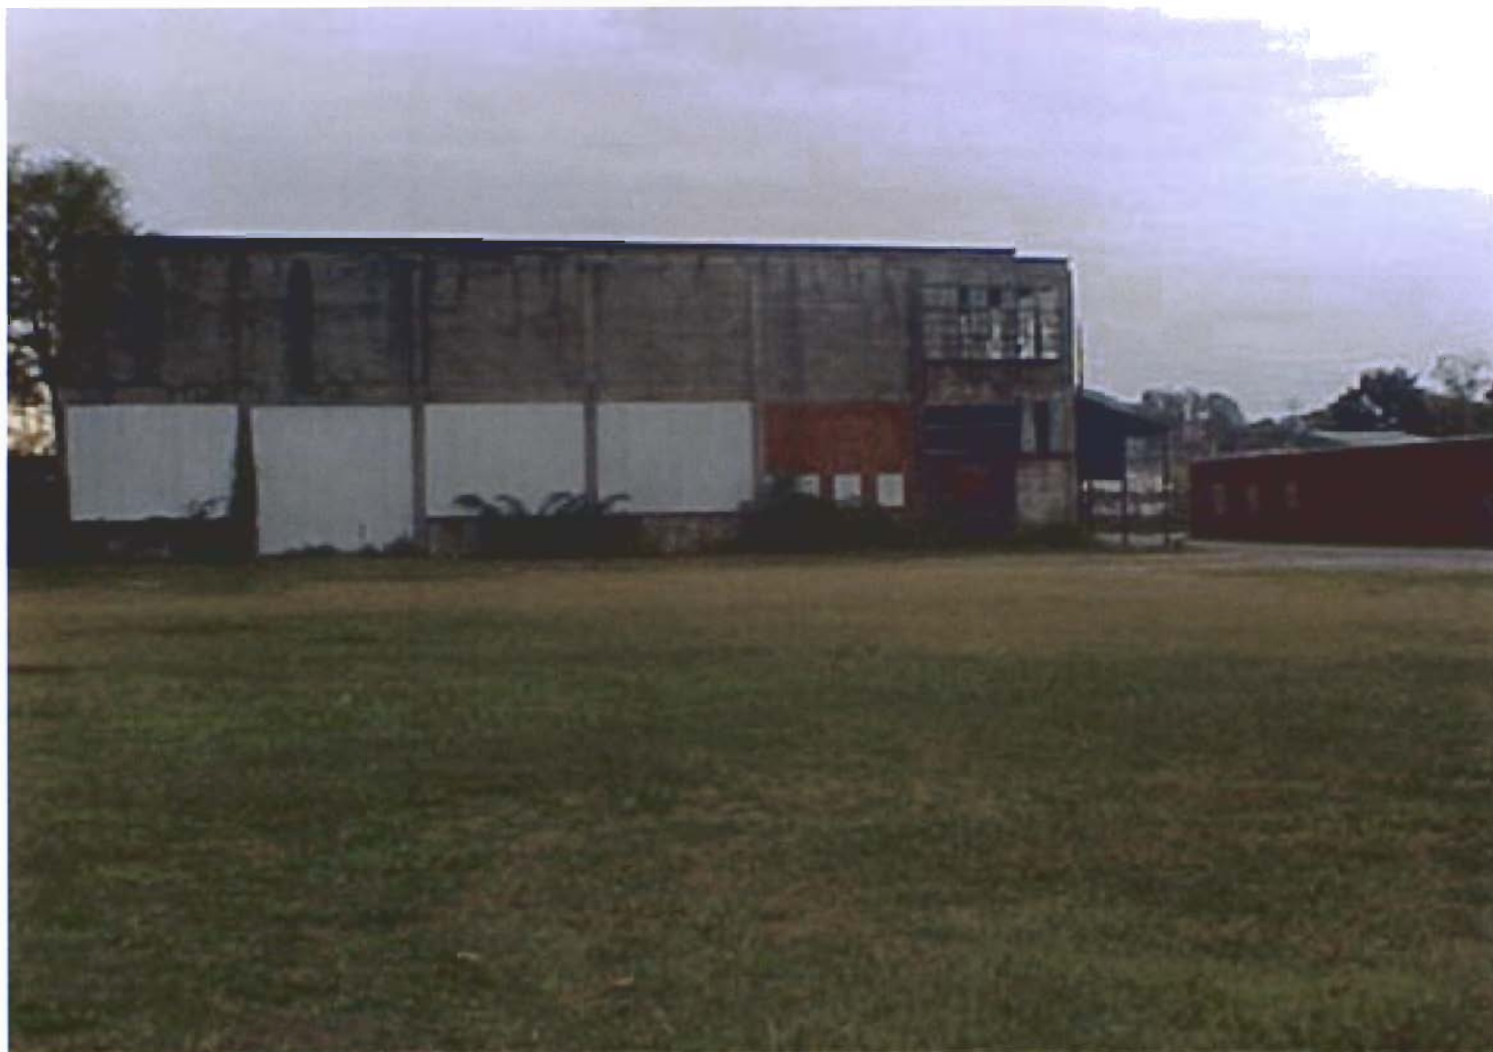
**INDUSTRIAL LAND USE WITH MAINTAINED FIELD
AND SPARSE ORNAMENTAL TREES AND SHRUBS**

Industrial. Land use in industrial areas is dominated by the presence of commercial buildings, manufacturing facilities, junkyards, parking areas, railroad tracks, and areas with impervious cover (usually greater than 80%), or if not impervious, groundcover disturbed by maintenance, excavation, or debris (Figures 16 and 17). Potential habitats are primarily disturbed or abandoned fields, patches of urban scrub/shrub forest, or maintained lawns with sparse ornamental trees and shrubs. Little or no wildlife were observed at locations throughout industrial areas.

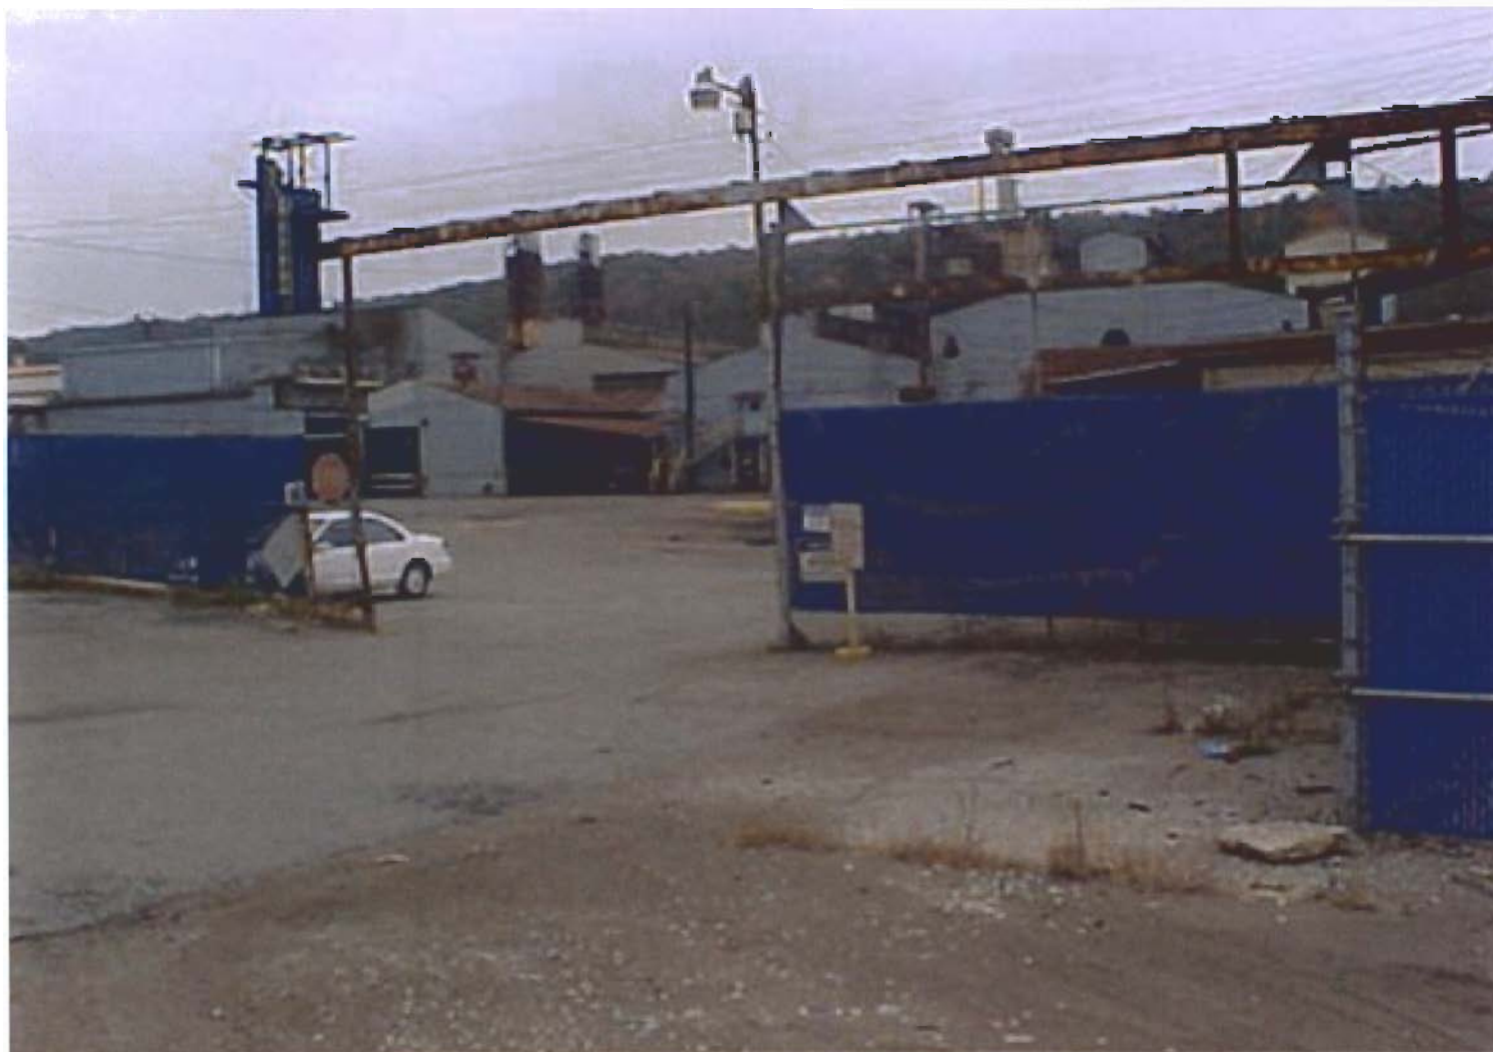
FIGURE
17

**INDUSTRIAL LAND USE SHOWING IMPERVIOUS
LAYERS OF FACILITY ENVIRONS AND NO
HABITAT**

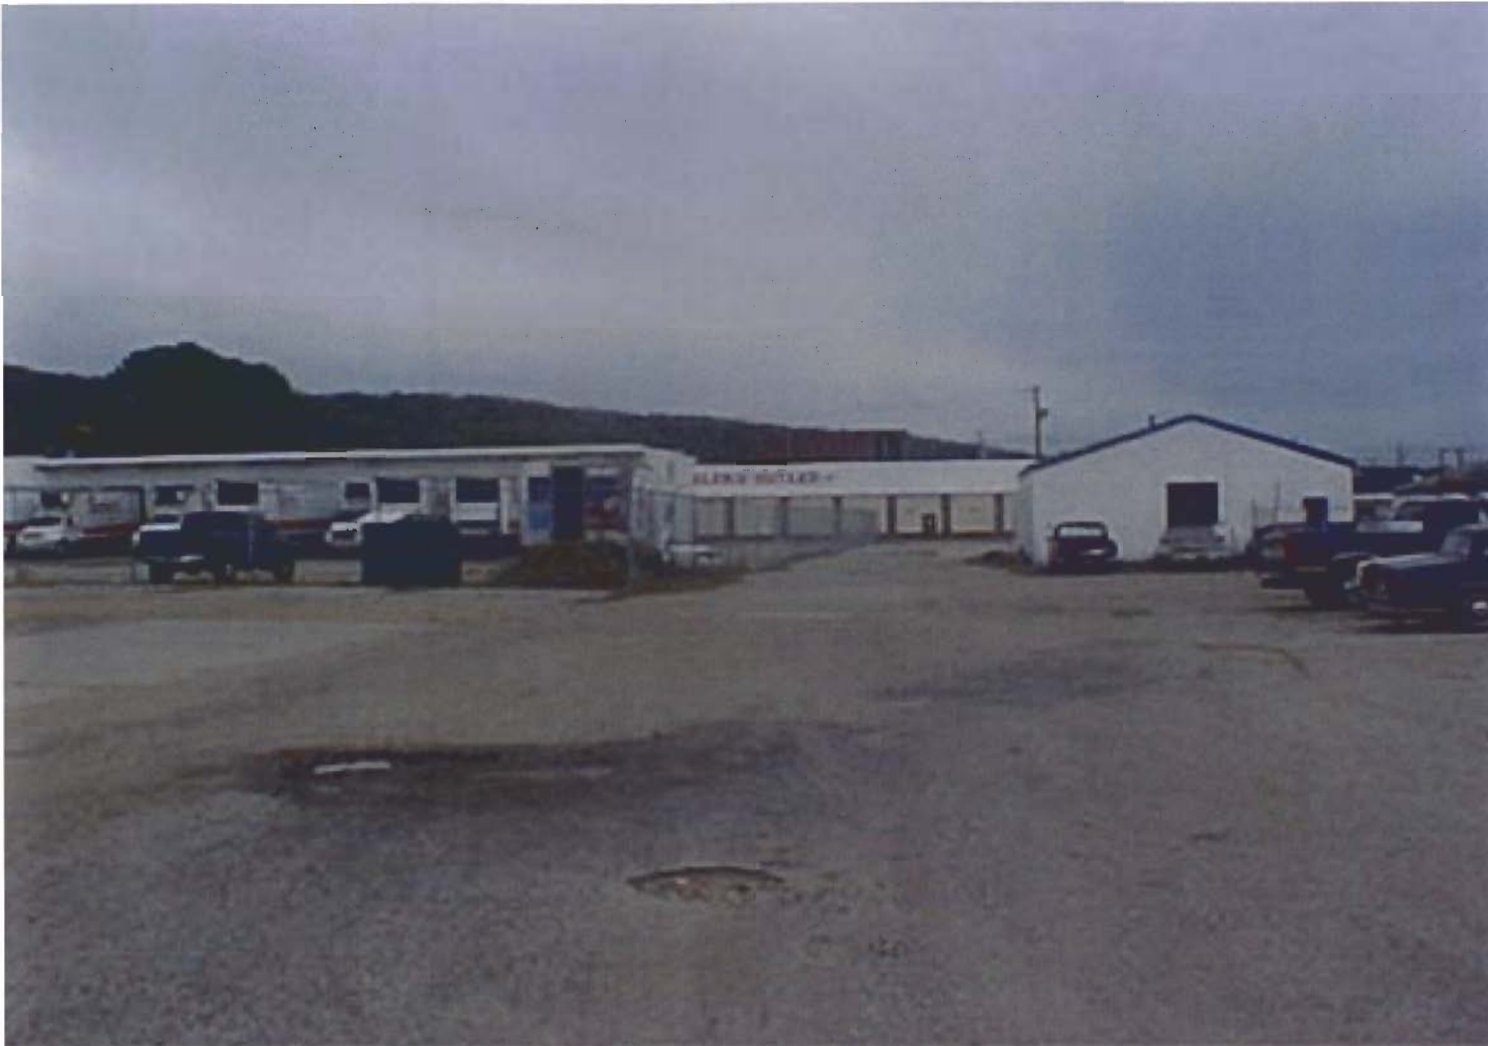
FIGURE
18

**COMMERCIAL LAND USE WITH EXTENSIVE
IMPERVIOUS LAYER AND ESSENTIALLY NO
HABITAT**

Commercial. Land use in commercial areas is dominated by retail structures, single stores, strip malls, associated parking areas, landscaping, stormwater facilities, and areas with an impervious cover (usually greater than 80%) (Figures 18 and 19). Potential habitats consist of maintained lawns, and sparse ornamental trees and shrubs. Little or no wildlife were observed in these areas.

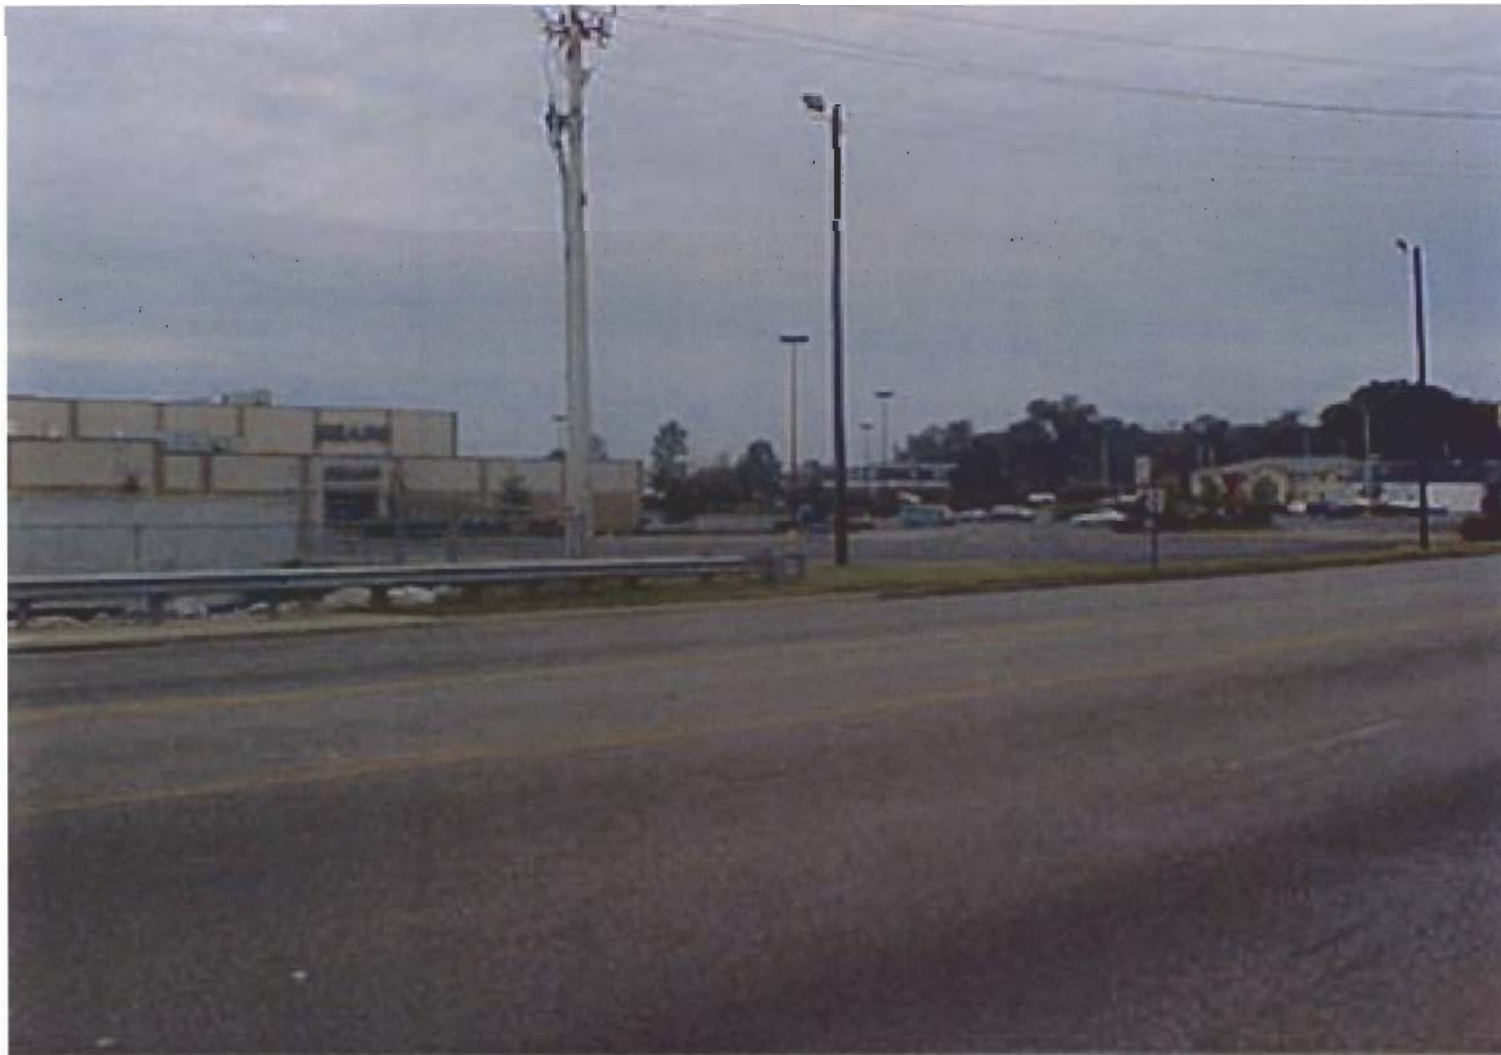
FIGURE
19

**EXTENSIVE PARKING AREAS AND SMALL
ISLANDS OF ORNAMENTAL TREES AND SHRUBS
AT QUINTARD MALL**

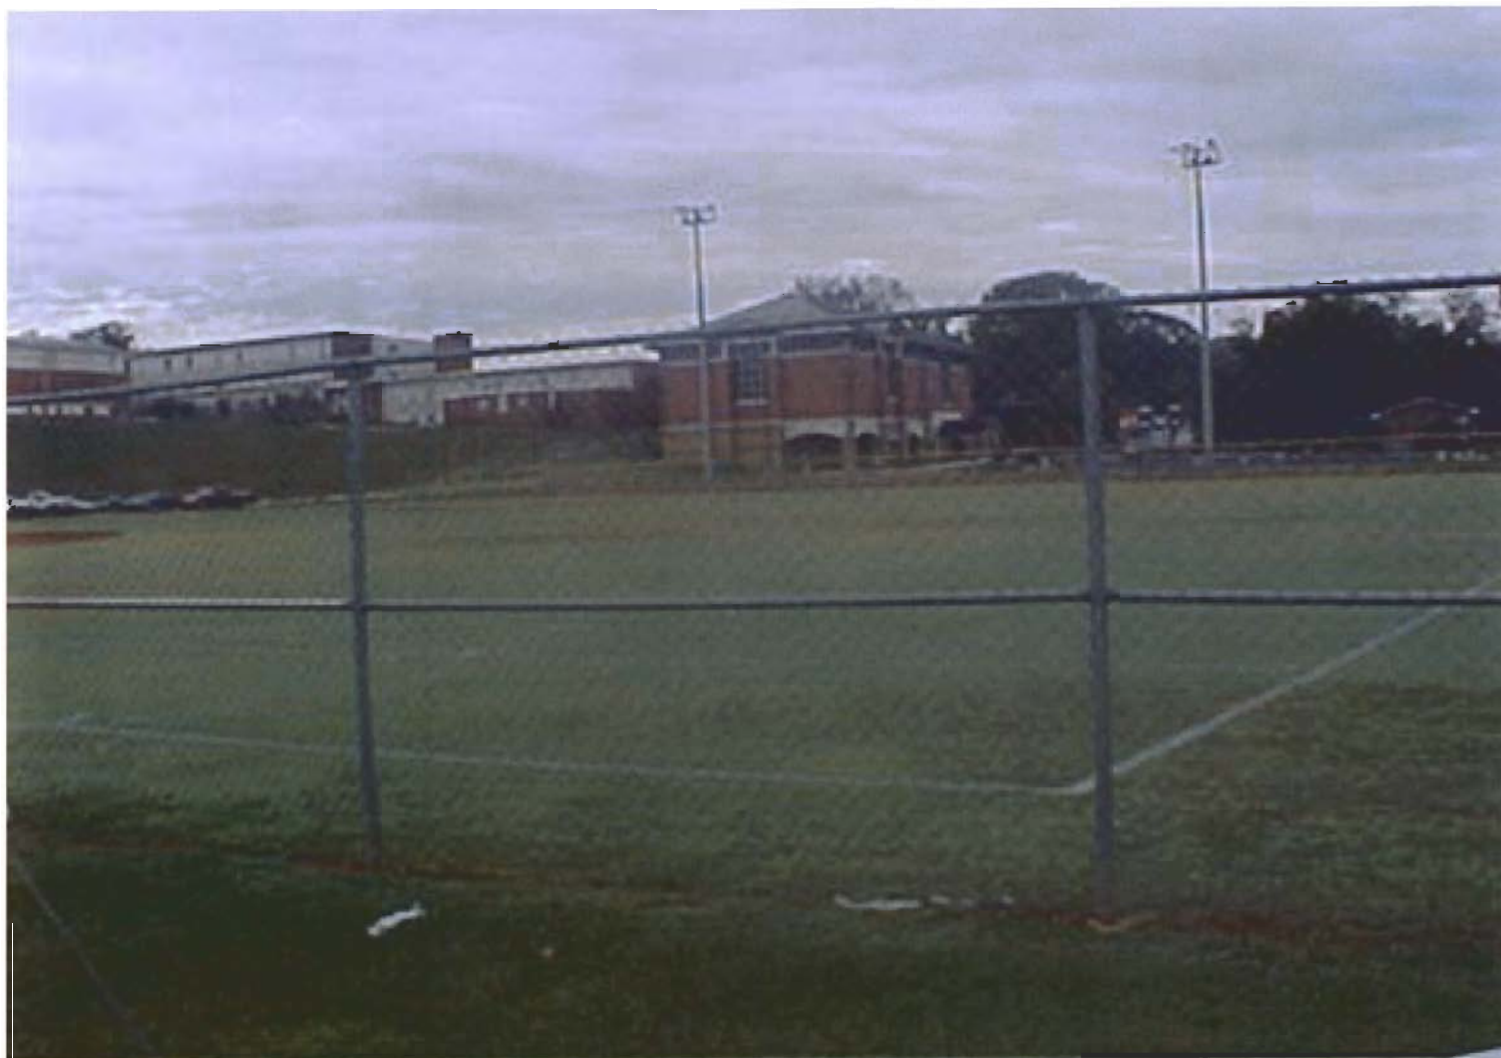
**FIGURE
 20**

**RECREATION/SCHOOL LAND USE SHOWING
 LARGE MANICURED FIELD FOR SPORTS**

Recreational/School. Land use in these areas is dominated by playgrounds, ball fields, and large areas of maintained and manicured lawns (nearly 100% cover) (Figures 20 and 21). Functional ecological habitats are confined to less regularly maintained fields where songbirds typical of urban environments were observed foraging.

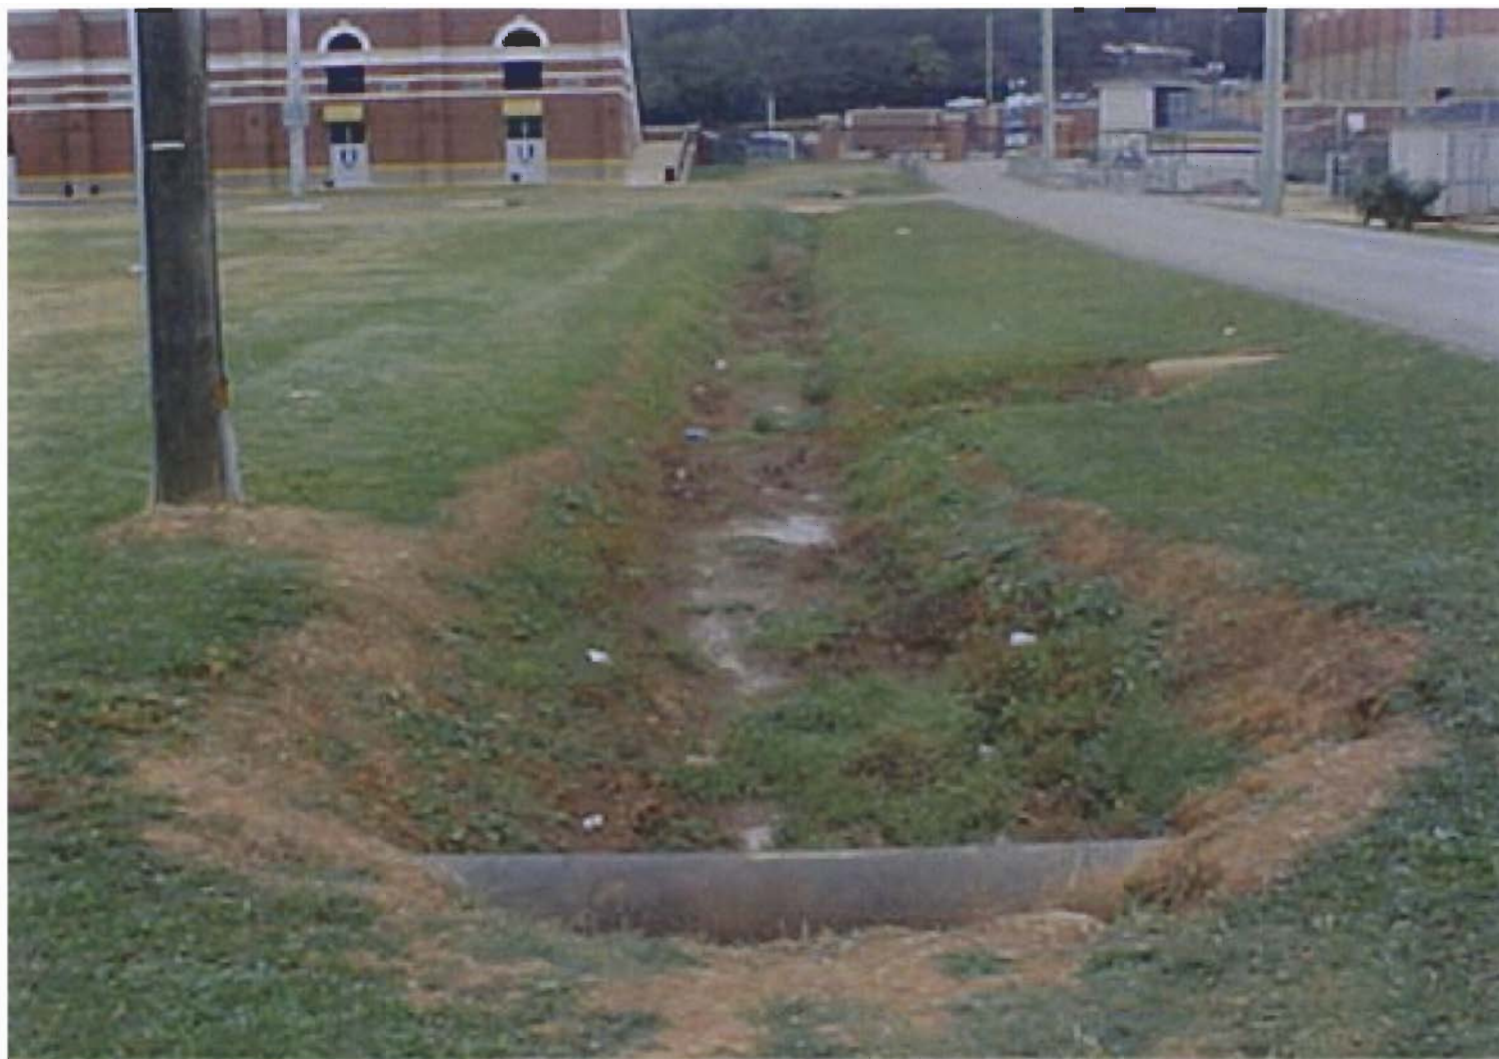
RECREATION/SCHOOL LAND USE SHOWING
DRAINAGE DITCH BEFORE BORDERING FIELD

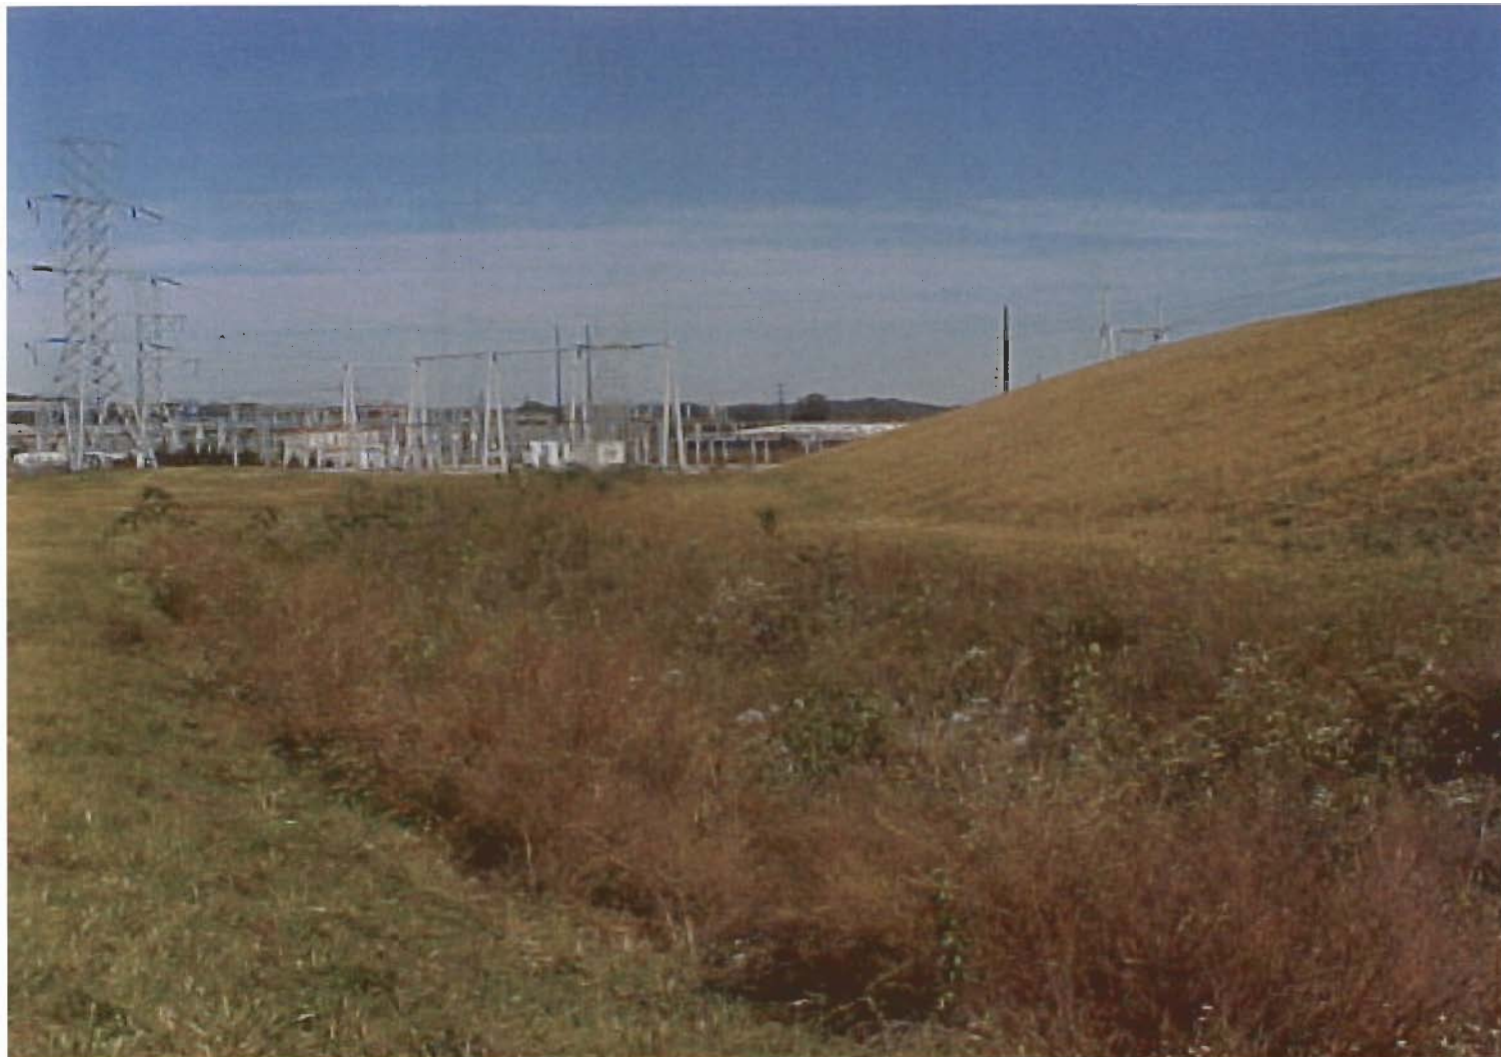
FIGURE
21

**WEST END LANDFILL: RIP-RAPPED DRAINAGE
 SWALE**

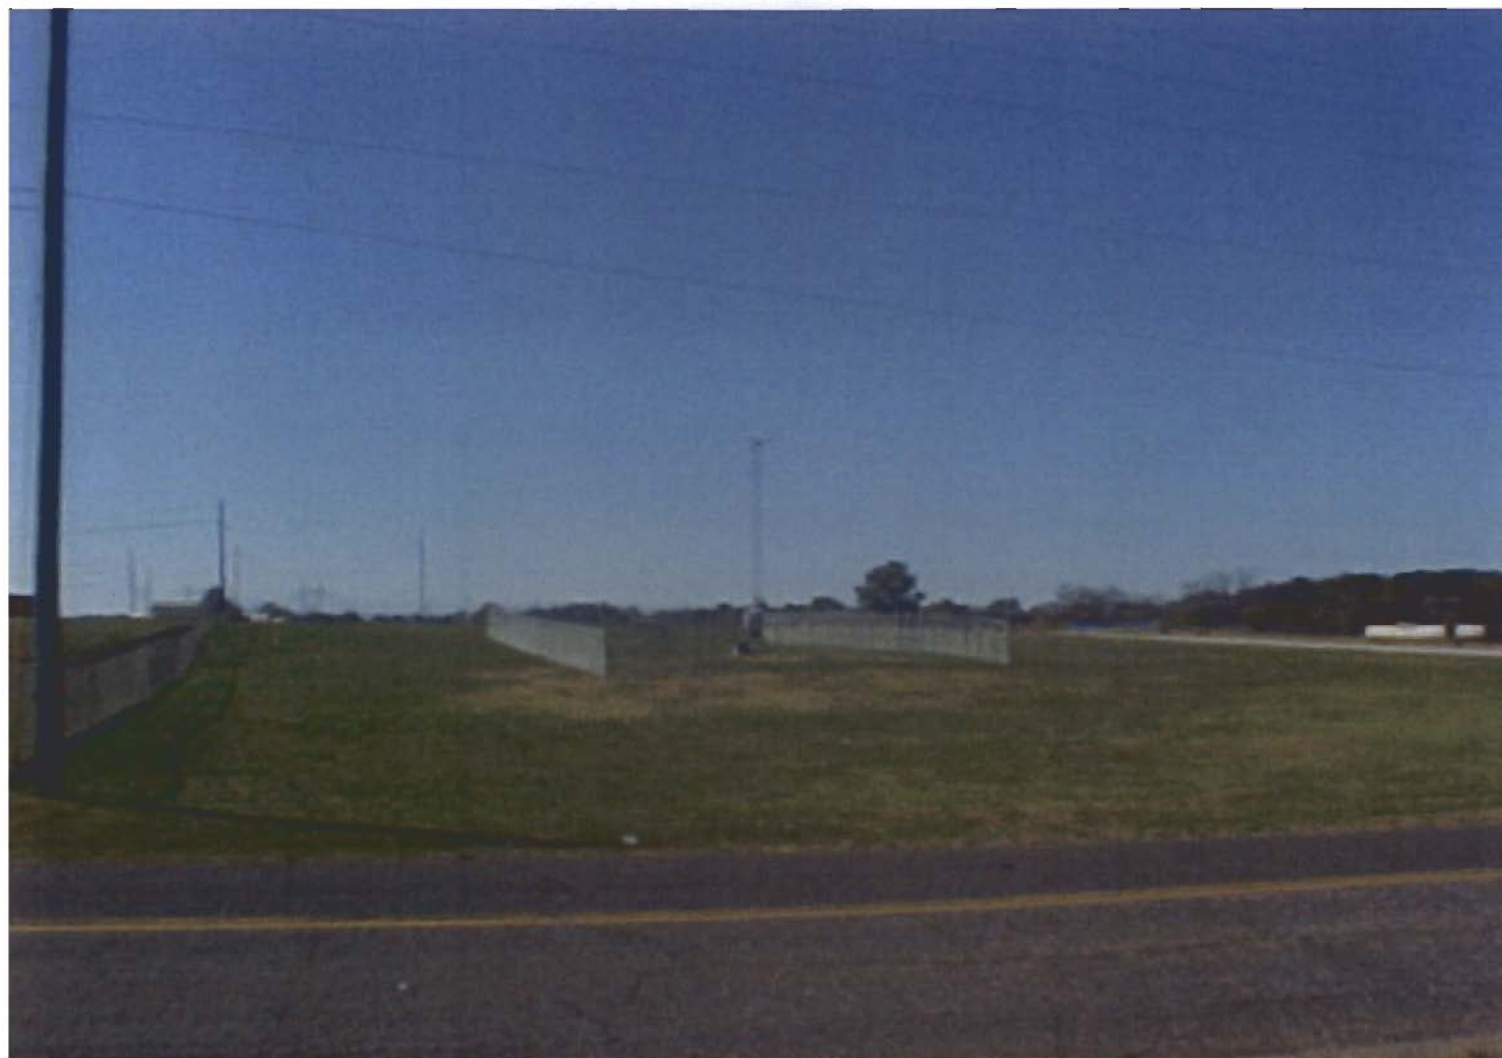
**FIGURE
 22**

NORTHEAST PORTION OF FACILITY: MAINTAINED
LAWN

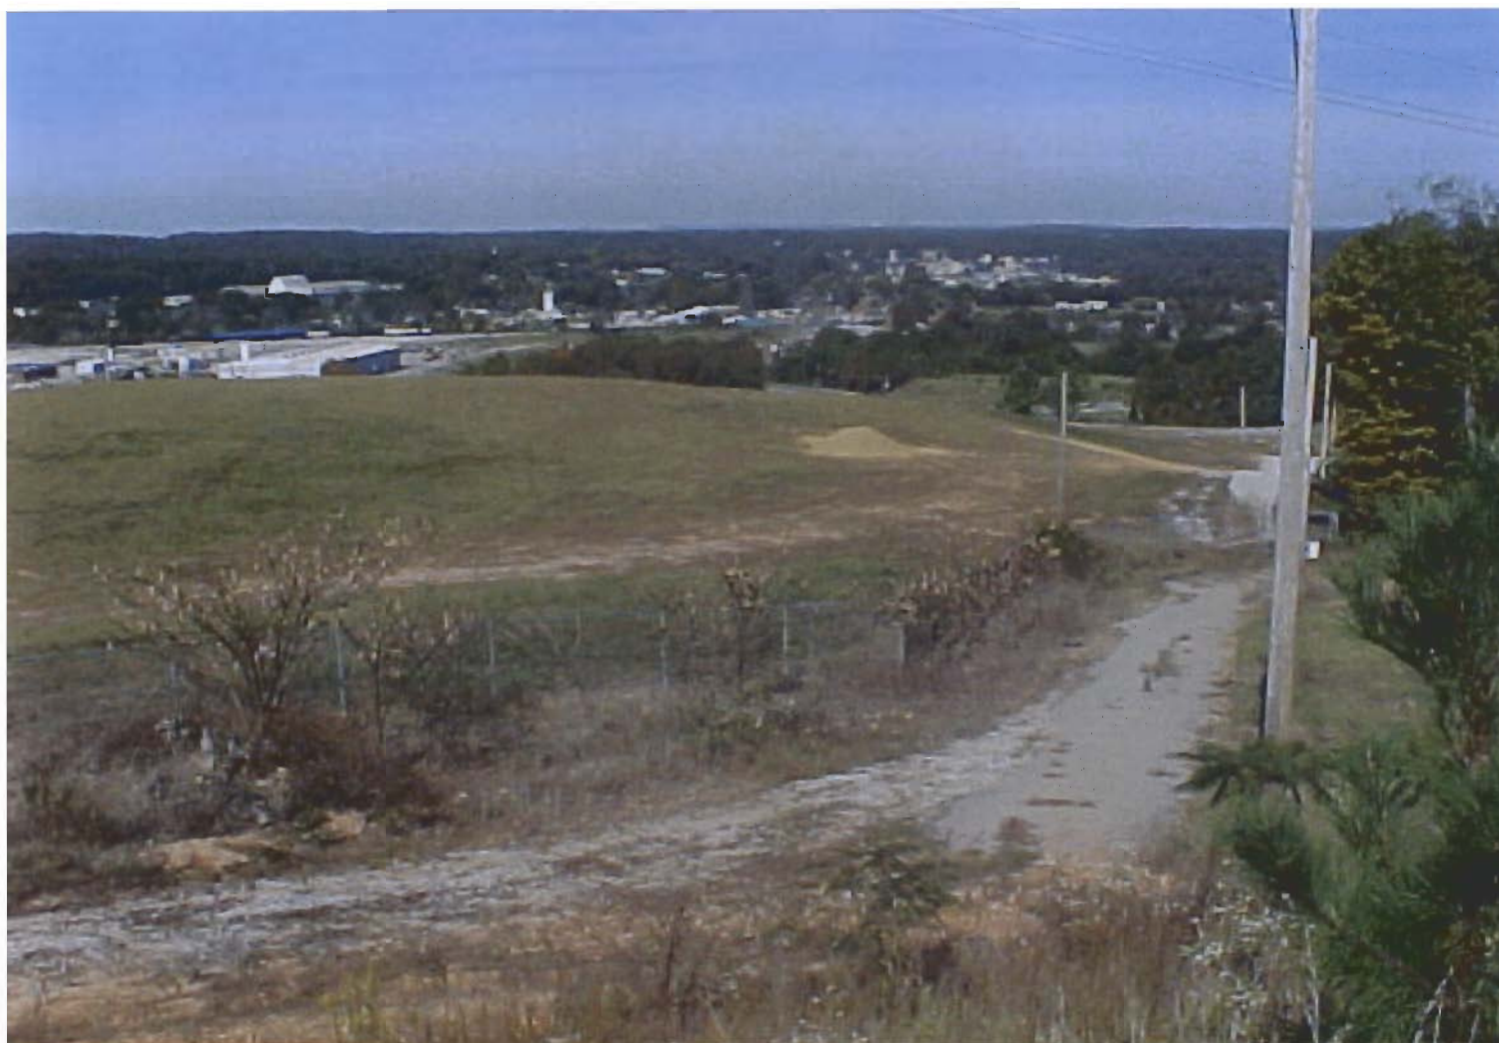
FIGURE
23

Maintained Grounds (Northeast). Maintained parcels in the northeastern portion of the Facility are routinely mowed, and surrounding areas are disturbed and managed. The area appears to have little or no ecological value (Figure 23).

NORTH VIEW OF SOUTH LANDFILL

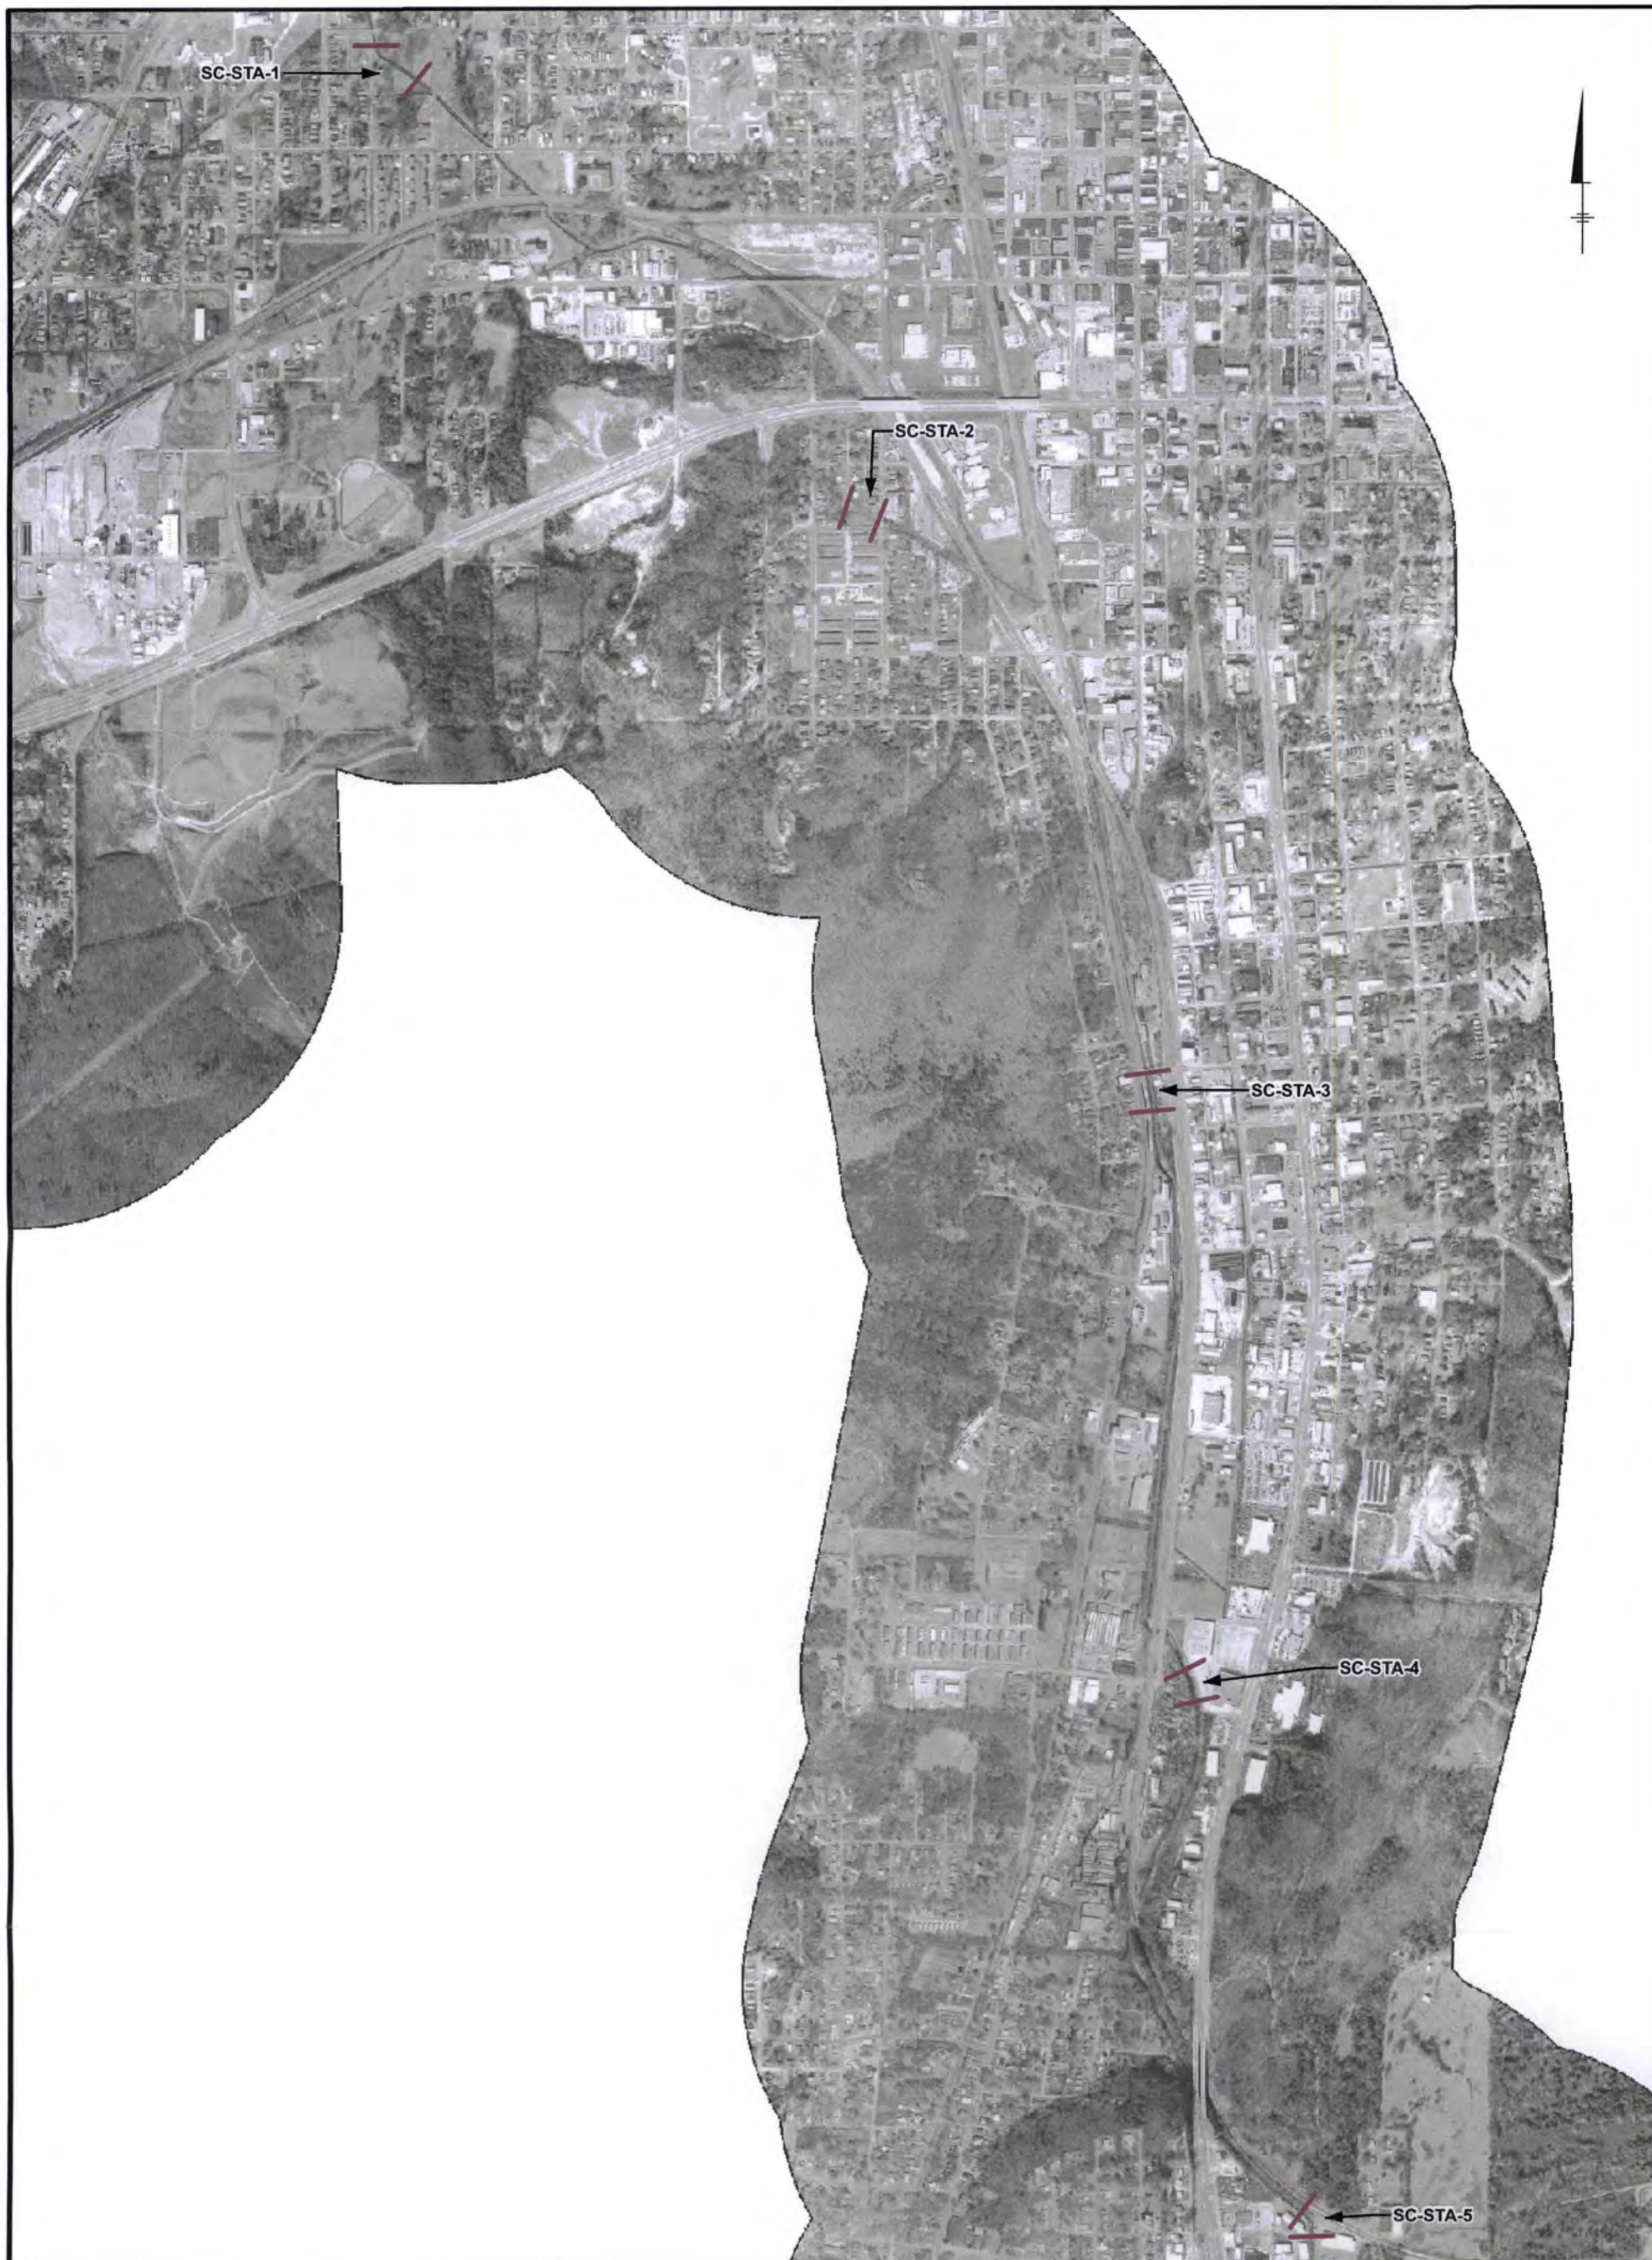
FIGURE
24

A preliminary reconnaissance was conducted by field ecologists before implementing the RBP methodology for Snow Creek to identify sample locations. Five sampling reaches for OU-1/OU-2, each approximately 100 meters in length, were distributed along Snow Creek (Figure 25). These reaches were selected to reflect conditions that adequately represent the natural heterogeneity of habitats that exist in Snow Creek. Data collected during previous investigations and reconnaissance activities indicate that significant portions of Snow Creek have been stabilized, channelized, and/or hardscaped to the point that natural conditions no longer exist in these areas. The channelized areas fragment the natural order of Snow Creek such that the continuity of hydrogeomorphic processes is disturbed. These areas were not surveyed as habitat. The five sample reaches that were assessed are indicative of the range of remnant natural conditions (pools, riffles, runs with natural substrate) that currently exist in Snow Creek.

LEGEND:
— SNOW CREEK SAMPLING STATION BOUNDARIES
