Re: Anniston PCB Site
Revision 1 of the *Screening Level Ecological Risk Assessment for Operable Units 1, 2, and 3*

*Screening Level Ecological Risk
Assessment (SLERA)
for Operable Units 1, 2, and 3
of the Anniston PCB Site*

**Anniston PCB Site
Anniston, Alabama**

**Revision 1
December 2005**

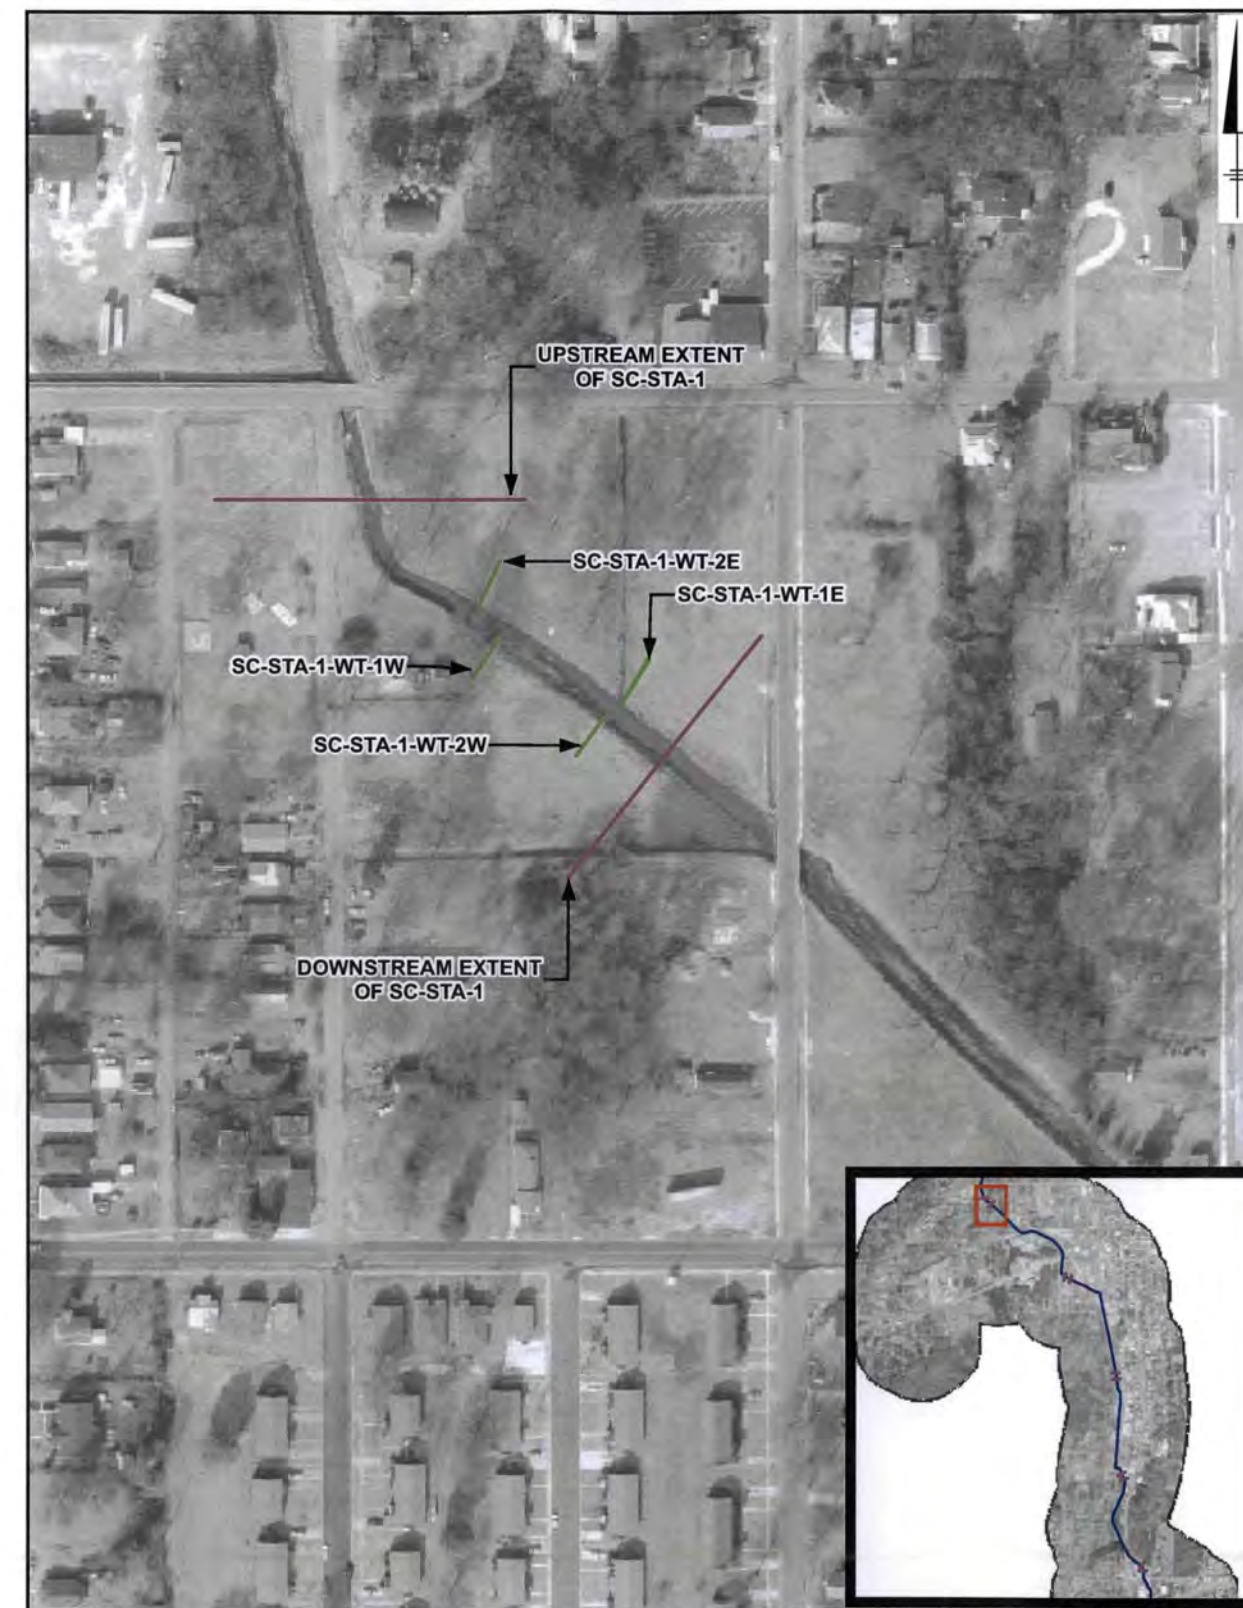
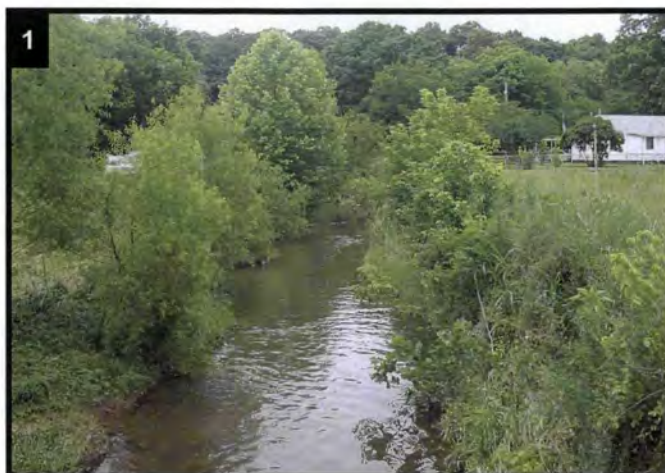
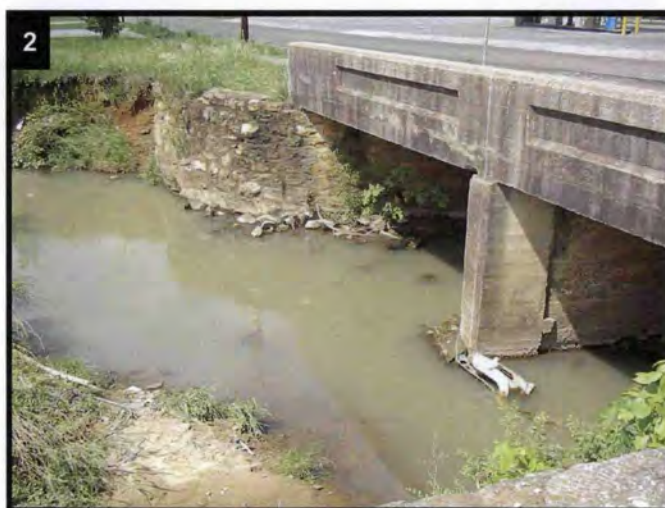
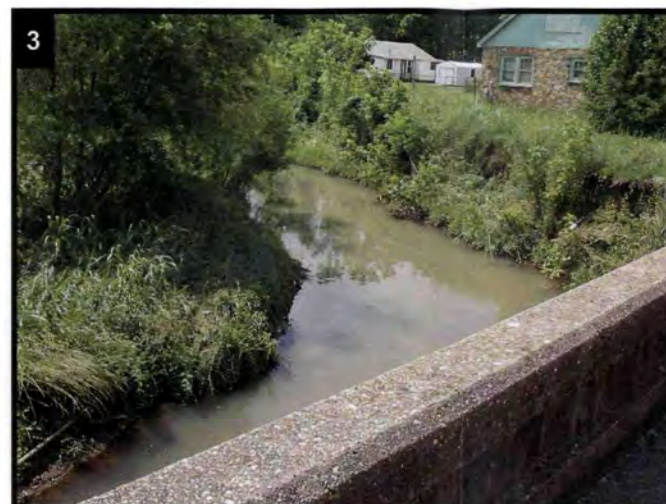
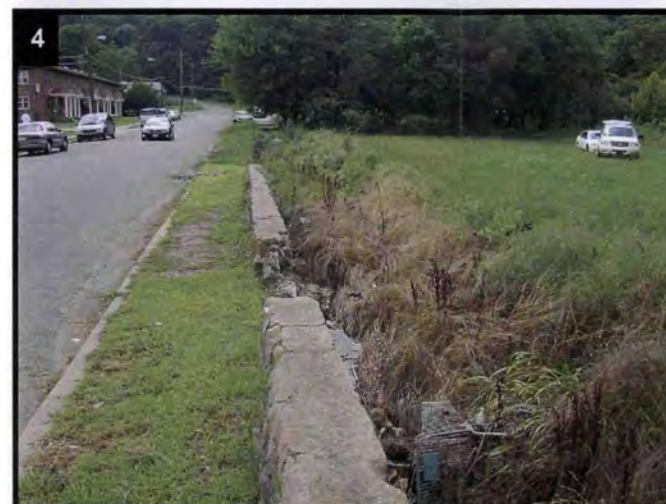
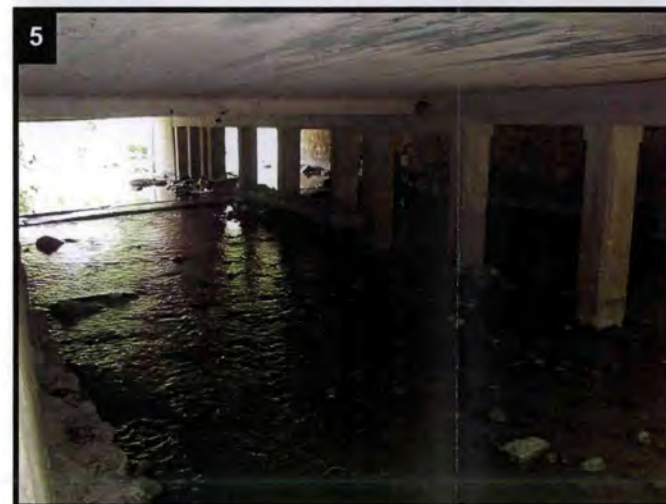
FIGURE
27

BIOSURVEY RESULTS FOR STA-1

Station	Fish Survey Total Shock Time (min)	Benthic Macroinvertebrate Survey Distribution of Kicks by Habitat Type (% of 20 kicks/jabs)*							Wildlife Observations	
		Cobble	Snag	Vegetated Banks	Sand & Gravel	SAV	Bedrock Outcrop	Other - see notes	Total Transect Length (ft)	Total Observation Time (min)
SC-STA-1	40	20		20	60				200	200
SC-STA-2	36	50			50				200	205
SC-STA-3	24	50			50				100	175
SC-STA-4	28	60			40				100	180
SC-STA-5*	39	31	11	8	34		8	8	100	250
RP-1	31			60		30		10	240	160

* - more kicks/jabs at this location
SC-STA-5 "Other" was detritus/leaf litter
RP-1 "Other" is emergent vegetation (Alligator weed)

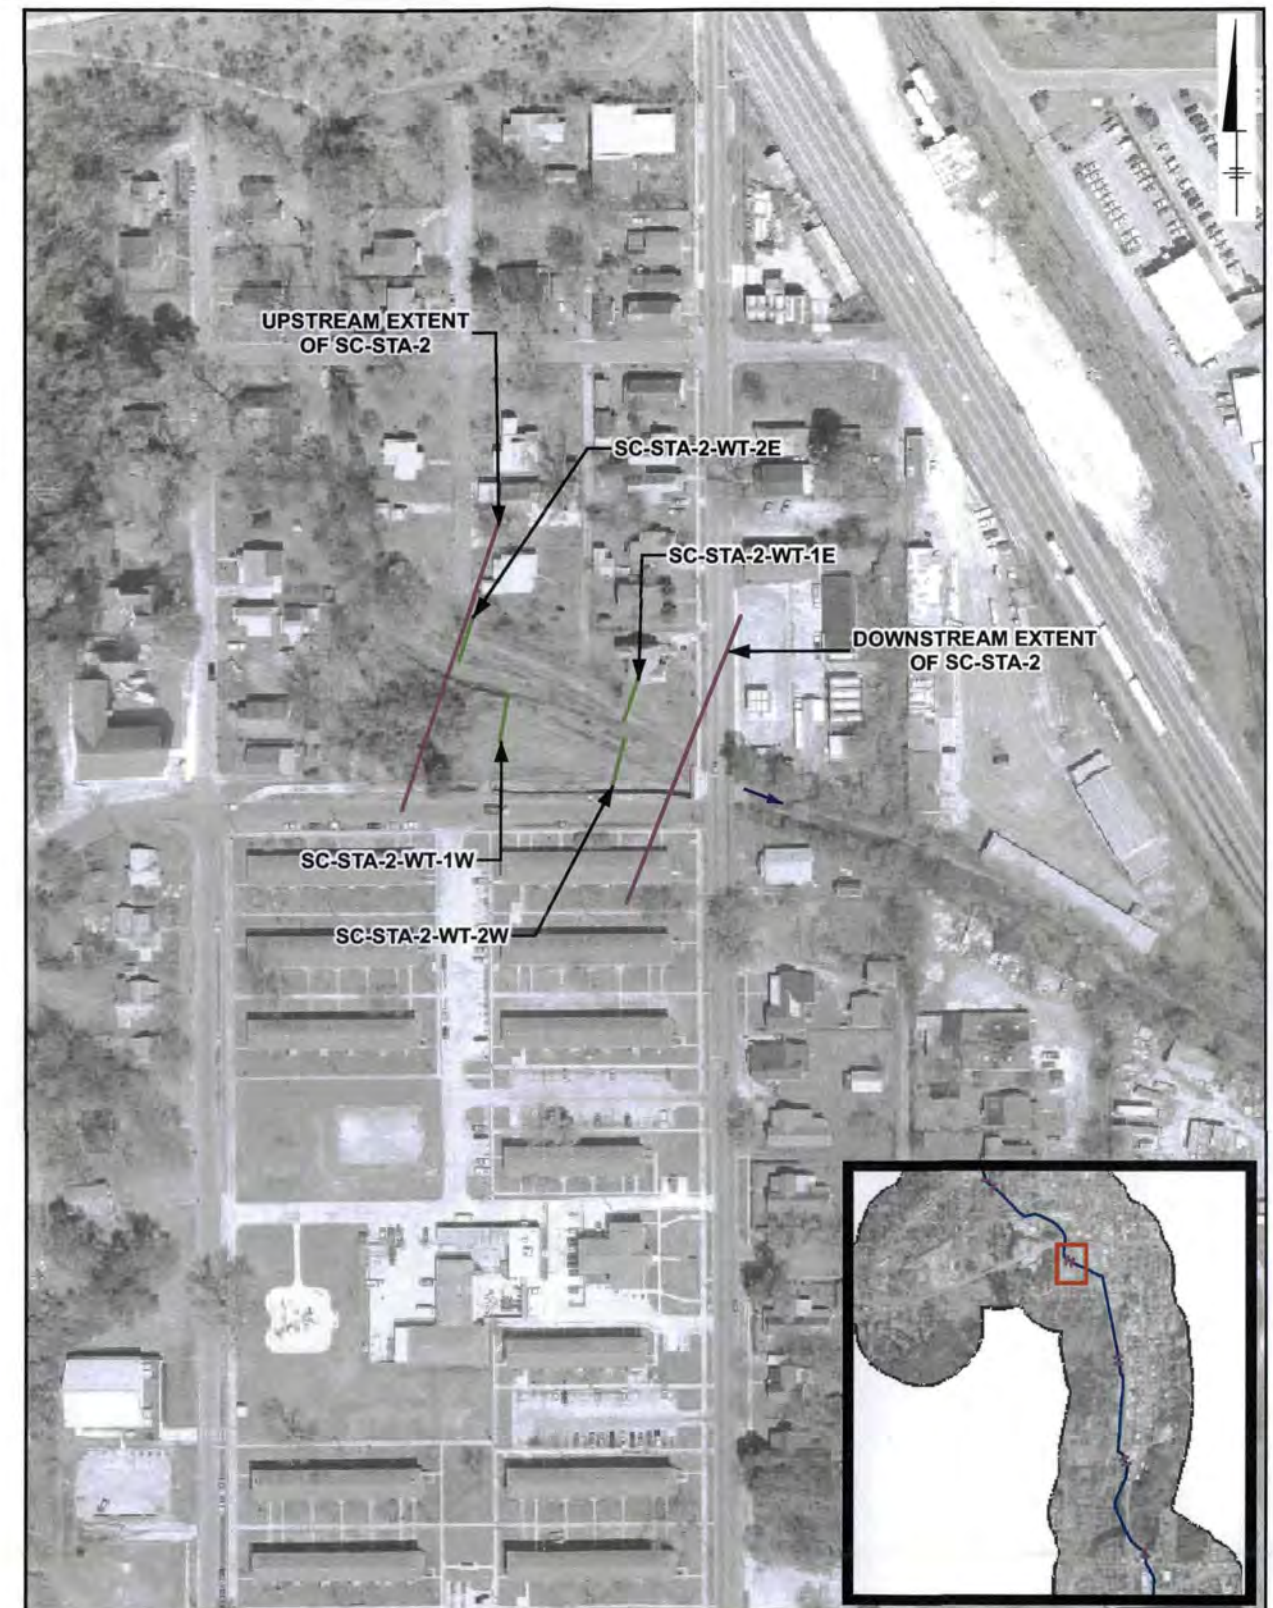
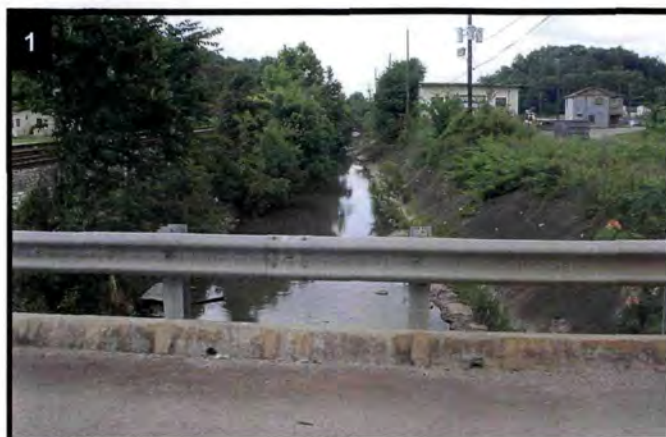
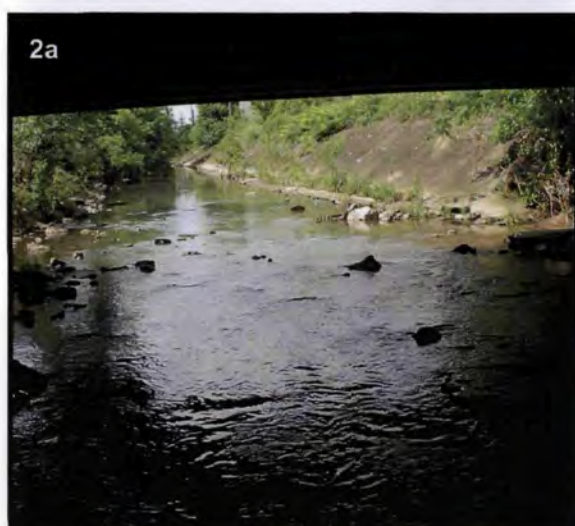
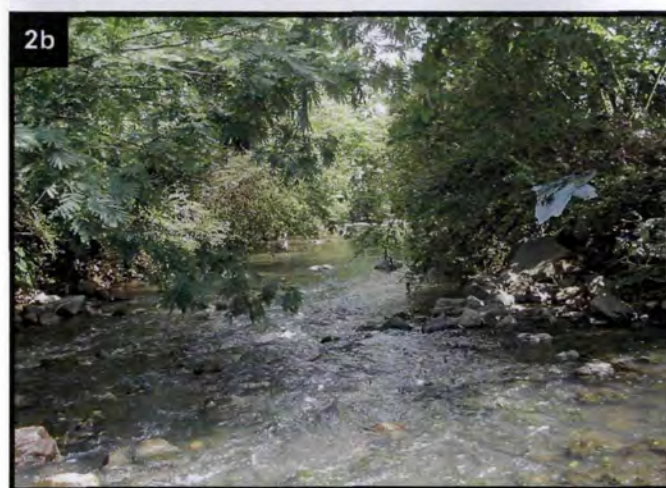
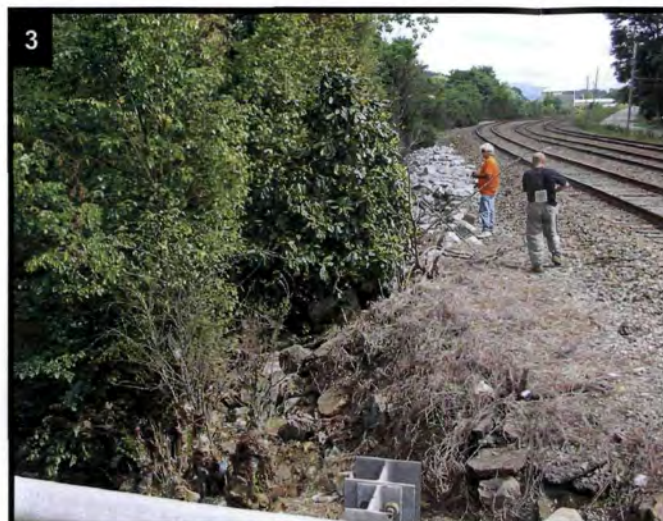
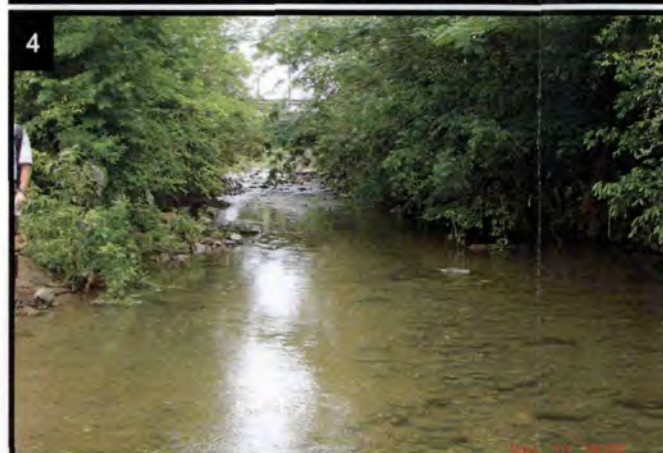
FIGURE
29

BIO SURVEY RESULTS FOR STA-2

Station	Fish Survey Total Shock Time (min)	Benthic Macroinvertebrate Survey Distribution of Kicks by Habitat Type (% of 20 kicks/jabs)*							Wildlife Observations	
		Cobble	Snag	Vegetated Banks	Sand & Gravel	SAV	Bedrock Outcrop	Other - see notes	Total Transect Length (ft)	Total Observation Time (min)
SC-STA-1	40	20		20	60				200	200
SC-STA-2	36	50			50				200	205
SC-STA-3	24	50			50				100	175
SC-STA-4	28	60			40				100	180
SC-STA-5*	39	31	11	8	34		8	8	100	250
RP-1	31			60		30		10	240	160

* - more kicks/jabs at this location
SC-STA-5 "Other" was detritus/leaf litter
RP-1 "Other" is emergent vegetation (Alligator weed)

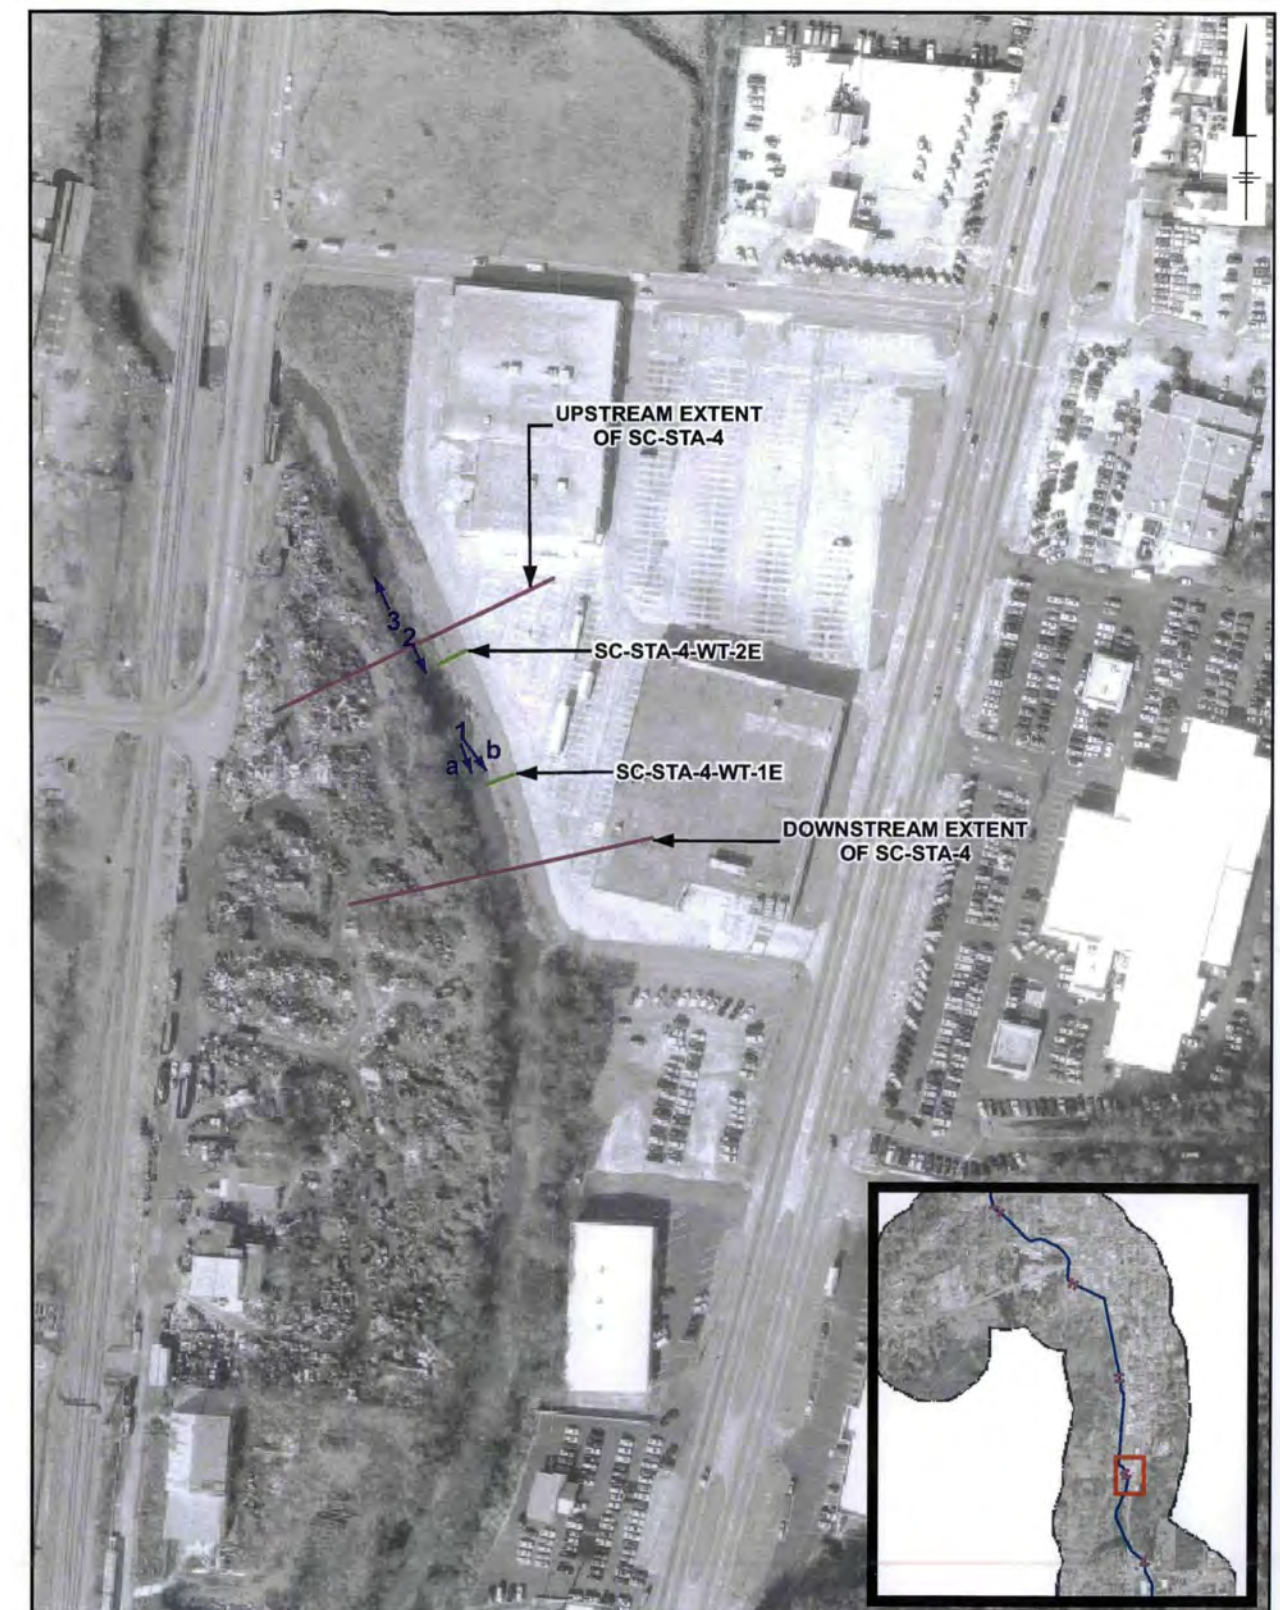
**BIOSURVEY LOCATIONS ON
SNOW CREEK: STA-4**

- WILDLIFE OBSERVATION TRANSECT
- SNOW CREEK SAMPLING STATION BOUNDARIES

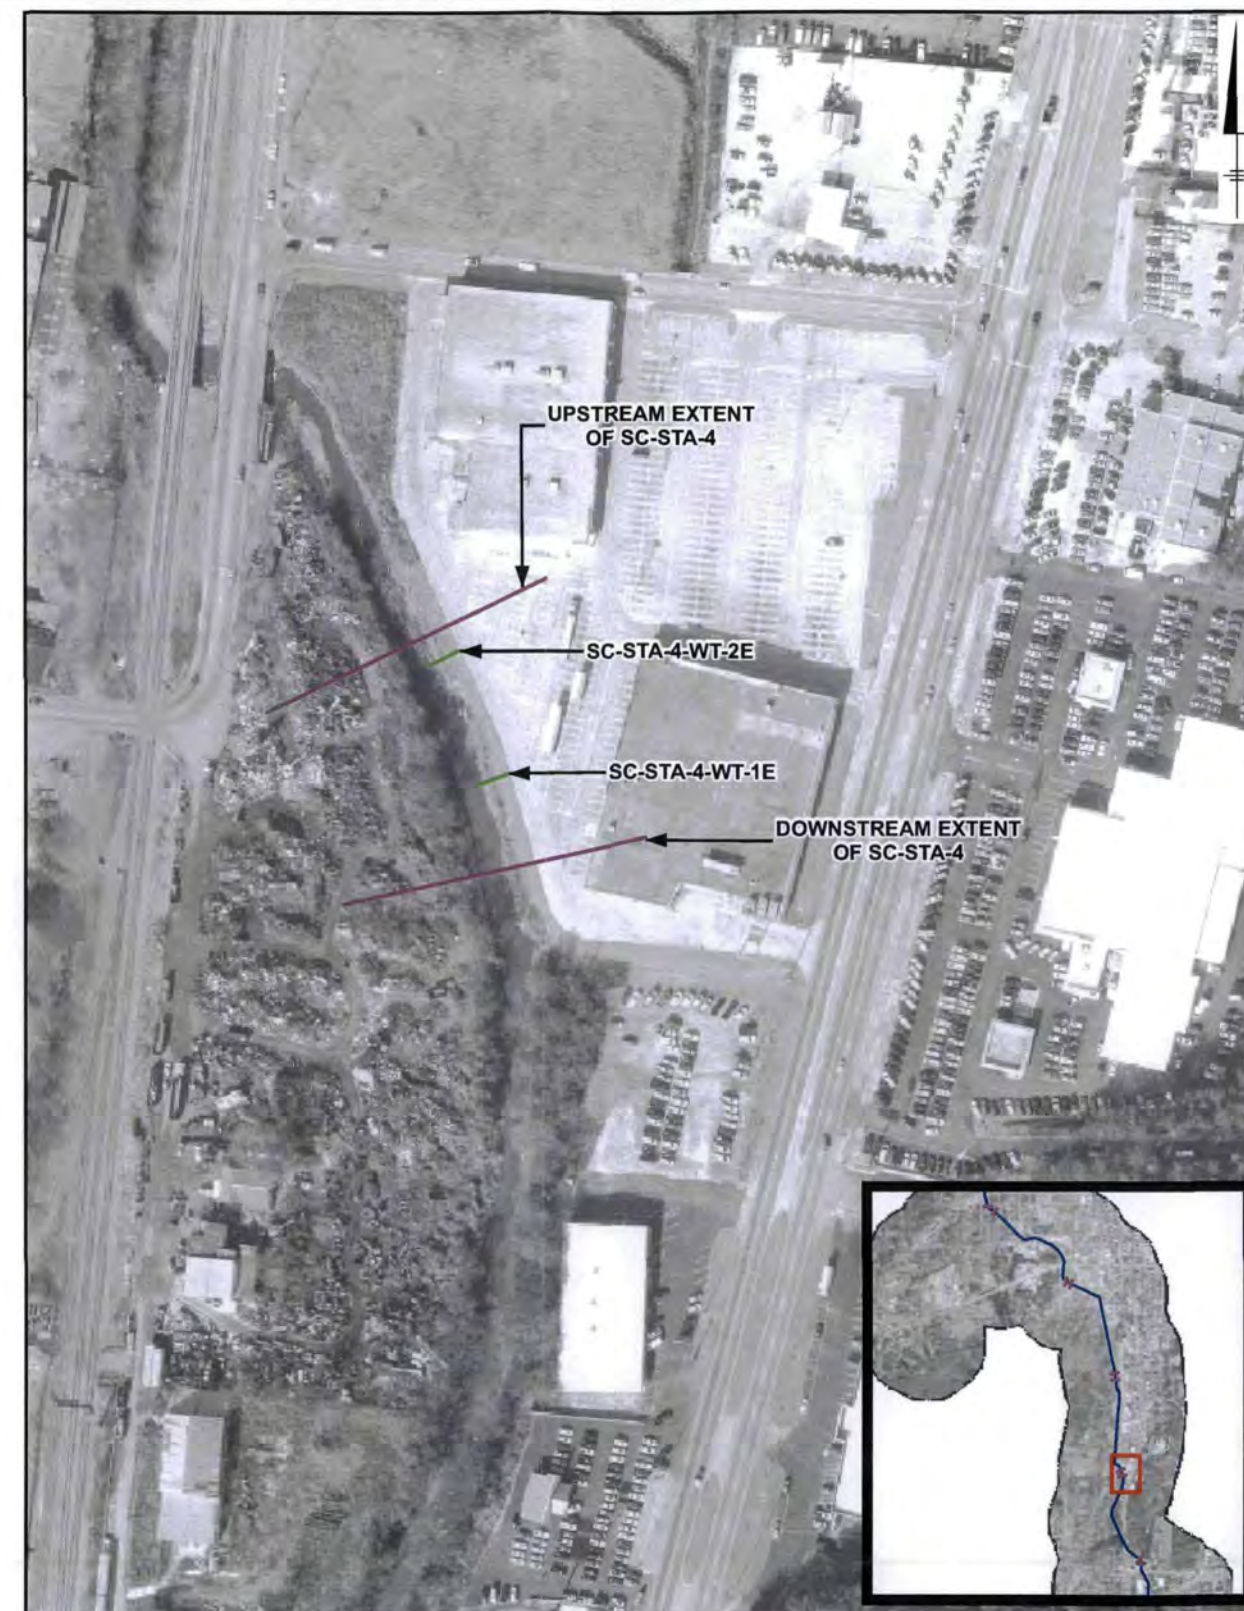
FIGURE
33

BIOSURVEY RESULTS FOR STA-4

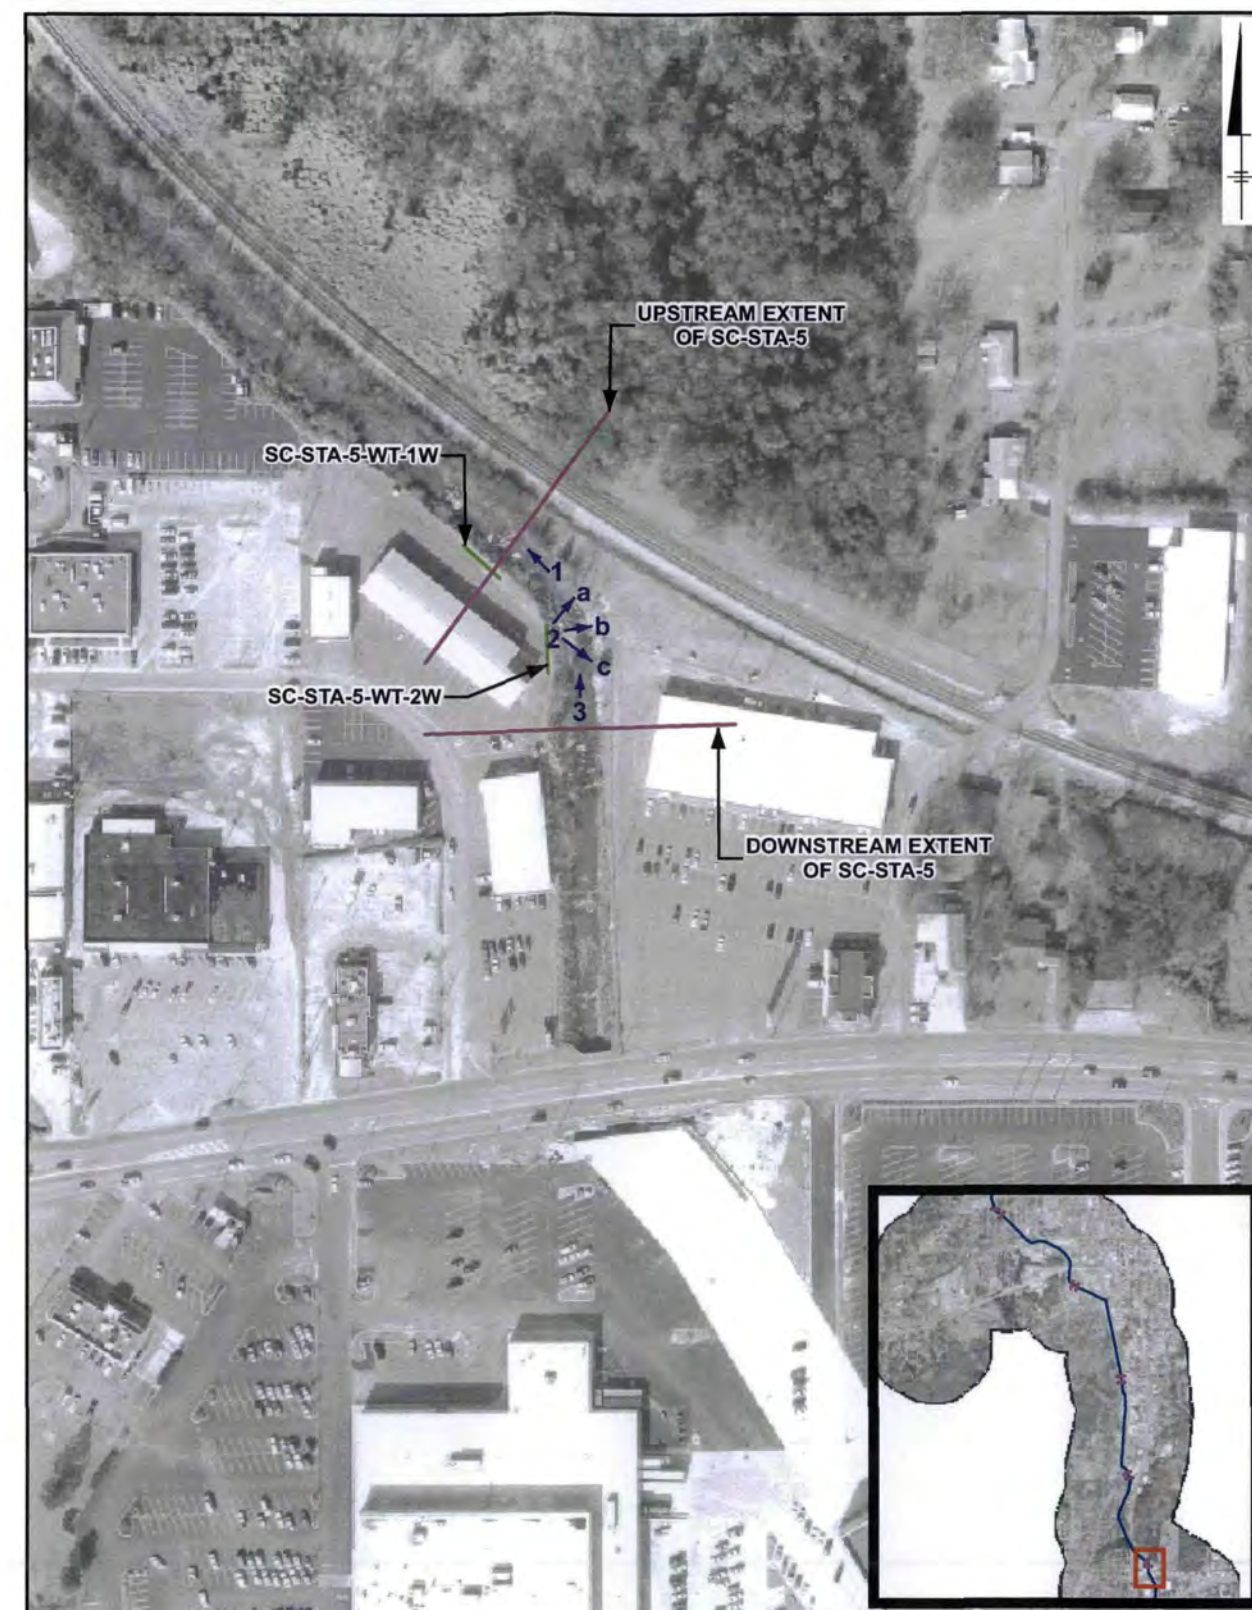
- WILDLIFE OBSERVATION TRANSECT
- SNOW CREEK SAMPLING STATION BOUNDARIES
- 2 PHOTO ID AND CAMERA DIRECTION

BIO SURVEY LOCATIONS ON SNOW CREEK: STA-5

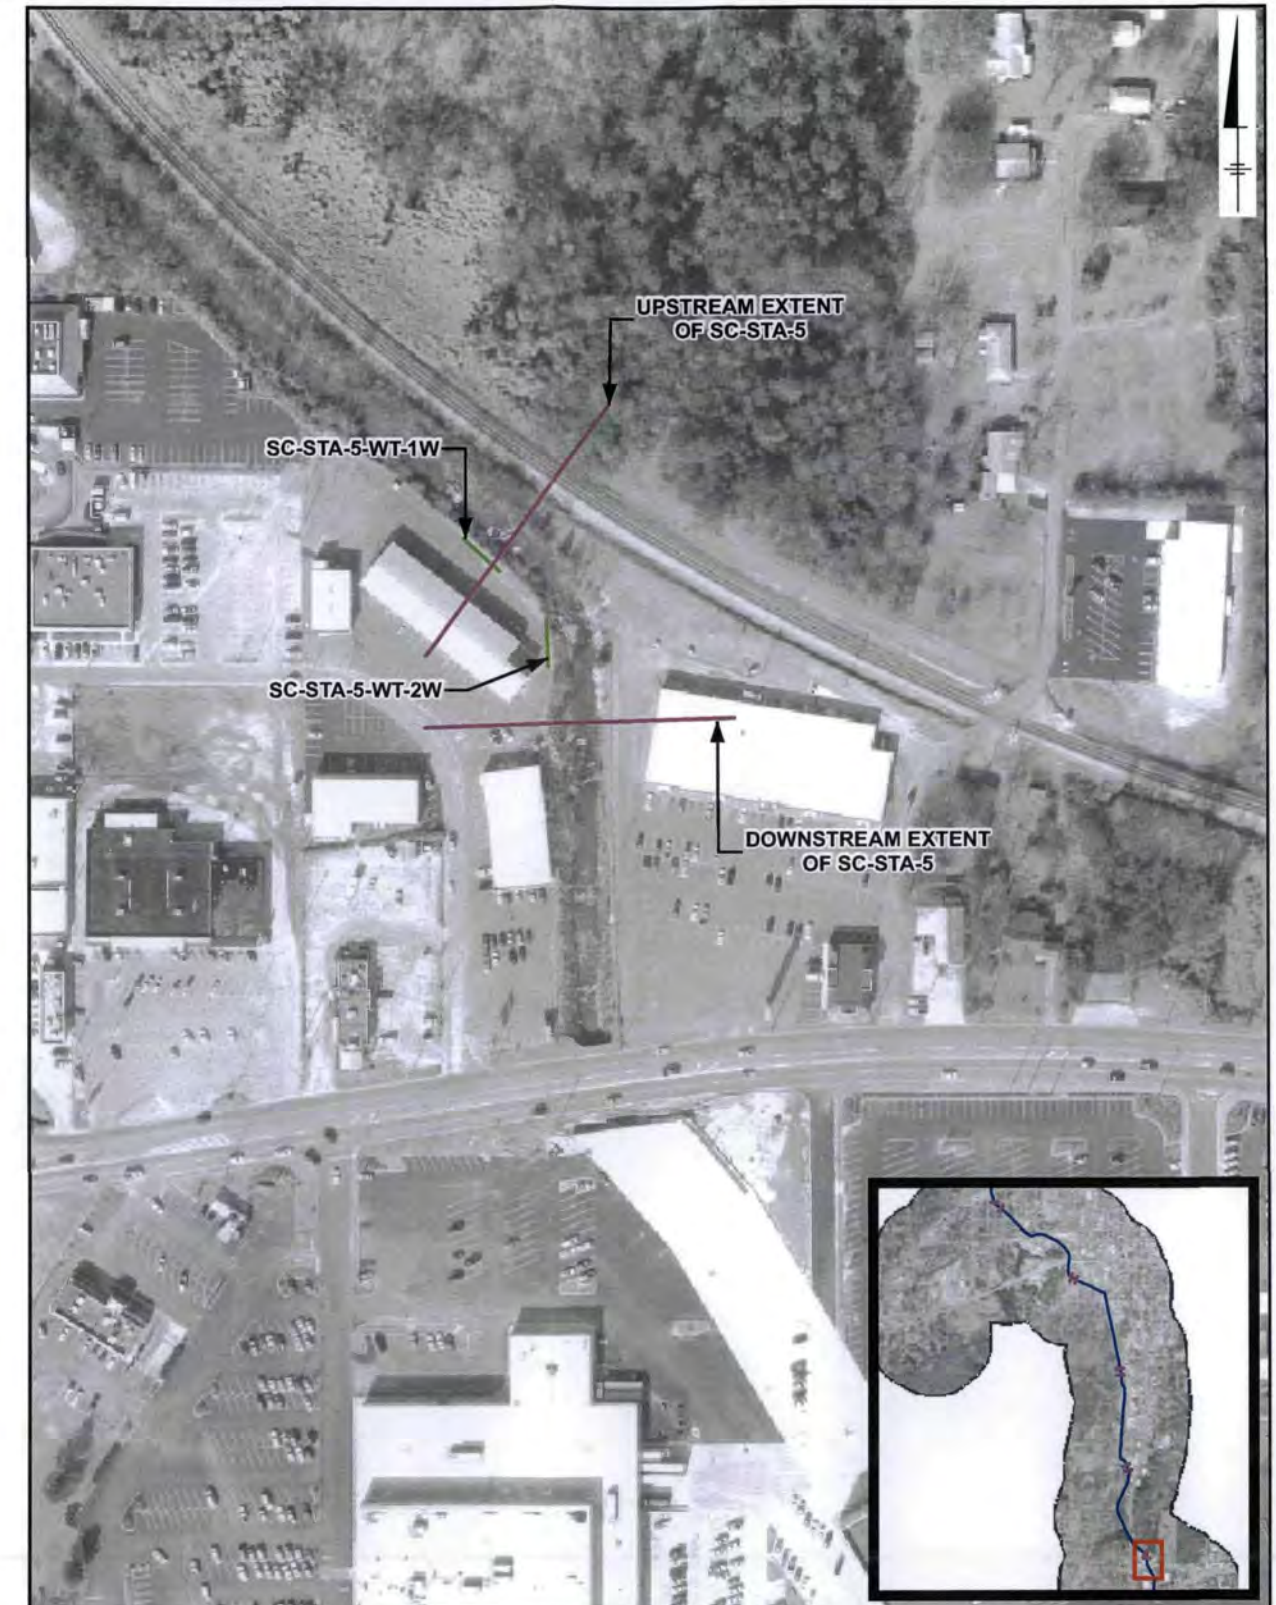
FIGURE
35

BIOSURVEY RESULTS FOR STA-5

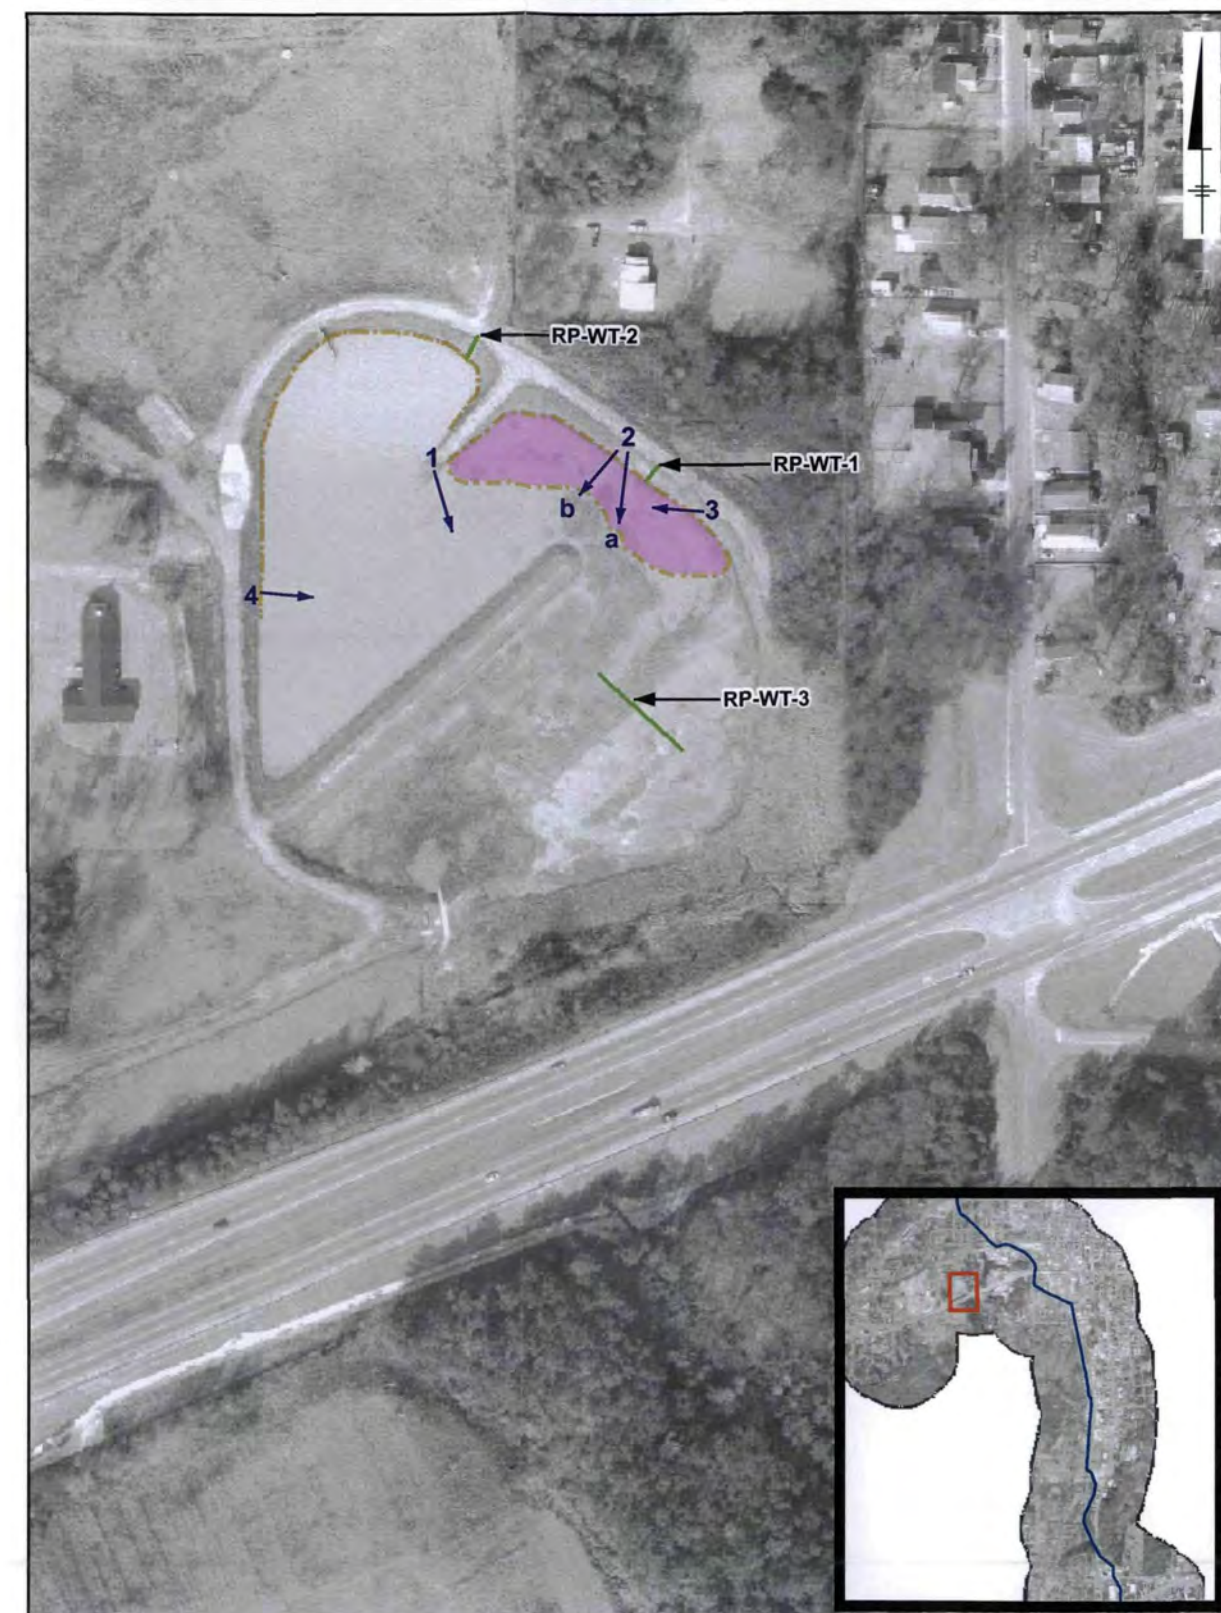
LEGEND:
 WILDLIFE OBSERVATION TRANSECT
 FISH SAMPLING AREA
 BENTHIC AND FISH SAMPLING AREA
 PHOTO ID AND CAMERA DIRECTION

**BIO SURVEY LOCATIONS FOR
 STORMWATER RETENTION STRUCTURE**

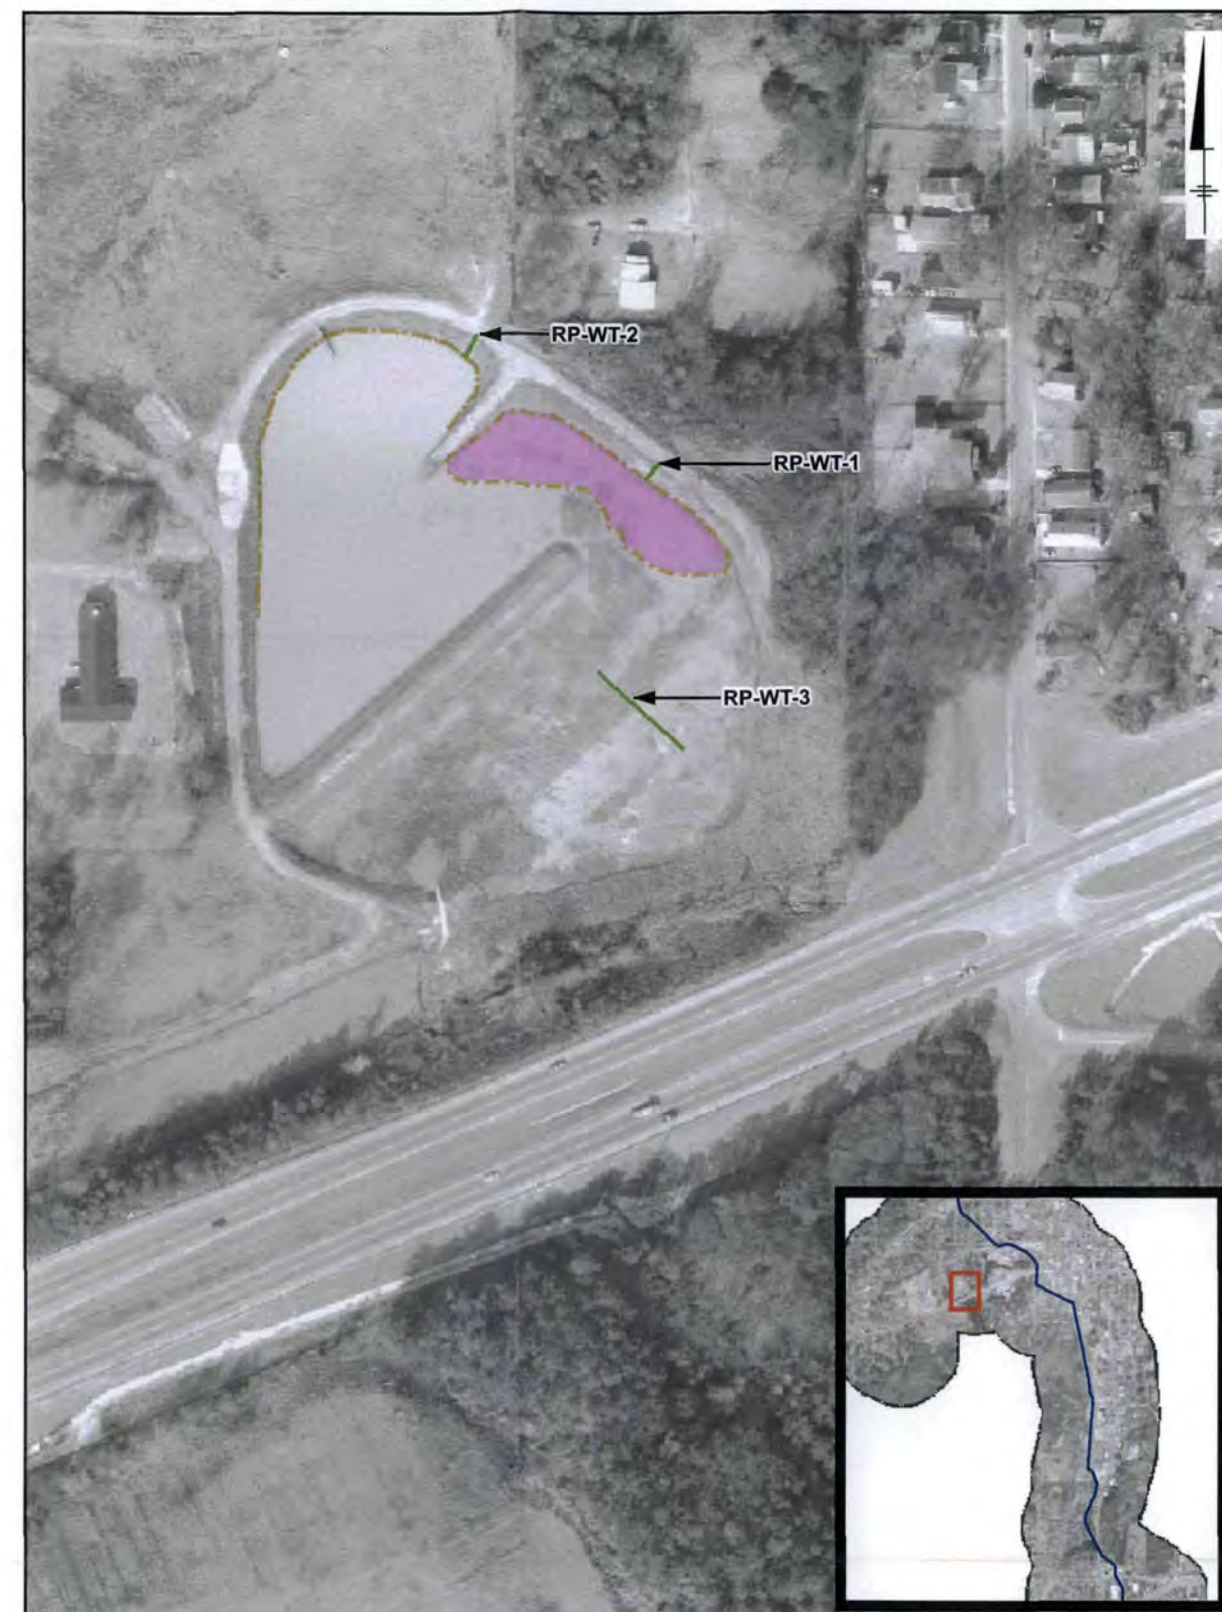
FIGURE
37

BIOSURVEY RESULTS FOR STORMWATER RETENTION STRUCTURE
