Re: Anniston PCB Site
Revision 1 of the *Screening Level Ecological Risk Assessment for Operable Units 1, 2, and 3*

*Screening Level Ecological Risk
Assessment (SLERA)
for Operable Units 1, 2, and 3
of the Anniston PCB Site*

**Anniston PCB Site
Anniston, Alabama**

**Revision 1
December 2005**

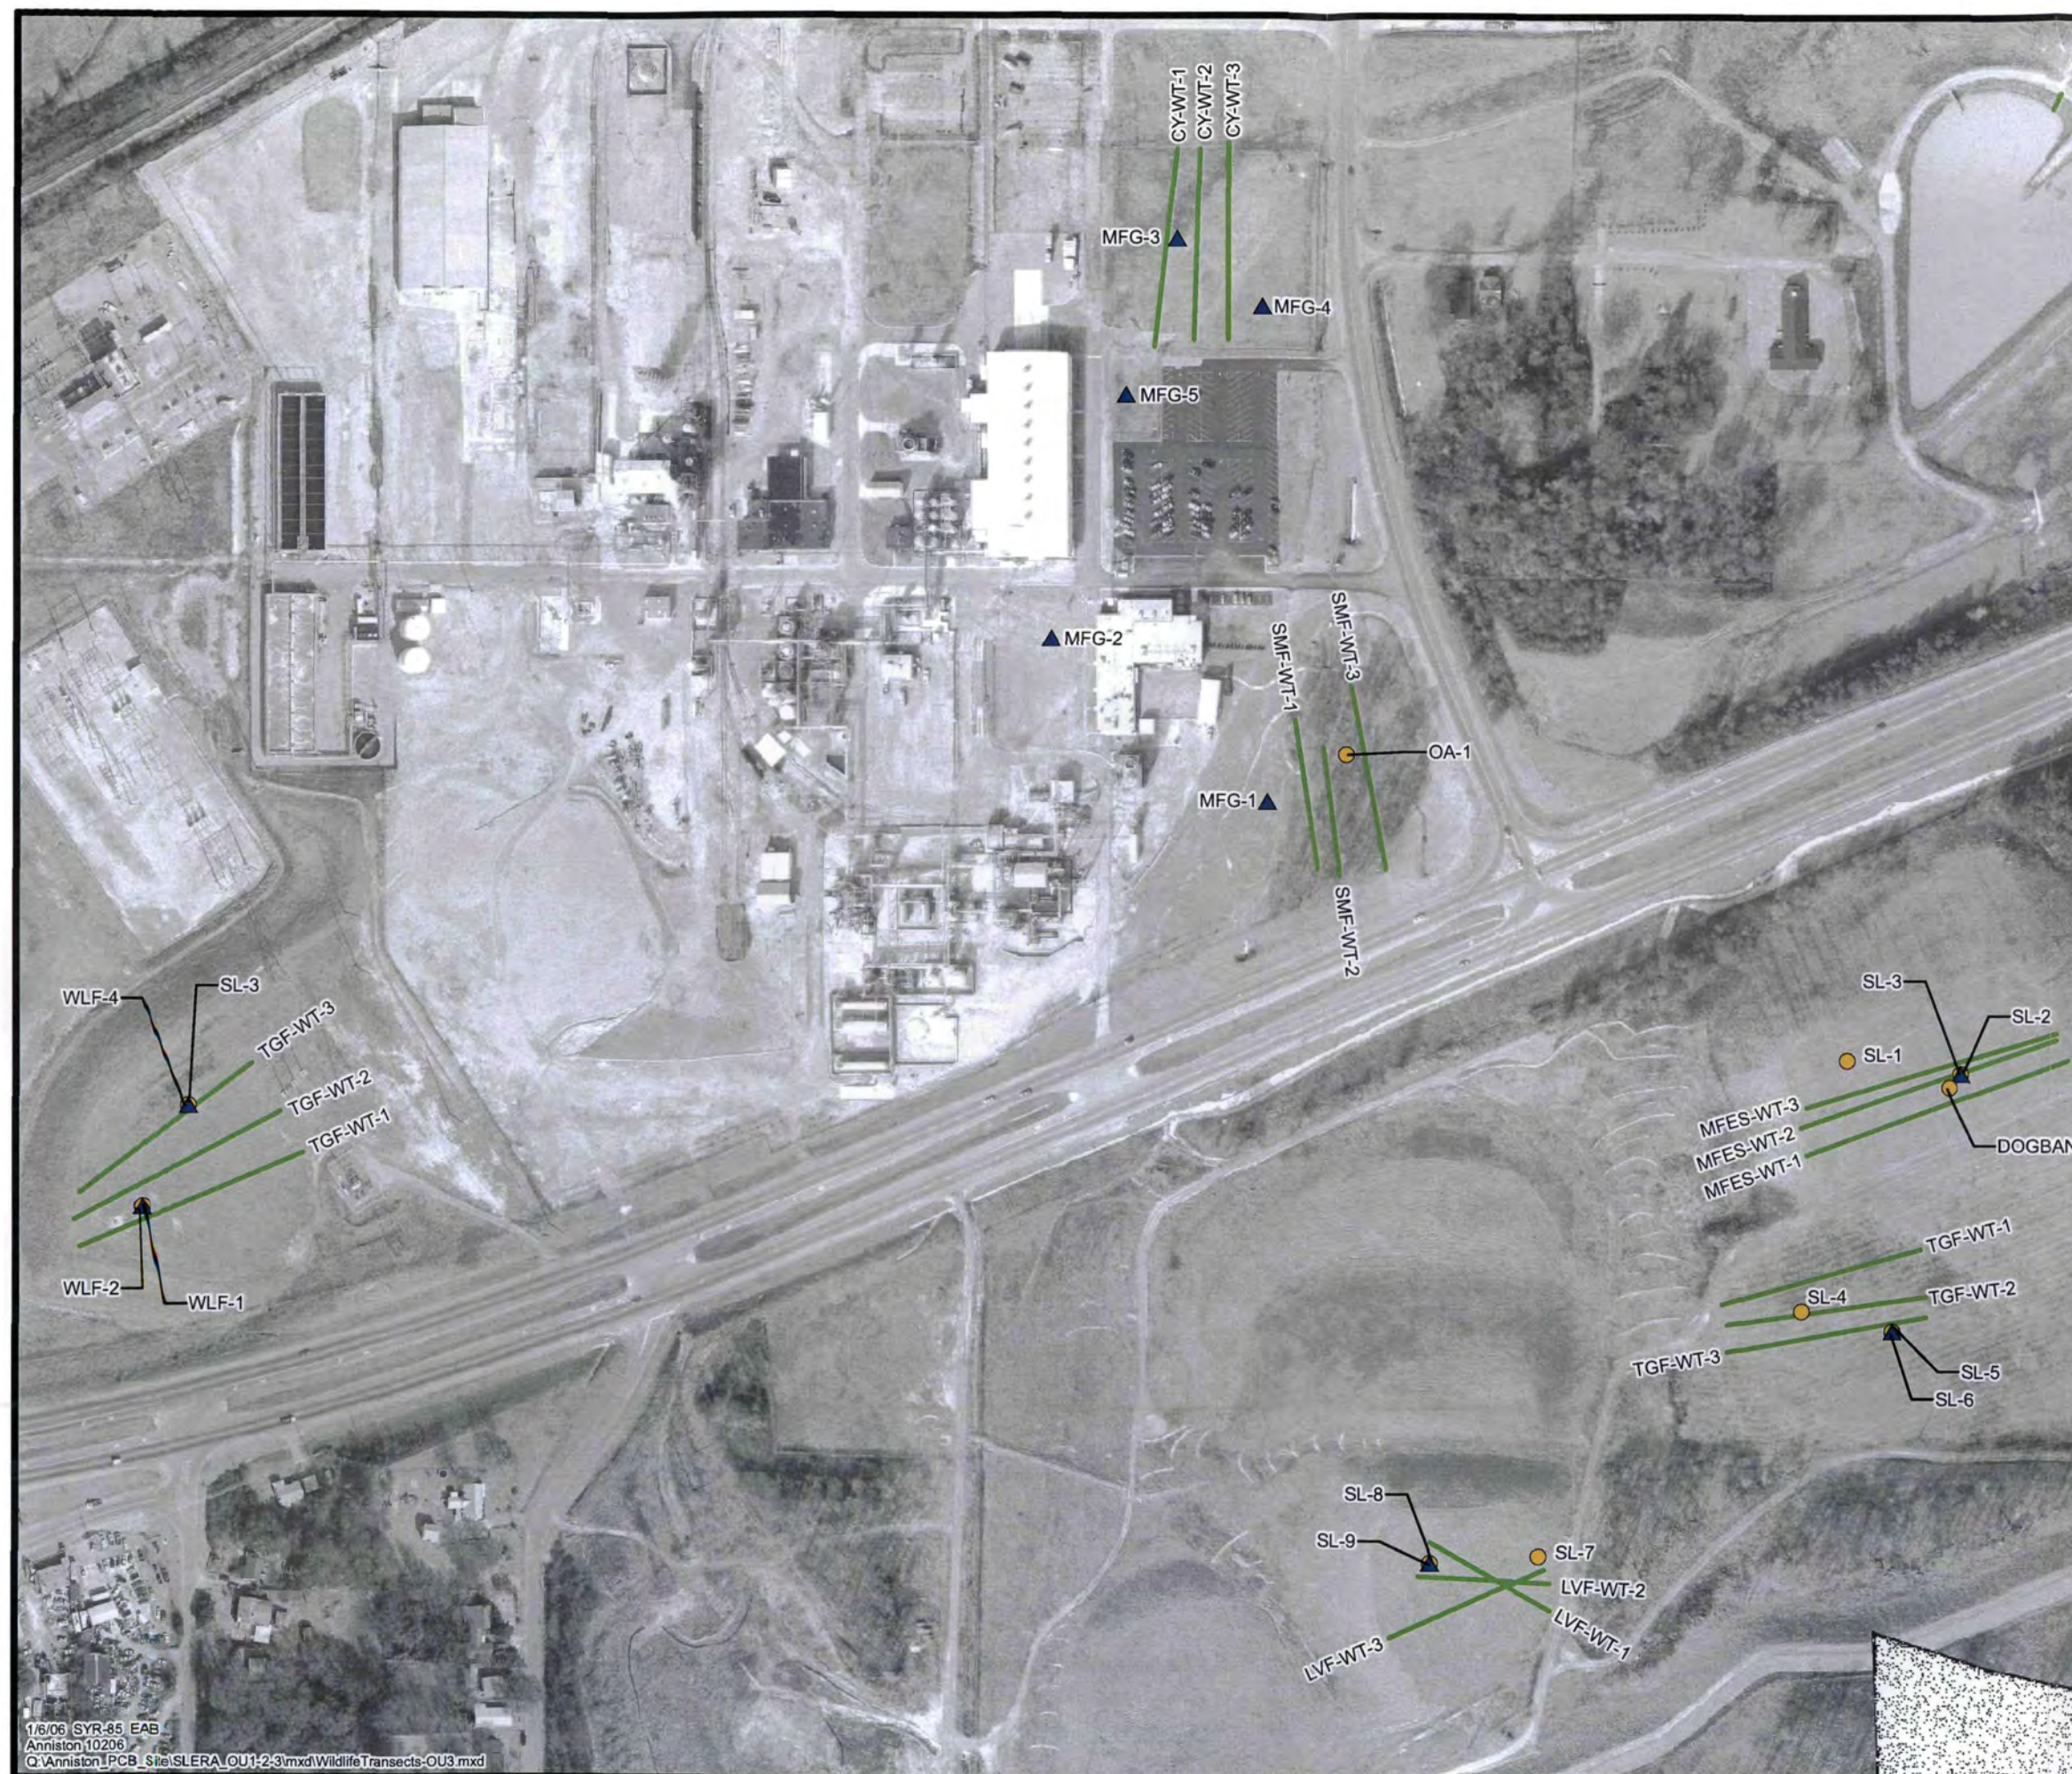
FIGURE
38

- WILDLIFE OBSERVATION LOCATION - 1 MINUTE SWEEP
- ▲ WILDLIFE OBSERVATION LOCATION - SOIL CORE
- WILDLIFE OBSERVATION TRANSECT

**WILDLIFE TRANSECT AND
SAMPLE LOCATIONS: OU-3**

Wildlife community surveys were conducted in the four general areas of OU-3: Maintained Facility Grounds, Open Area, West End Landfill and South Landfill (Figure 38). Observations were made along three transects running the length of each sample area. The focus of the wildlife survey was to document the use of OU-3 habitats by birds and mammals either directly or by signs. The survey included a reconnaissance of each sample area and was conducted simultaneously with the invertebrate survey. In addition to direct observations, the

The South Landfill is a vegetated landfill cap that includes sampling areas identified as MFES, TGF, and LVF. These areas were sampled along transect lines shown on Figure 38. In general, the primary habitats identified throughout the three sampling areas of the South Landfill were vegetated fields containing various grass and clover species. The percent vegetation cover observed in each sampling area was visually estimated and recorded. Tables 17 and 18 summarize the results of the habitat characterization and vegetation survey.

In general, the primary habitats identified in the open area were a hardwood forest and an open area with low-lying vegetation. The percent vegetation cover observed in the sampling area was visually estimated and recorded. Tables 17 and 18 summarize the results of the habitat characterization and vegetation survey, and the open area sampling location is identified as "OA" on Figure 38.

sampling area was visually estimated and recorded. Tables 17 and 18 summarize the results of the habitat characterization and vegetation survey, and the sampling transects are identified on Figure 38.

In general, the primary habitat identified at the West End Landfill (designated as WLF) was a field composed of herbs and grasses growing over the landfill cap. The percent vegetation cover observed in the sampling area was visually estimated and recorded. Tables 17 and 18 summarize the results of the habitat characterization and vegetation survey, and the sampling transects are identified on Figure 38.
