ANNISTON PCB SITE ANNISTON, ALABAMA SCREENING LEVEL ECOLOGICAL RISK ASSESSMENT FOR OPERABLE UNITS 1, 2, AND 3	
OPERABLE UNITS 1, 2, AND 3	
  BLASLAND, BOUCK & LEE, INC. engineers, scientists, economists	FIGURE 1

ANNISTON PCB SITE
ANNISTON, ALABAMA
SCREENING LEVEL ECOLOGICAL RISK
ASSESSMENT FOR OPERABLE UNITS 1, 2, AND 3

**SCREENING LEVEL ECOLOGICAL RISK ASSESSMENT
FOR OPERABLE UNITS 1, 2, AND 3**

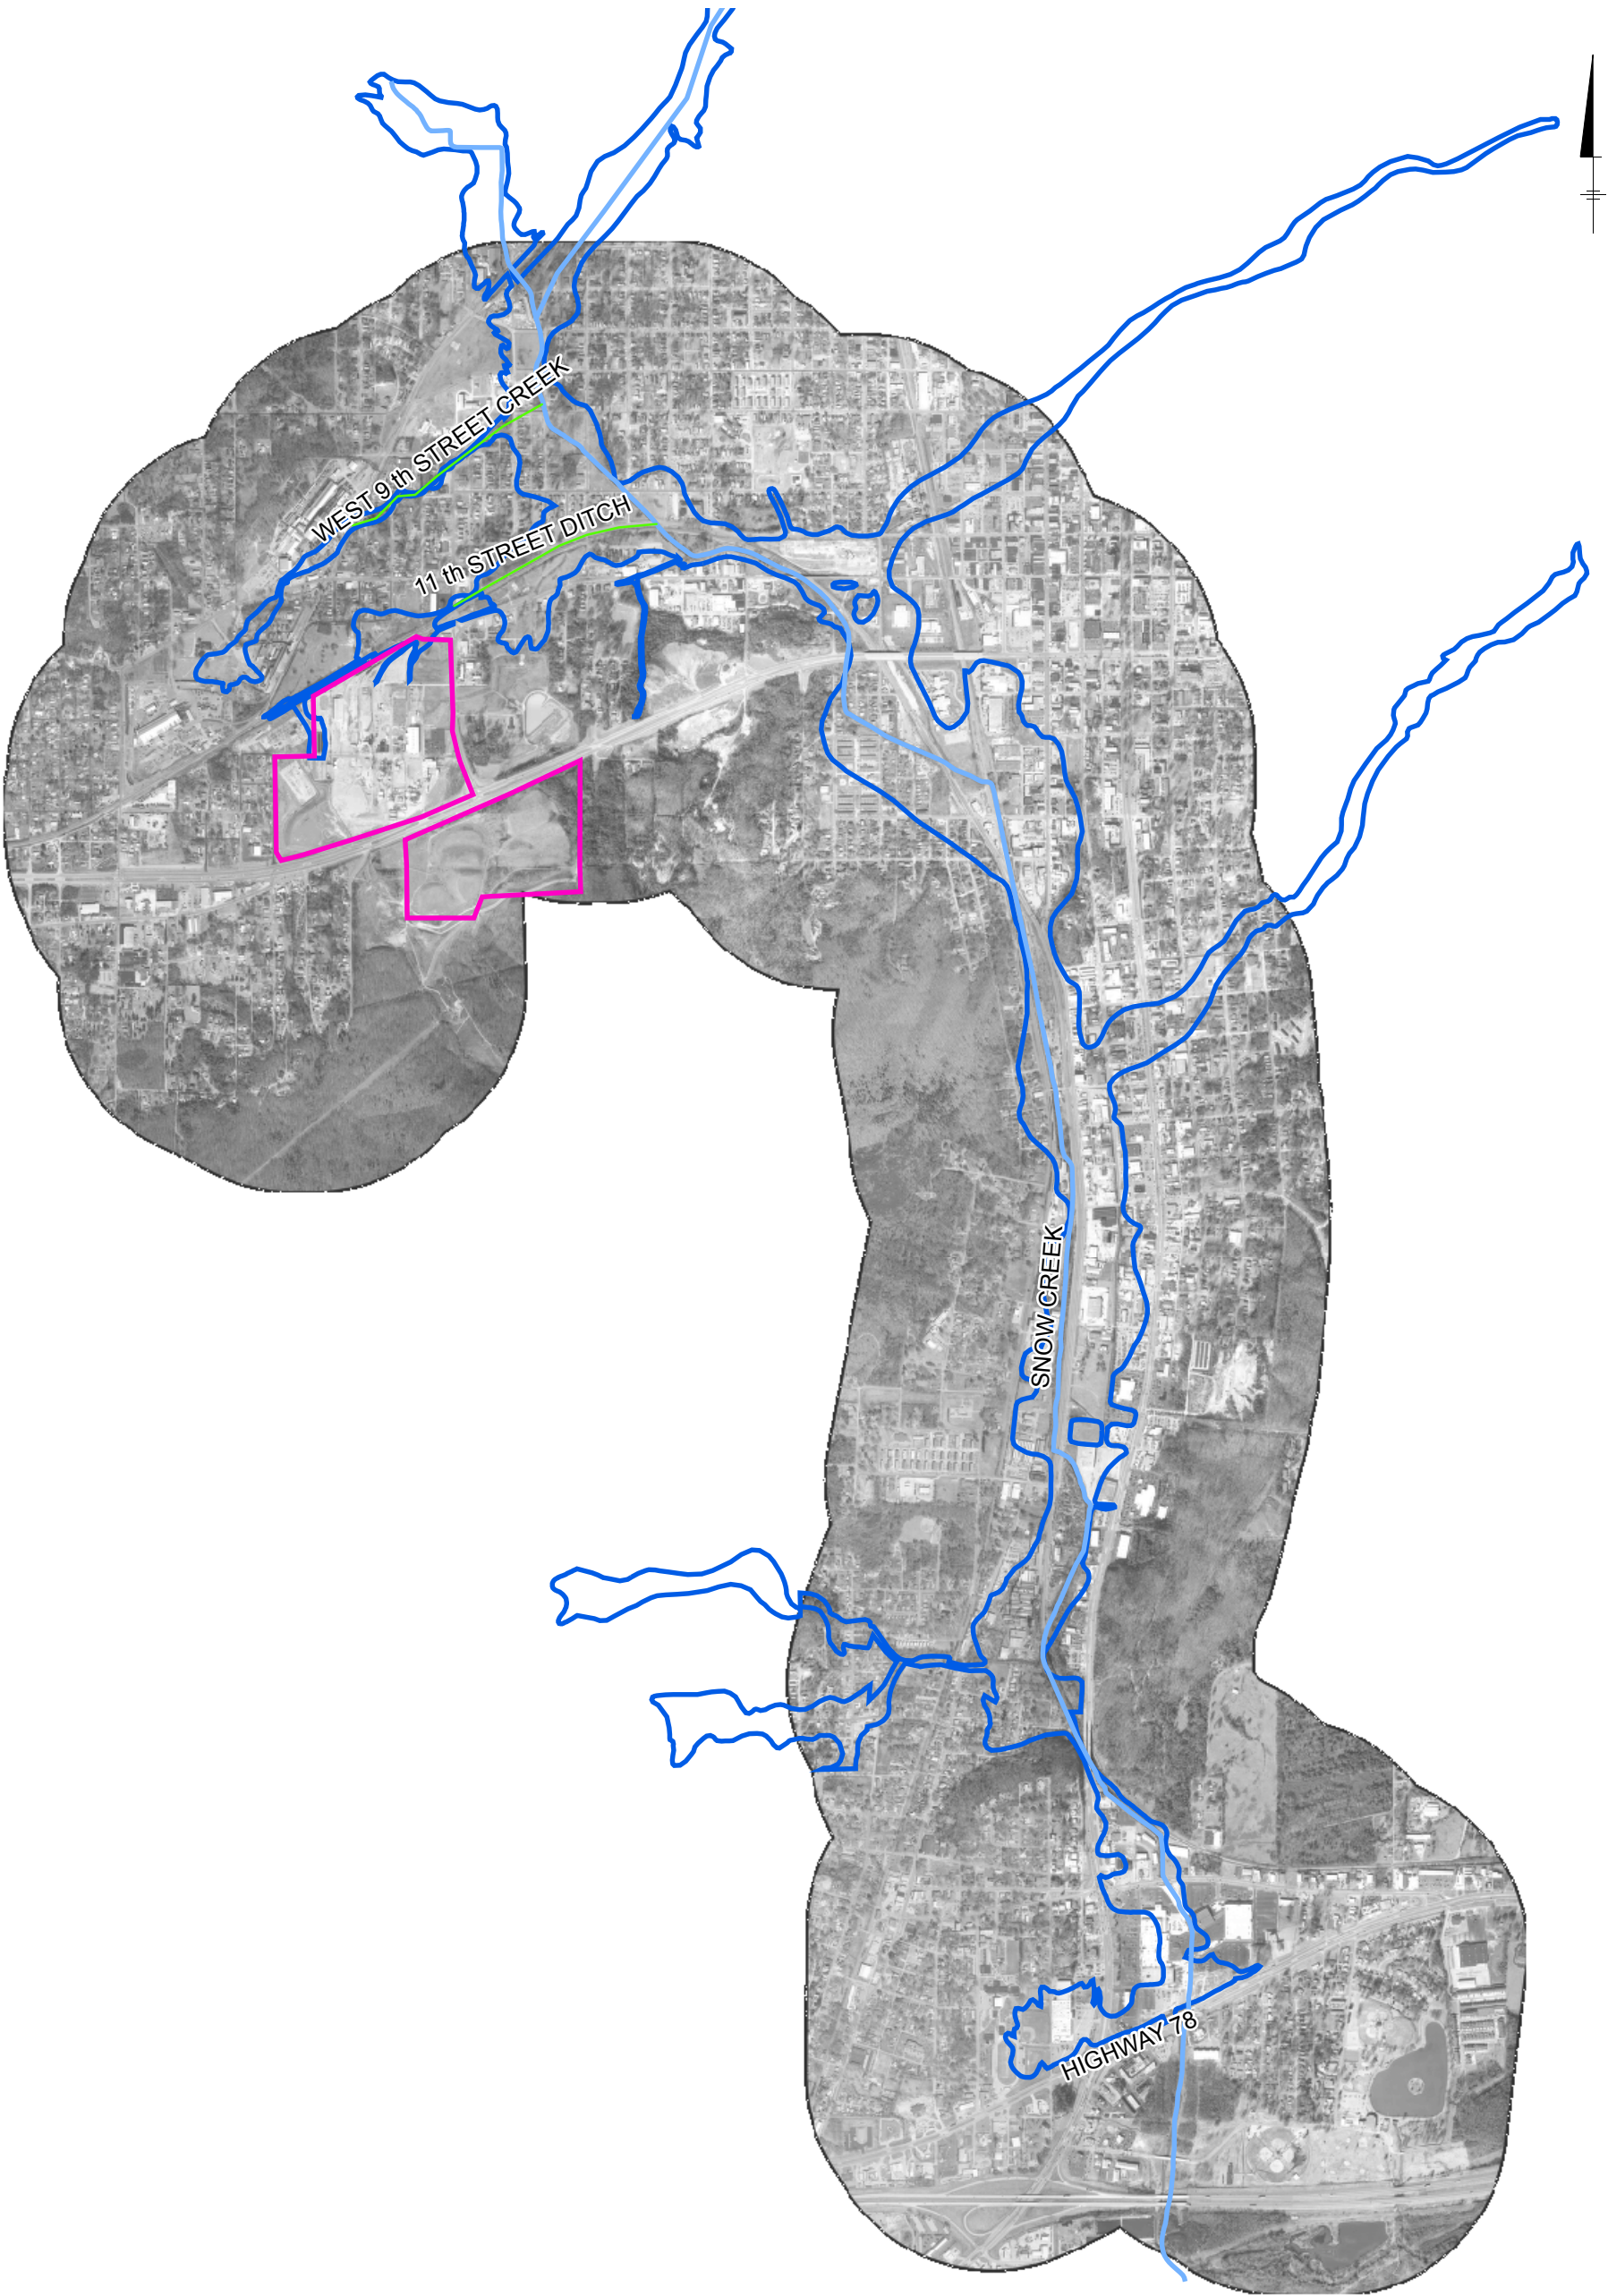
100-YR FLOODPLAIN AND DRAINAGE AREA
-

OU-3
-

SNOW CREEK

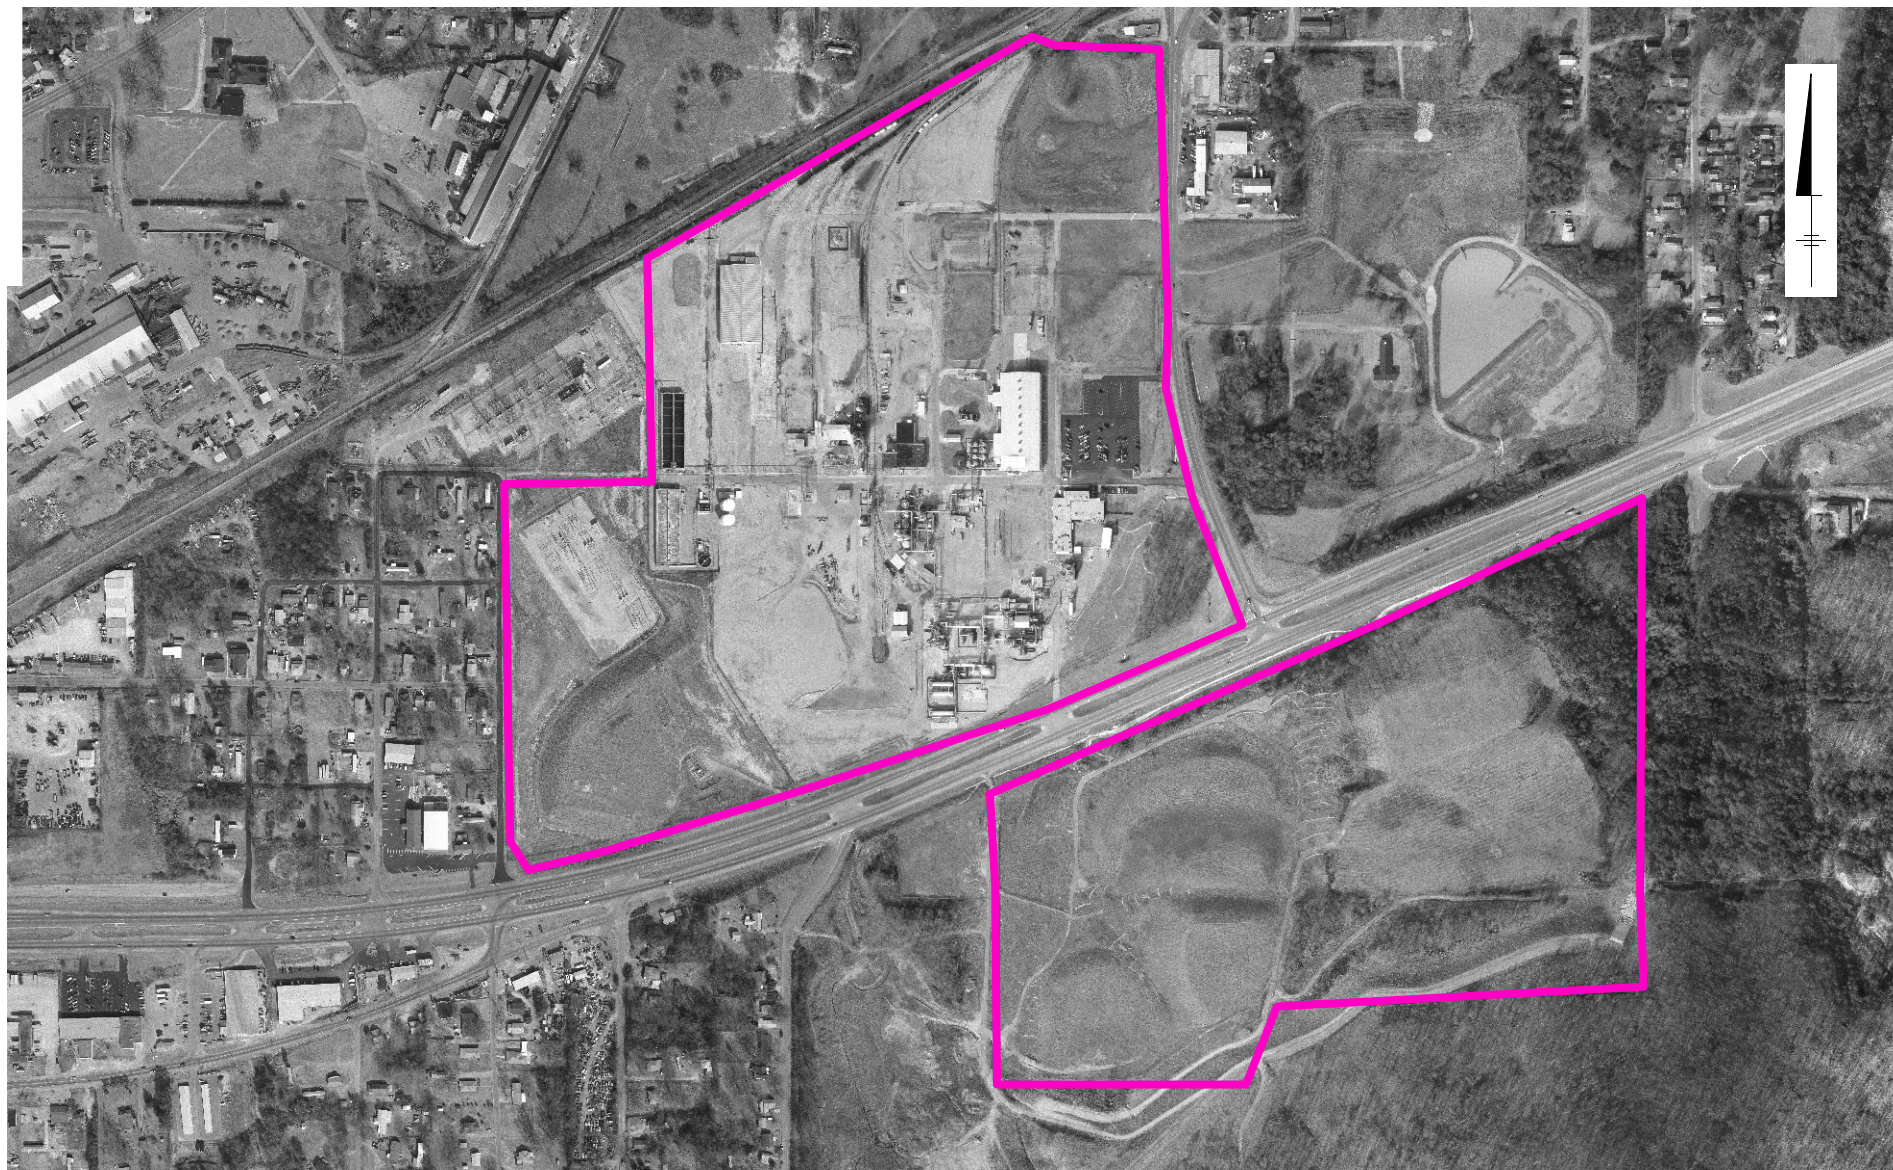
FIGURE
2

OPERABLE UNIT 3

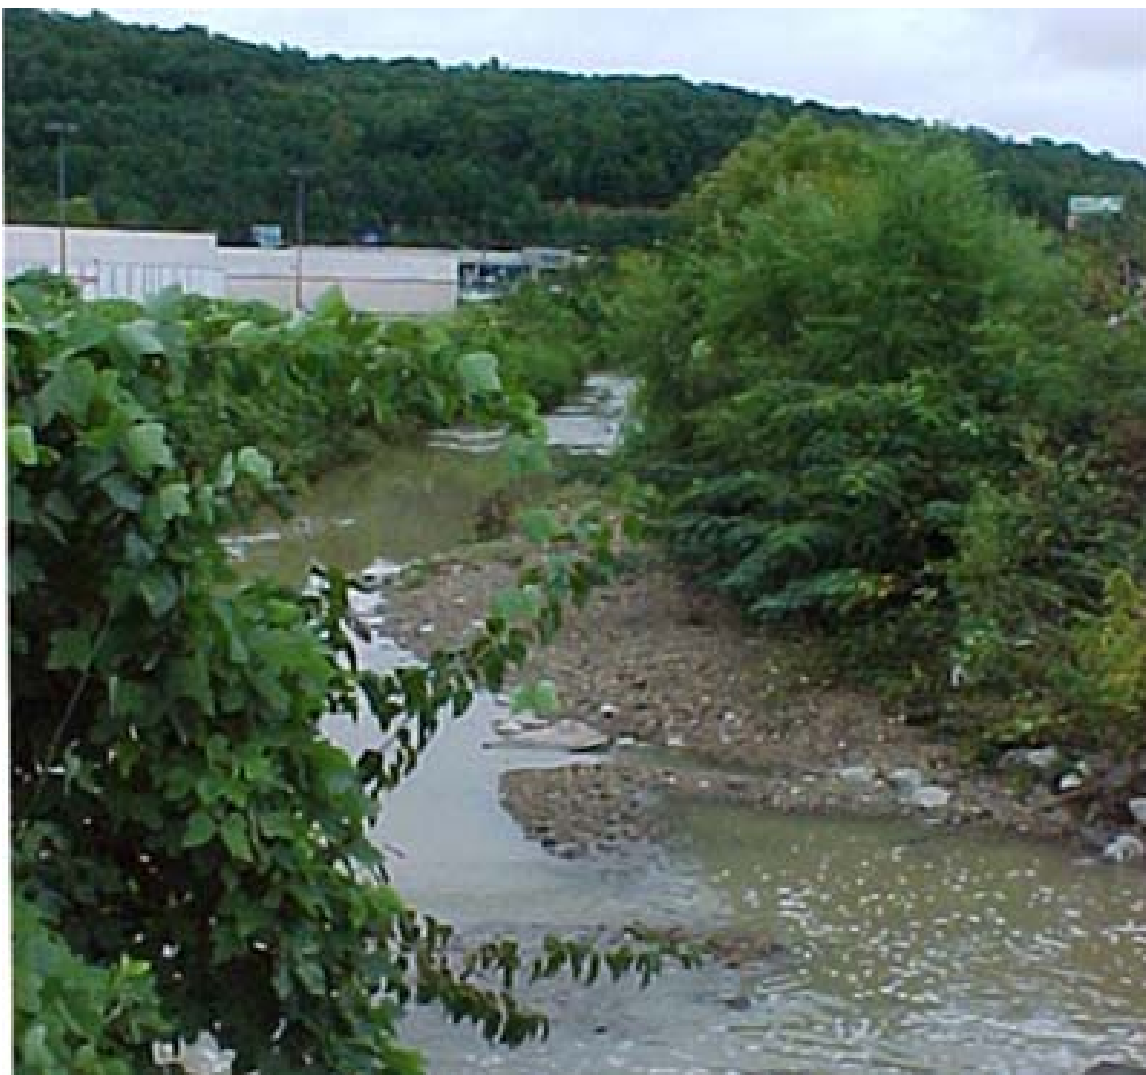
FIGURE
10

**RIPARIAN VEGETATION AND DEPOSITIONAL
BARS IN SNOW CREEK (BELOW NOBLE STREET)**

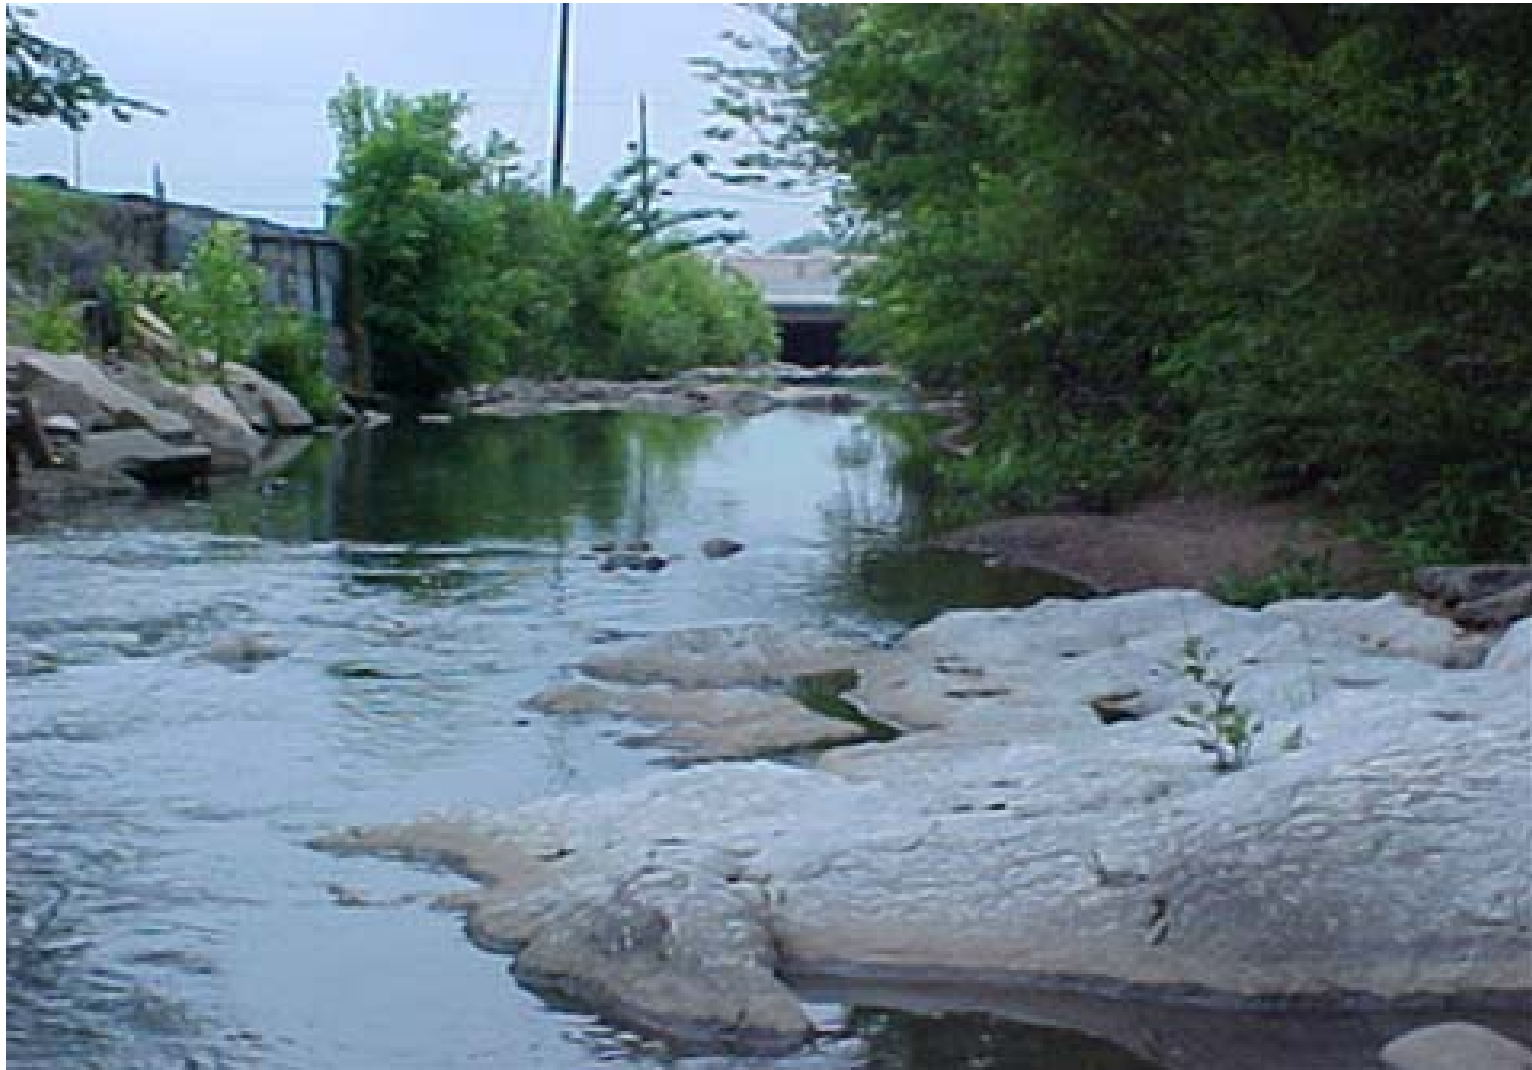
FIGURE
11

**SNOW CREEK BEFORE FLOWING INTO CULVERT
UNDER QUINTARD MALL (IN BACKGROUND)**

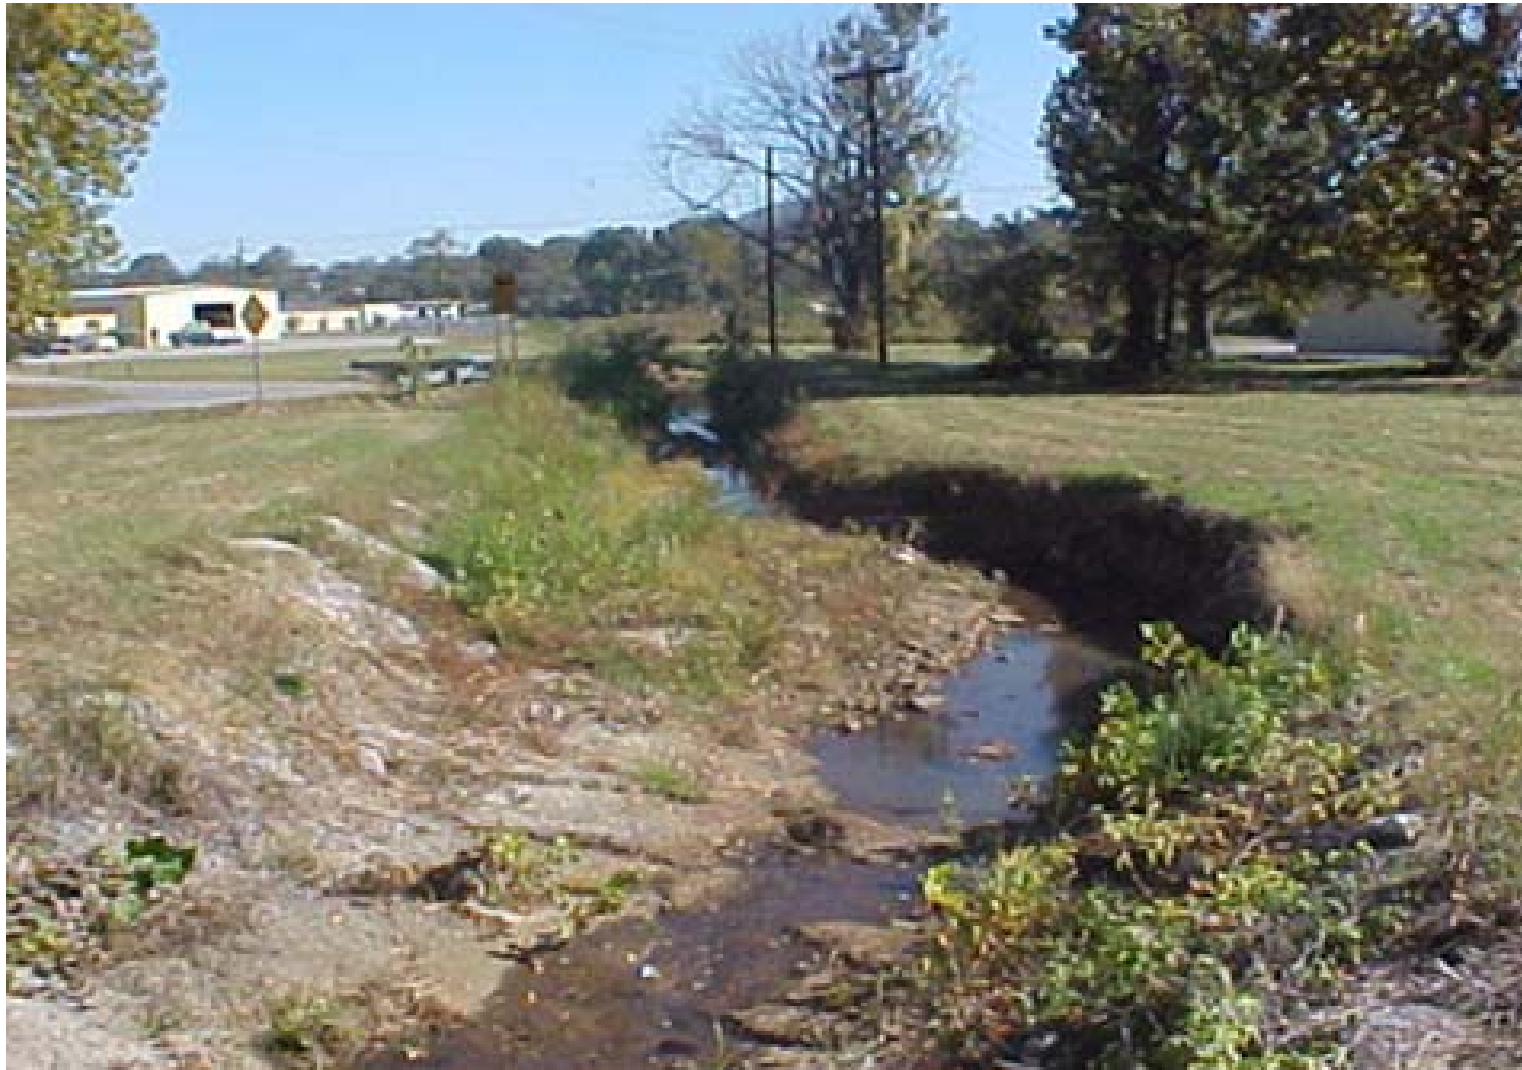
FIGURE
15

**MAINTAINED LAND USE TO EDGE OF SNOW
CREEK (UPSTREAM). NOTE: UNSTABLE BANKS
DUE TO EROSION AND SLOUGHING**

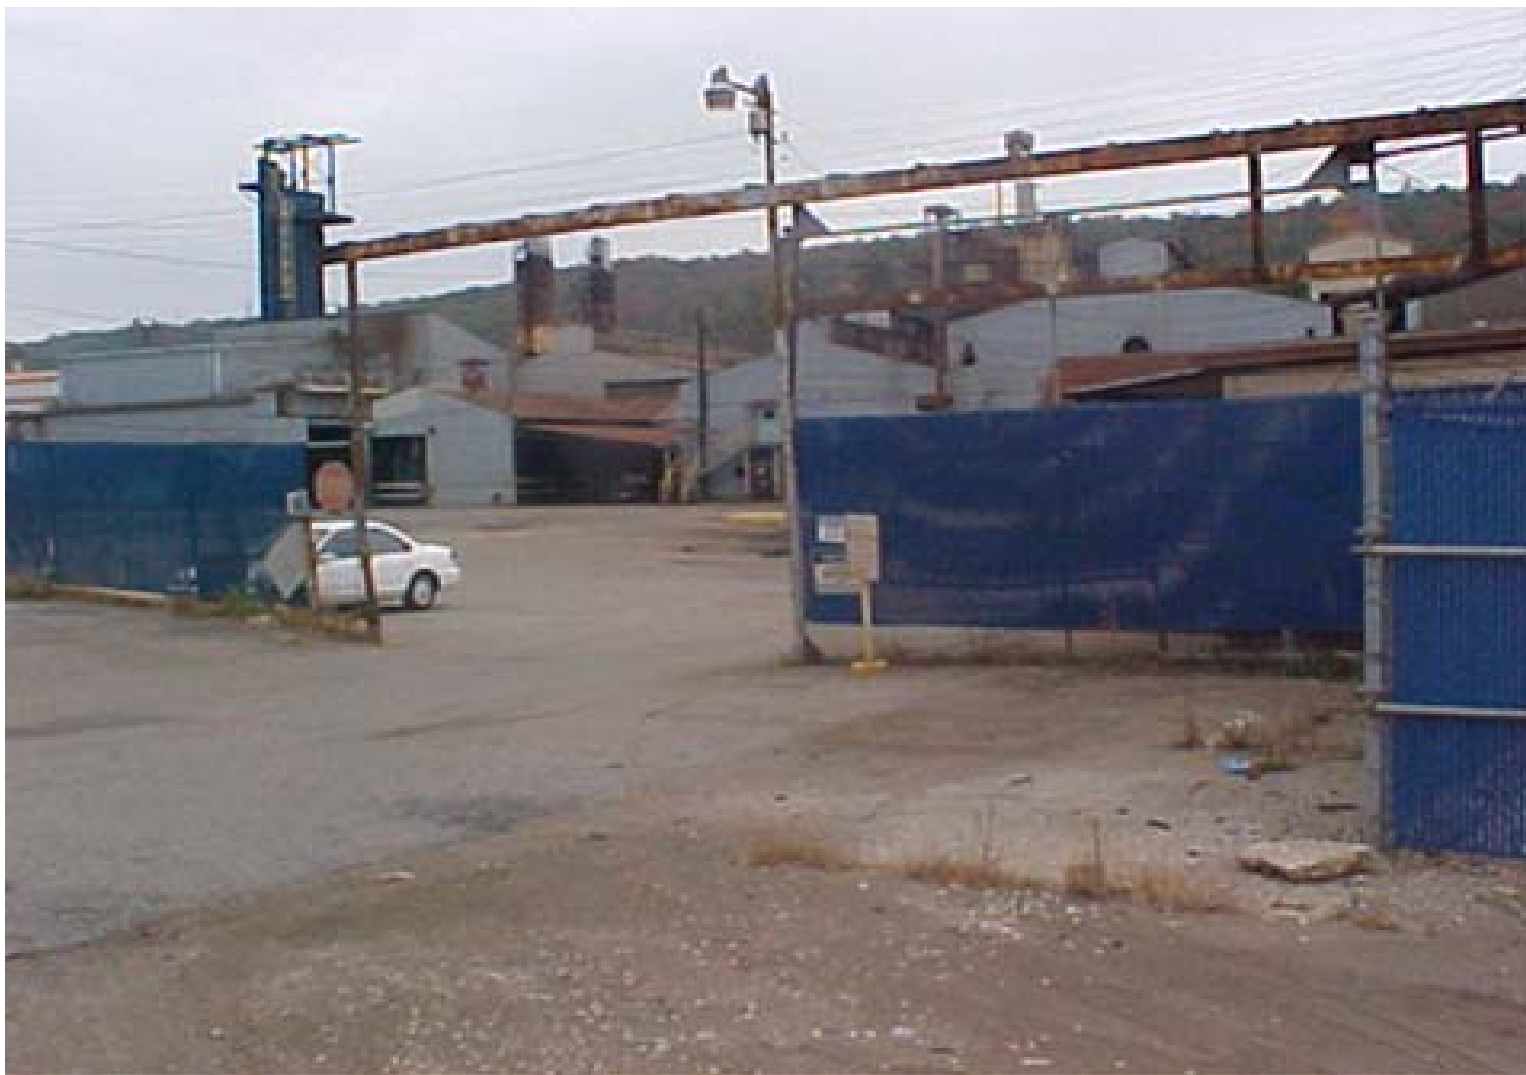
**INDUSTRIAL LAND USE SHOWING IMPERVIOUS
LAYERS OF FACILITY ENVIRONS AND NO
HABITAT**

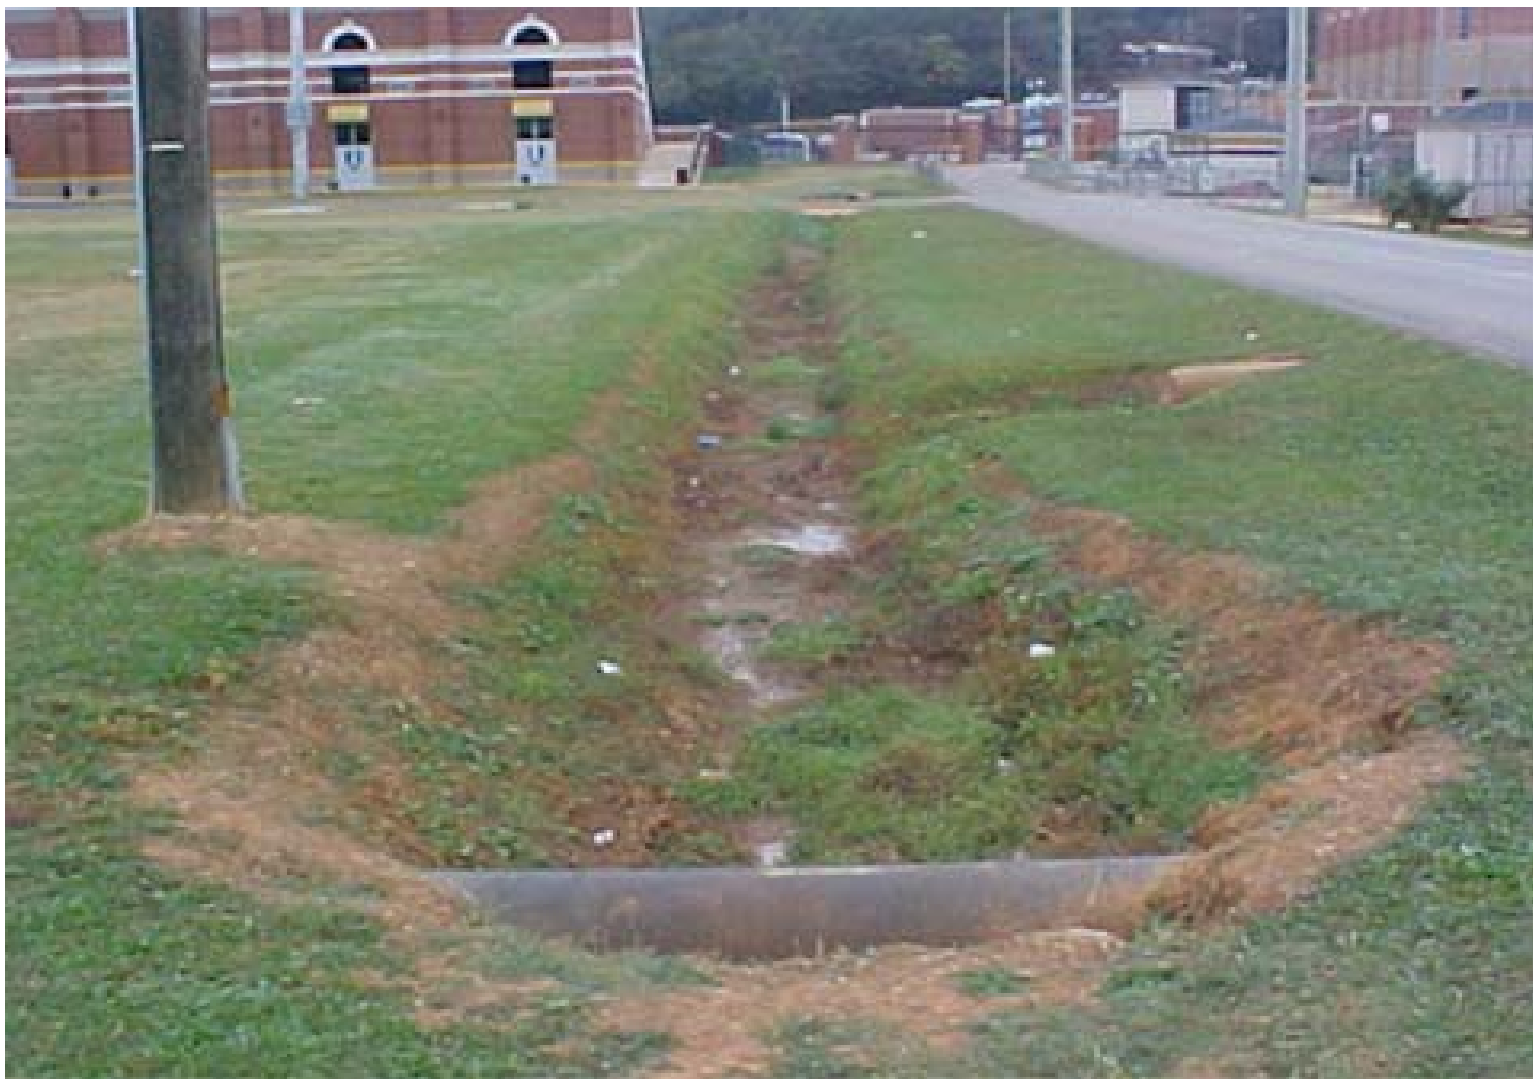
FIGURE
21

RECREATION/SCHOOL LAND USE SHOWING
DRAINAGE DITCH BEFORE BORDERING FIELD

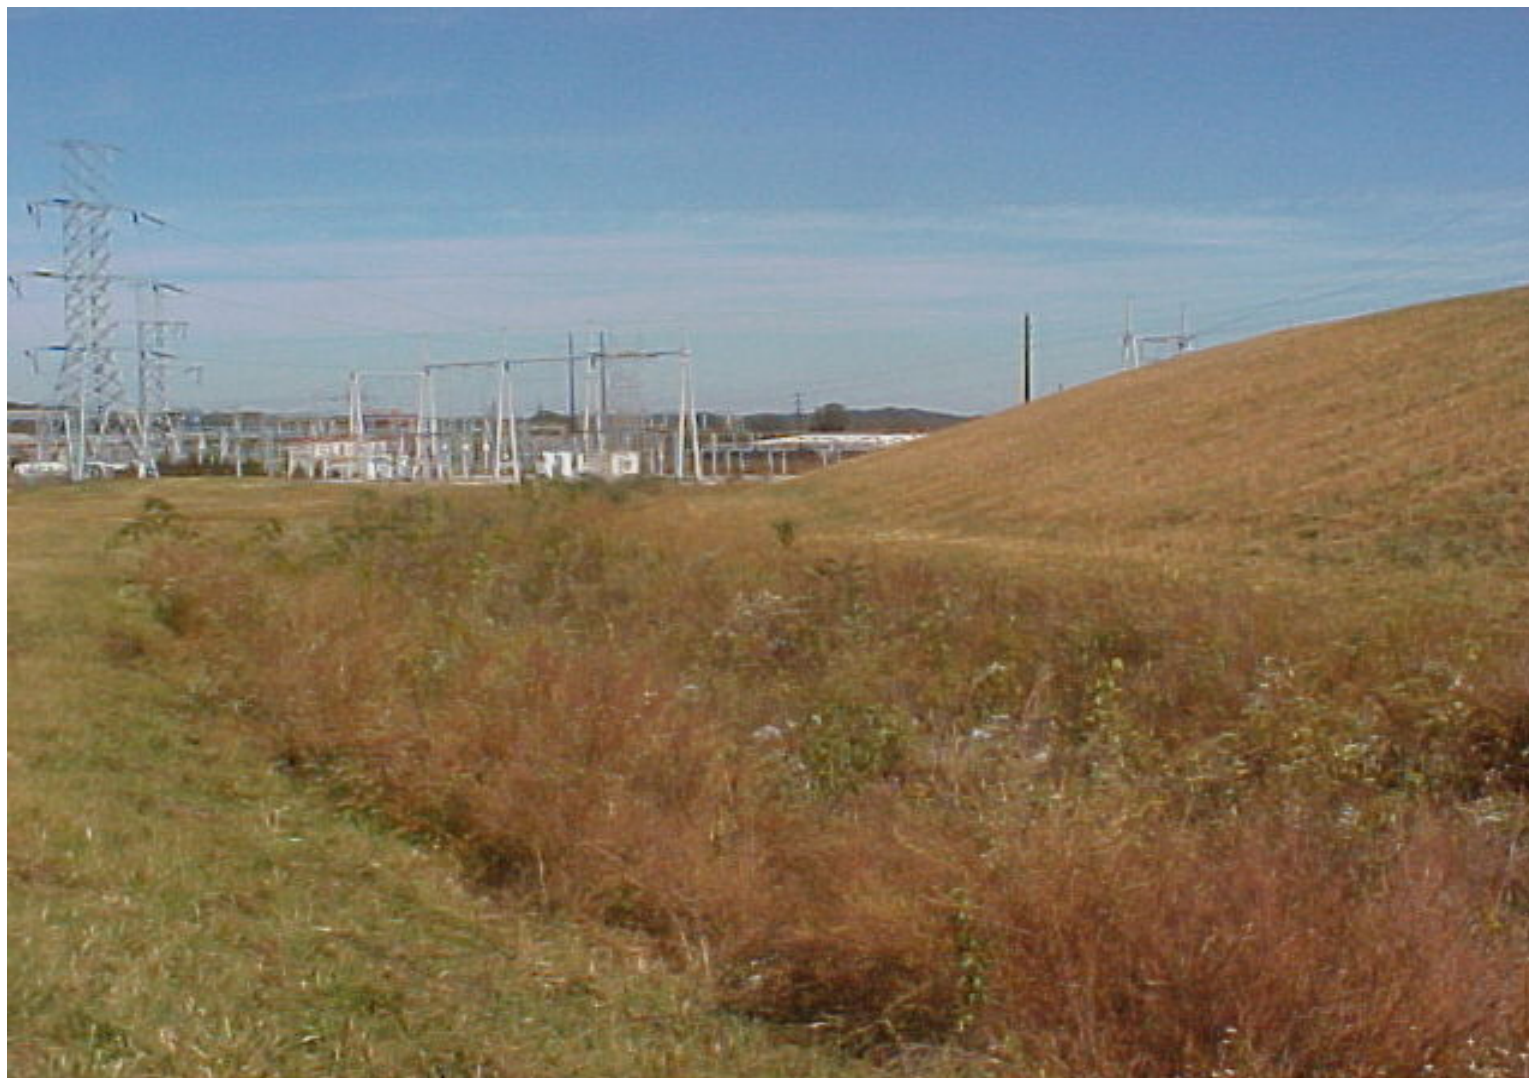
**WEST END LANDFILL: RIP-RAPPED DRAINAGE
SWALE**

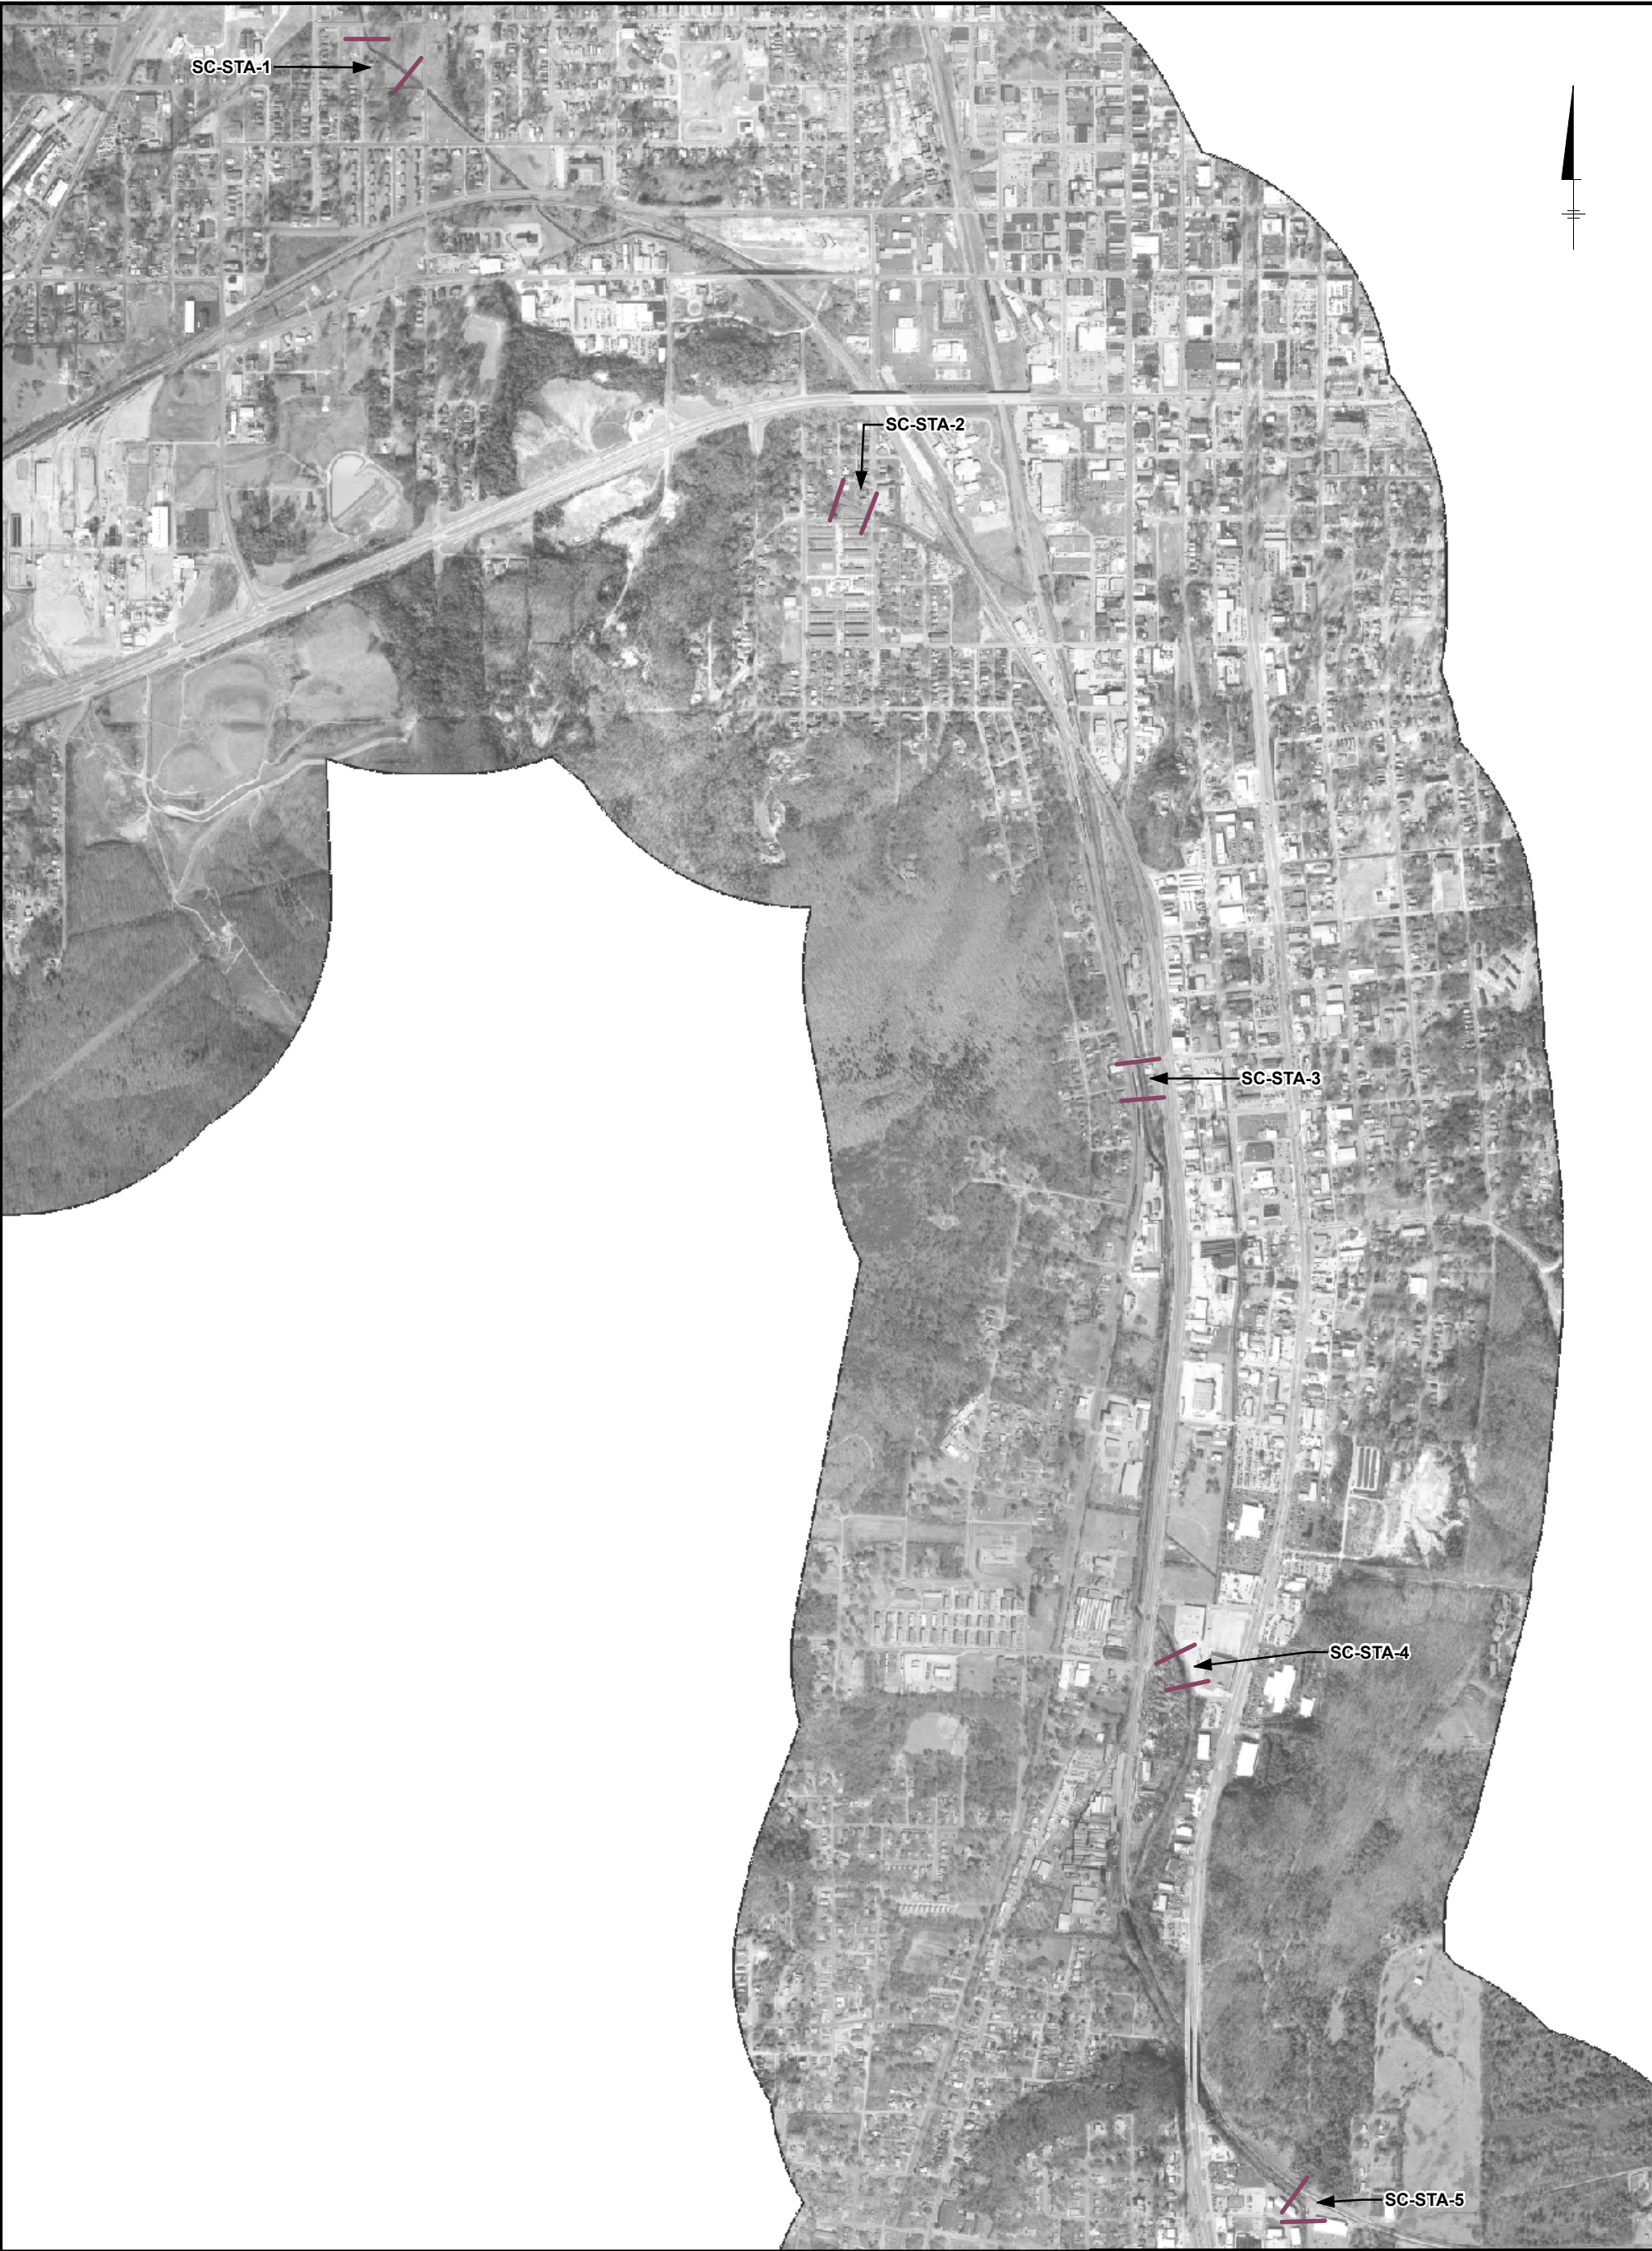
**FIGURE
25**

**SNOW CREEK SAMPLING
STATION LOCATIONS**

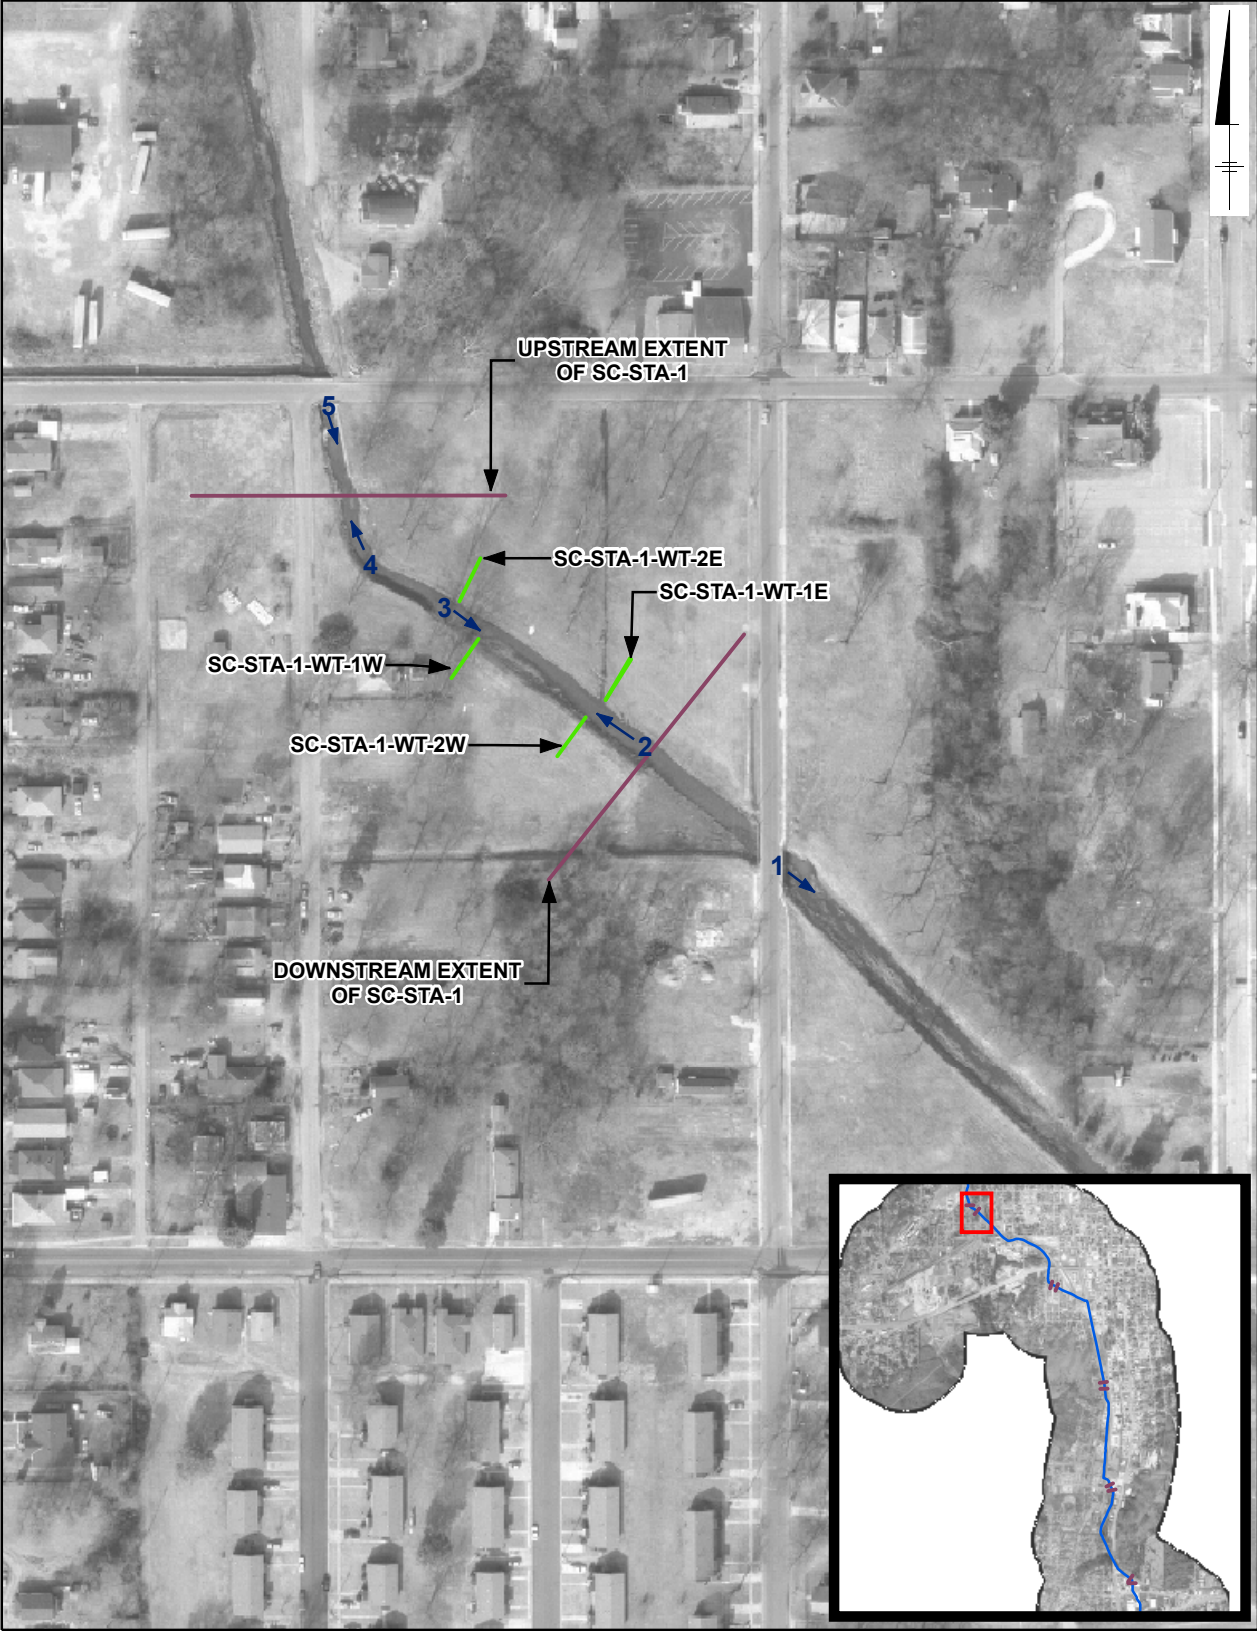
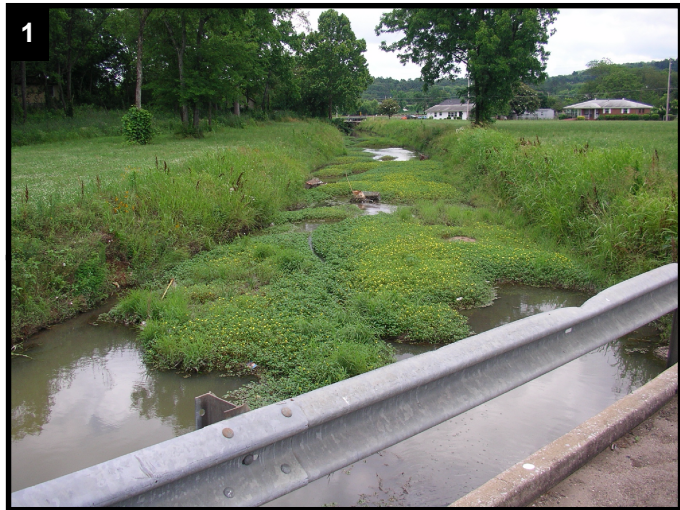
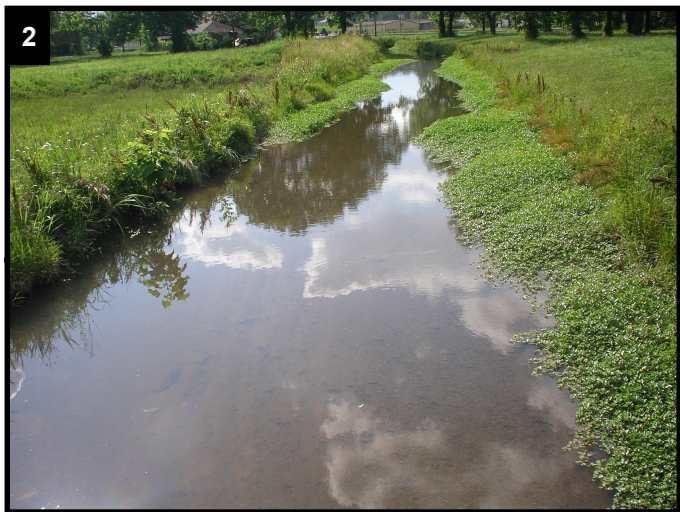
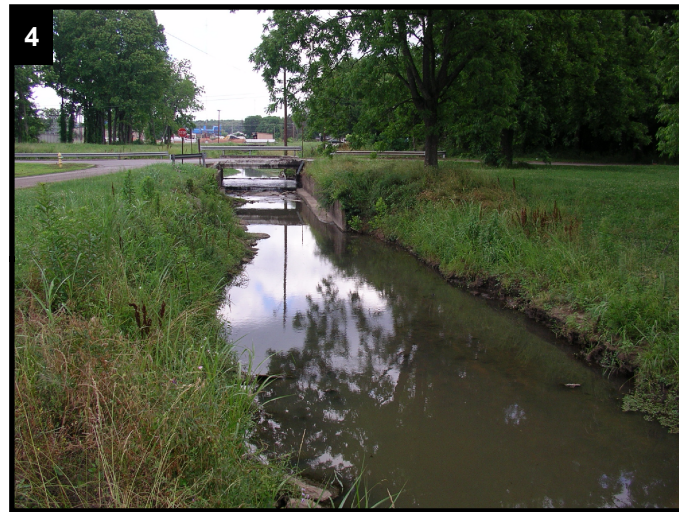
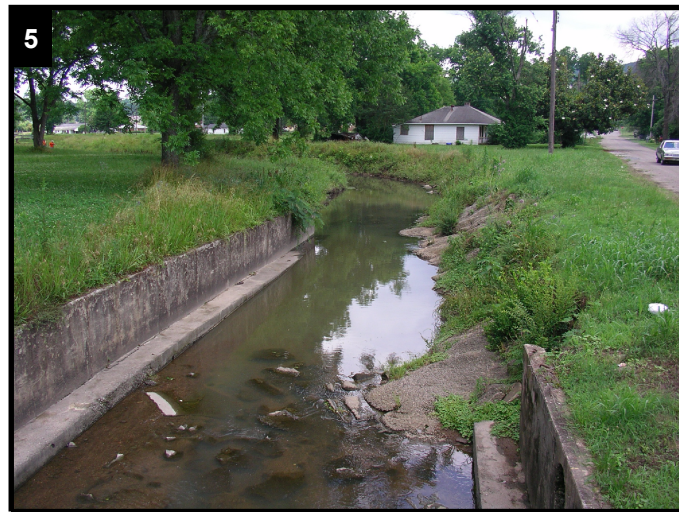
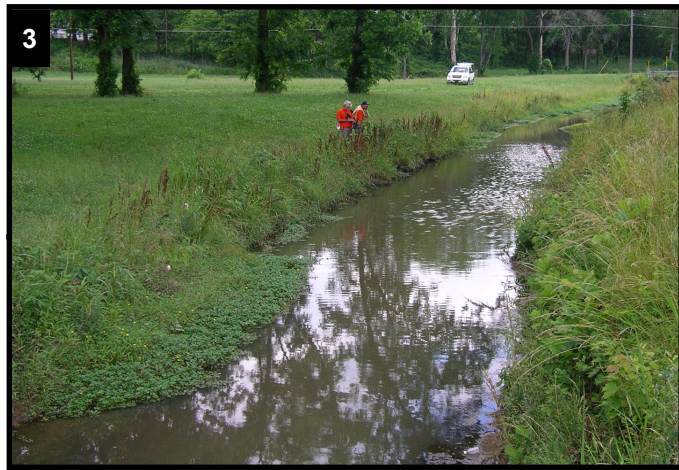
NOTE:
1. ALL BENTHOS AND FISH SAMPLING ACTIVITIES
CONDUCTED WITHIN REACH BOUNDARIES.

BIOSURVEY LOCATIONS ON SNOW CREEK: STA-1
