ANNISTON PCB SITE ANNISTON, ALABAMA SCREENING LEVEL ECOLOGICAL RISK ASSESSMENT FOR OPERABLE UNITS 1, 2, AND 3	
OPERABLE UNITS 1, 2, AND 3	
  BLASLAND, BOUCK & LEE, INC. engineers, scientists, economists	FIGURE 1

ANNISTON PCB SITE
ANNISTON, ALABAMA
SCREENING LEVEL ECOLOGICAL RISK
ASSESSMENT FOR OPERABLE UNITS 1, 2, AND 3

**SCREENING LEVEL ECOLOGICAL RISK ASSESSMENT
FOR OPERABLE UNITS 1, 2, AND 3**

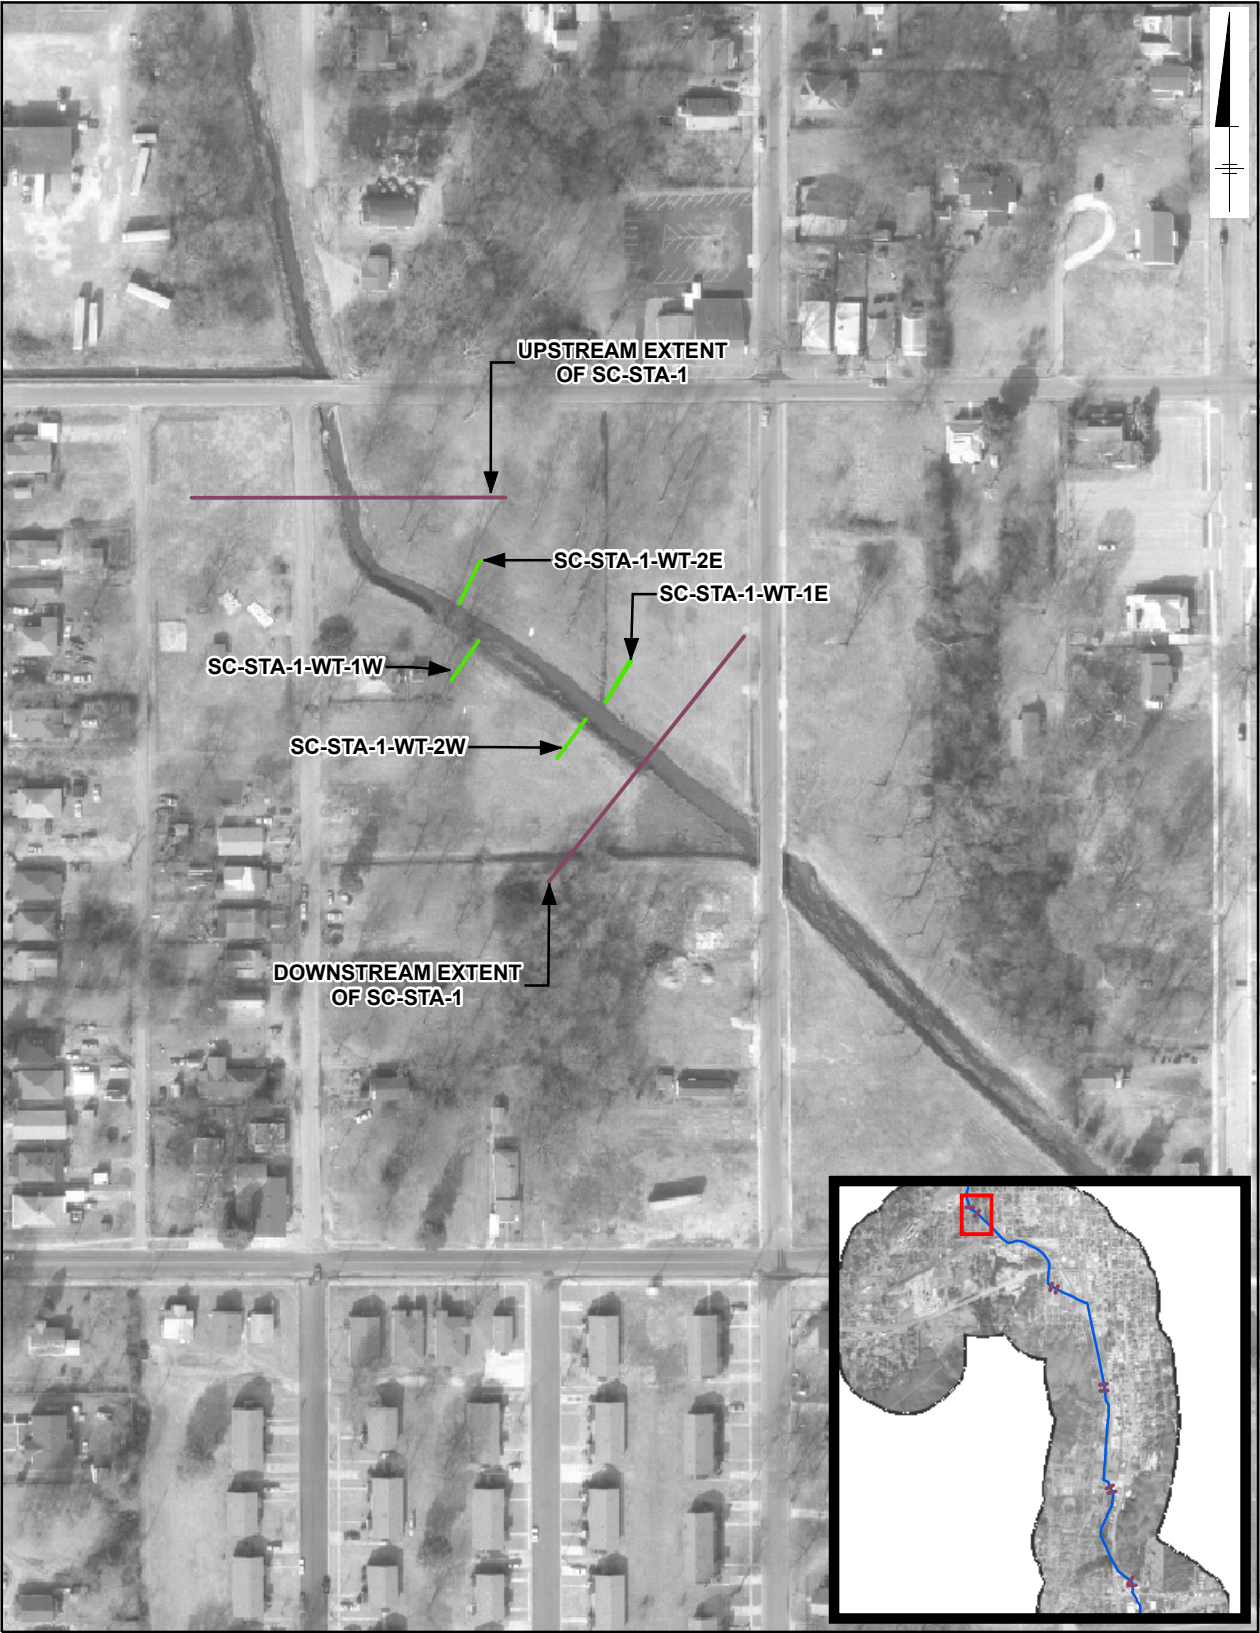
FIGURE
27

Habitat Evaluation Summary						
Habitat Parameters - Low Gradient Streams Reaches		Condition Category & Score				
		Optimal (20 - 16) --- Suboptimal (15 - 11) --- Marginal (10 - 6) --- Poor (5 - 0)				
		SC-STA-1	SC-STA-2	SC-STA-3	SC-STA-4	SC-STA-5
Epifaunal Substrate/Available Cover		8	11	17	12	17
Pool Substrate Characterization		14	8	7	8	4
Pool Variability		3	4	8	11	15
Sediment Deposition		14	12	17	14	17
Channel Flow Status		17	17	17	17	18
Channel Alteration		14	17	18	18	9
Channel Sinuosity		5	6	3	4	6
Bank Stability	Right Bank (10 - 0)	9	9	7	10	10
	Left Bank (10 - 0)	9	9	10	10	10
Vegetative Protection	Right Bank (10 - 0)	9	9	7	10	9
	Left Bank (10 - 0)	8	8	10	9	7
Riparian Vegetative Zone Width	Right Bank (10 - 0)	6	6	1	5	2
	Left Bank (10 - 0)	6	5	2	2	1
TOTAL SCORE		122	121	124	130	125

Fish Community Survey Summary						
Species Observed	Count by Location					Total Fish
	SC-STA-1	SC-STA-2	SC-STA-3	SC-STA-4	SC-STA-5	
Largescale Stoneroller (<i>Campostoma oligolepis</i>)	15	21	2	70	91	199
Eastern Mosquitofish (<i>Gambusia holbrooki</i>)	110	2		7		119
Unknown Shiner #2 (<i>Notropis</i> spp.)		5	8	62	3	78
Unknown Shiner #1 (<i>Notropis</i> spp.)		12	3	23	4	42
Bluespotted Sunfish (<i>Enneacanthus gloriosus</i>)	2	18	1	5	1	27
Unknown Shiner #3 (<i>Notropis</i> spp.)			7			7
Bluegill (<i>Lepomis macrochirus</i>)				6		6
Unknown Shiner (<i>Cyprinella</i> sp.)				3	1	4
Creek Chub (<i>Semotilus atromaculatus</i>)			1			1
Suckermouth minnow (<i>Phenacobius mirabilis</i>)				1		1
Longear Sunfish (<i>Lepomis megalotis</i>)					1	1
Black Redhorse (<i>Moxostoma duquesnei</i>)					1	1
Yellow Bullhead (<i>Ameiurus natalis</i>)					1	1
Total Fish	127	58	22	177	103	487
Species Richness	3	5	6	8	8	13
Total Shock Time (seconds)	2,386	2,146	1,468	1,678	2,322	10,000

Benthic Macroinvertebrate Summary Metrics							
Metric	Expected Response	STA-1	STA-2	STA-3	STA-4	STA-5	RP-1
Total Number of Specimens	Decrease	97	106	16	28	16	331
Species Richness	Decrease	19	13	5	7	4	31
Percent EPT	Decrease	0	42	19	14	63	37
Percent Diptera	Increase	23	45	69	82	31	10

BIOSURVEY RESULTS FOR STA-1

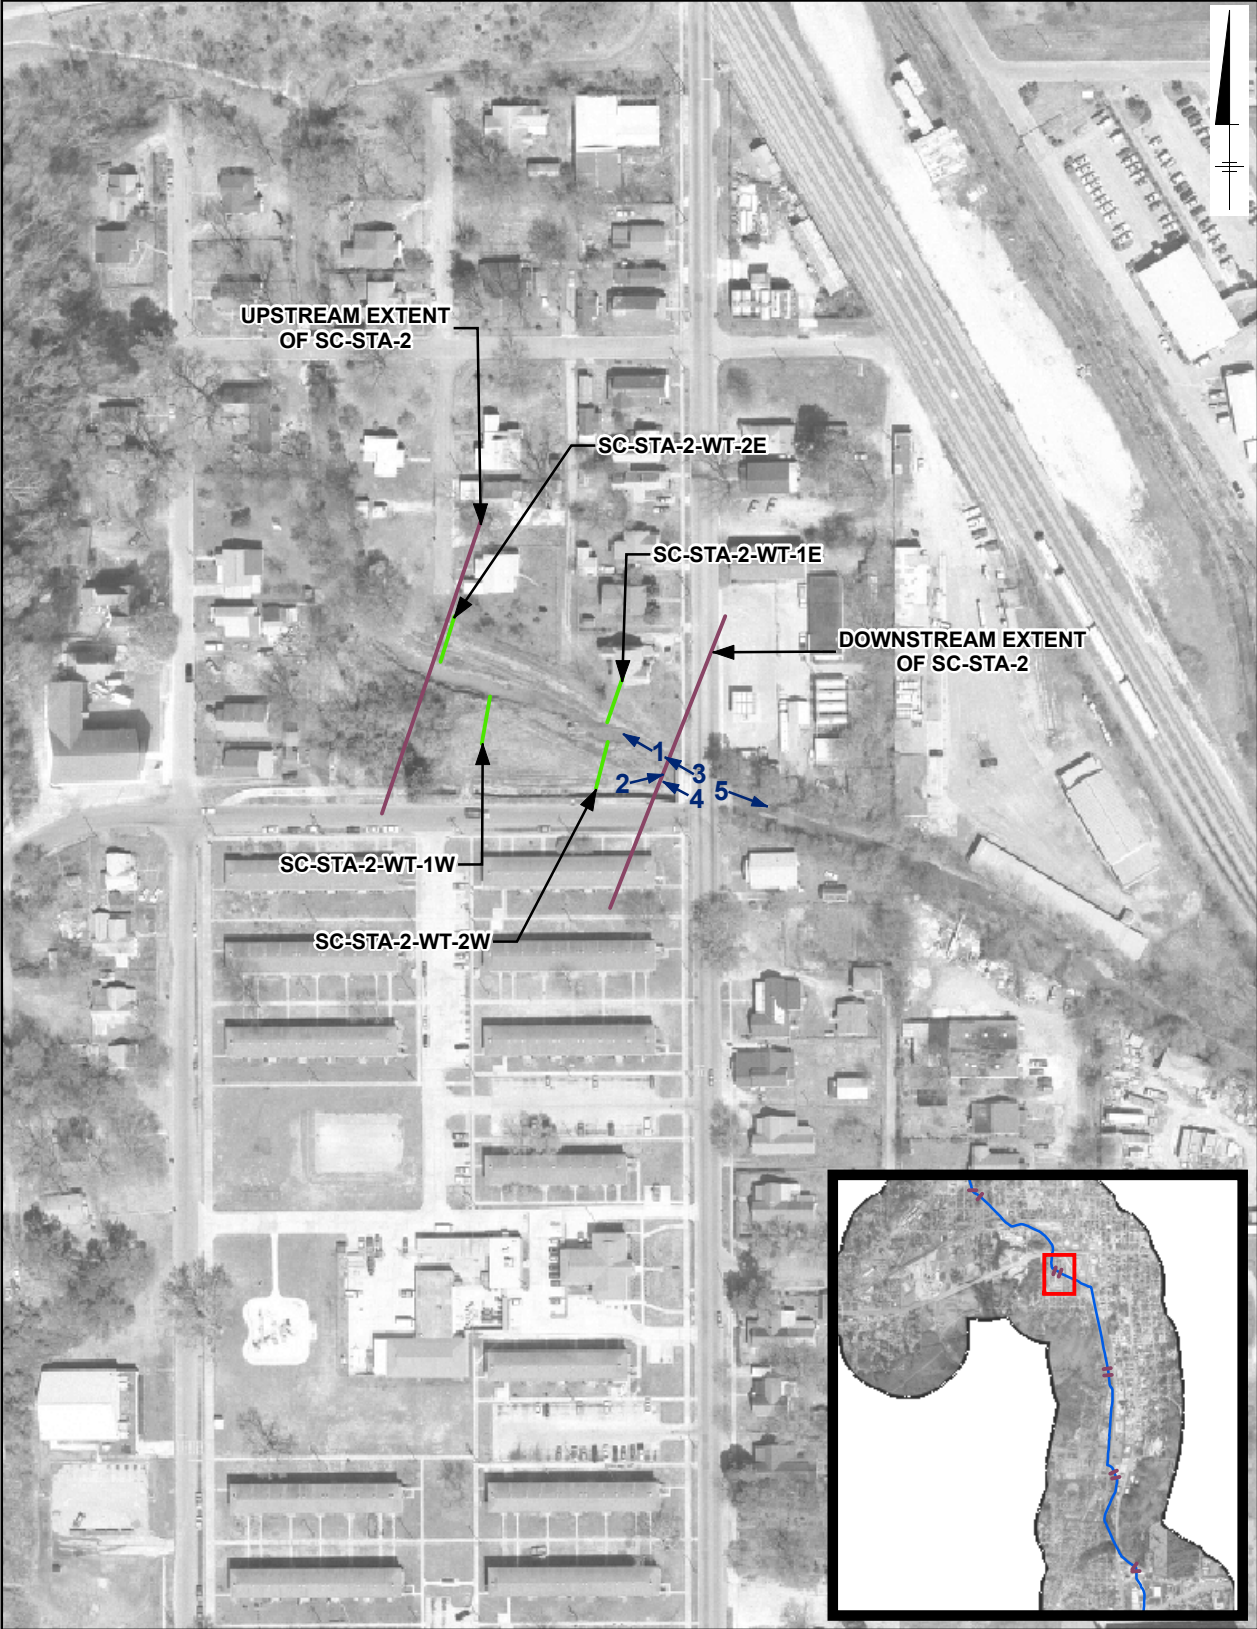
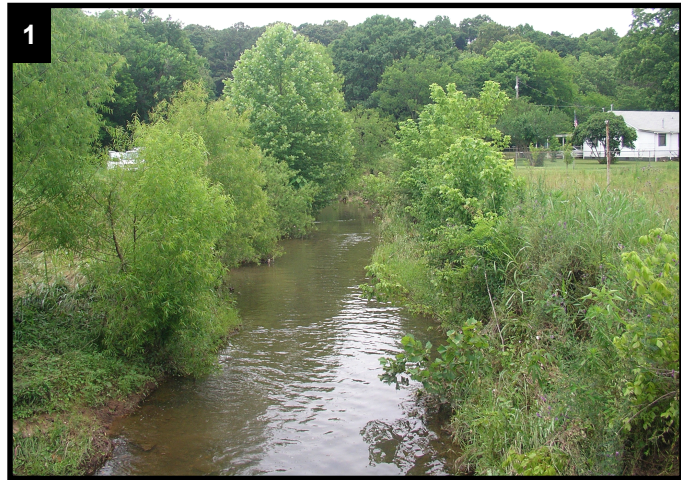
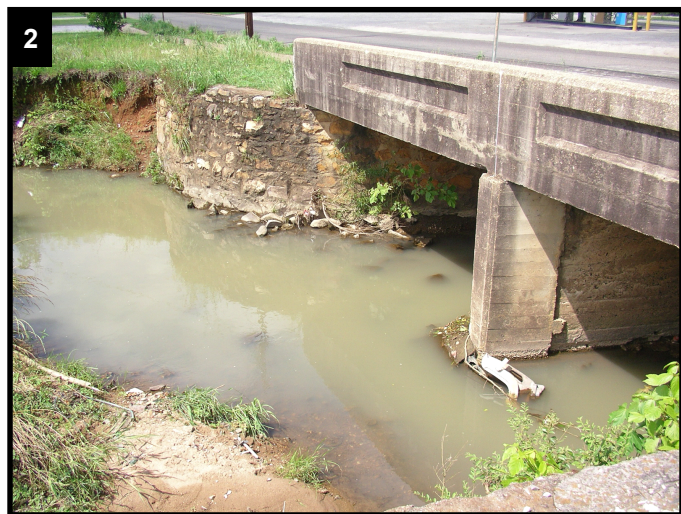
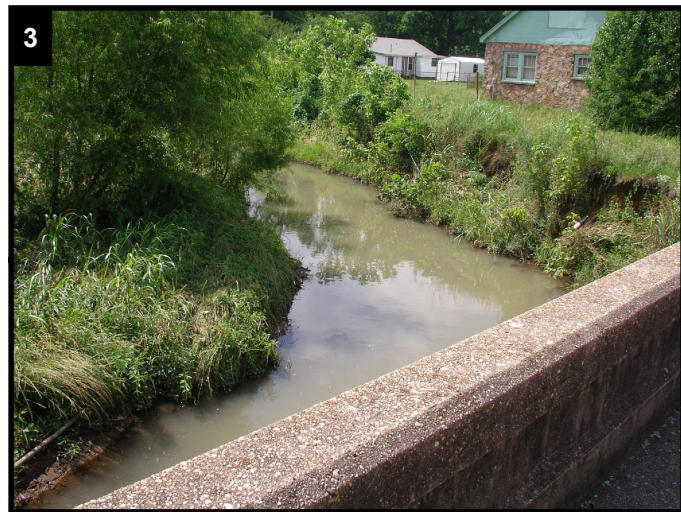
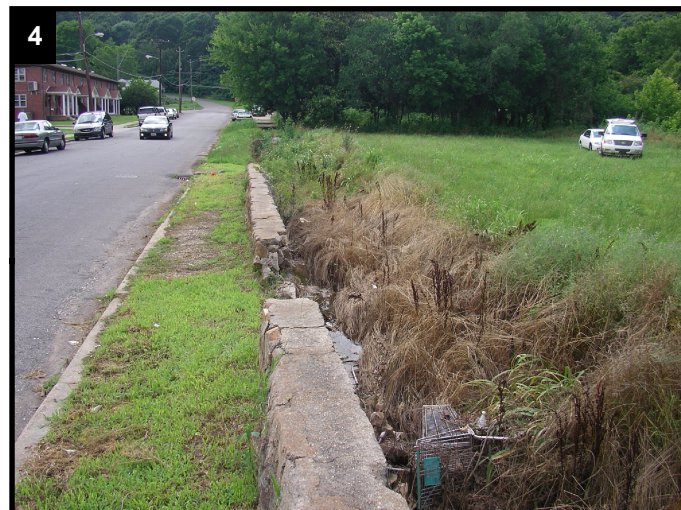
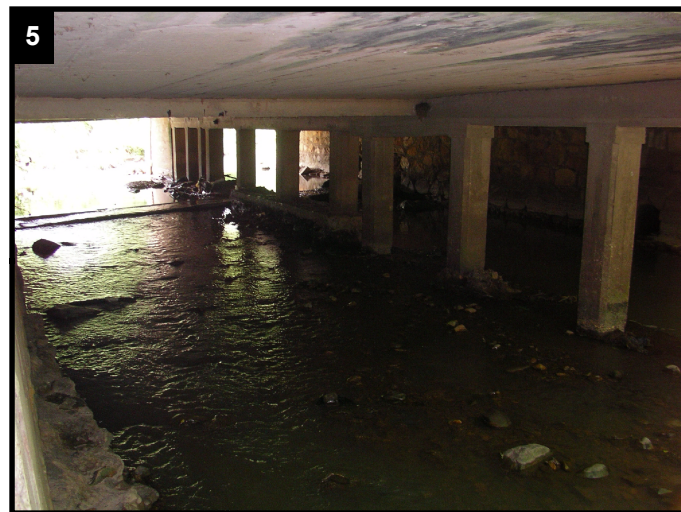
FIGURE
28

BIOSURVEY LOCATIONS ON
SNOW CREEK: STA-2

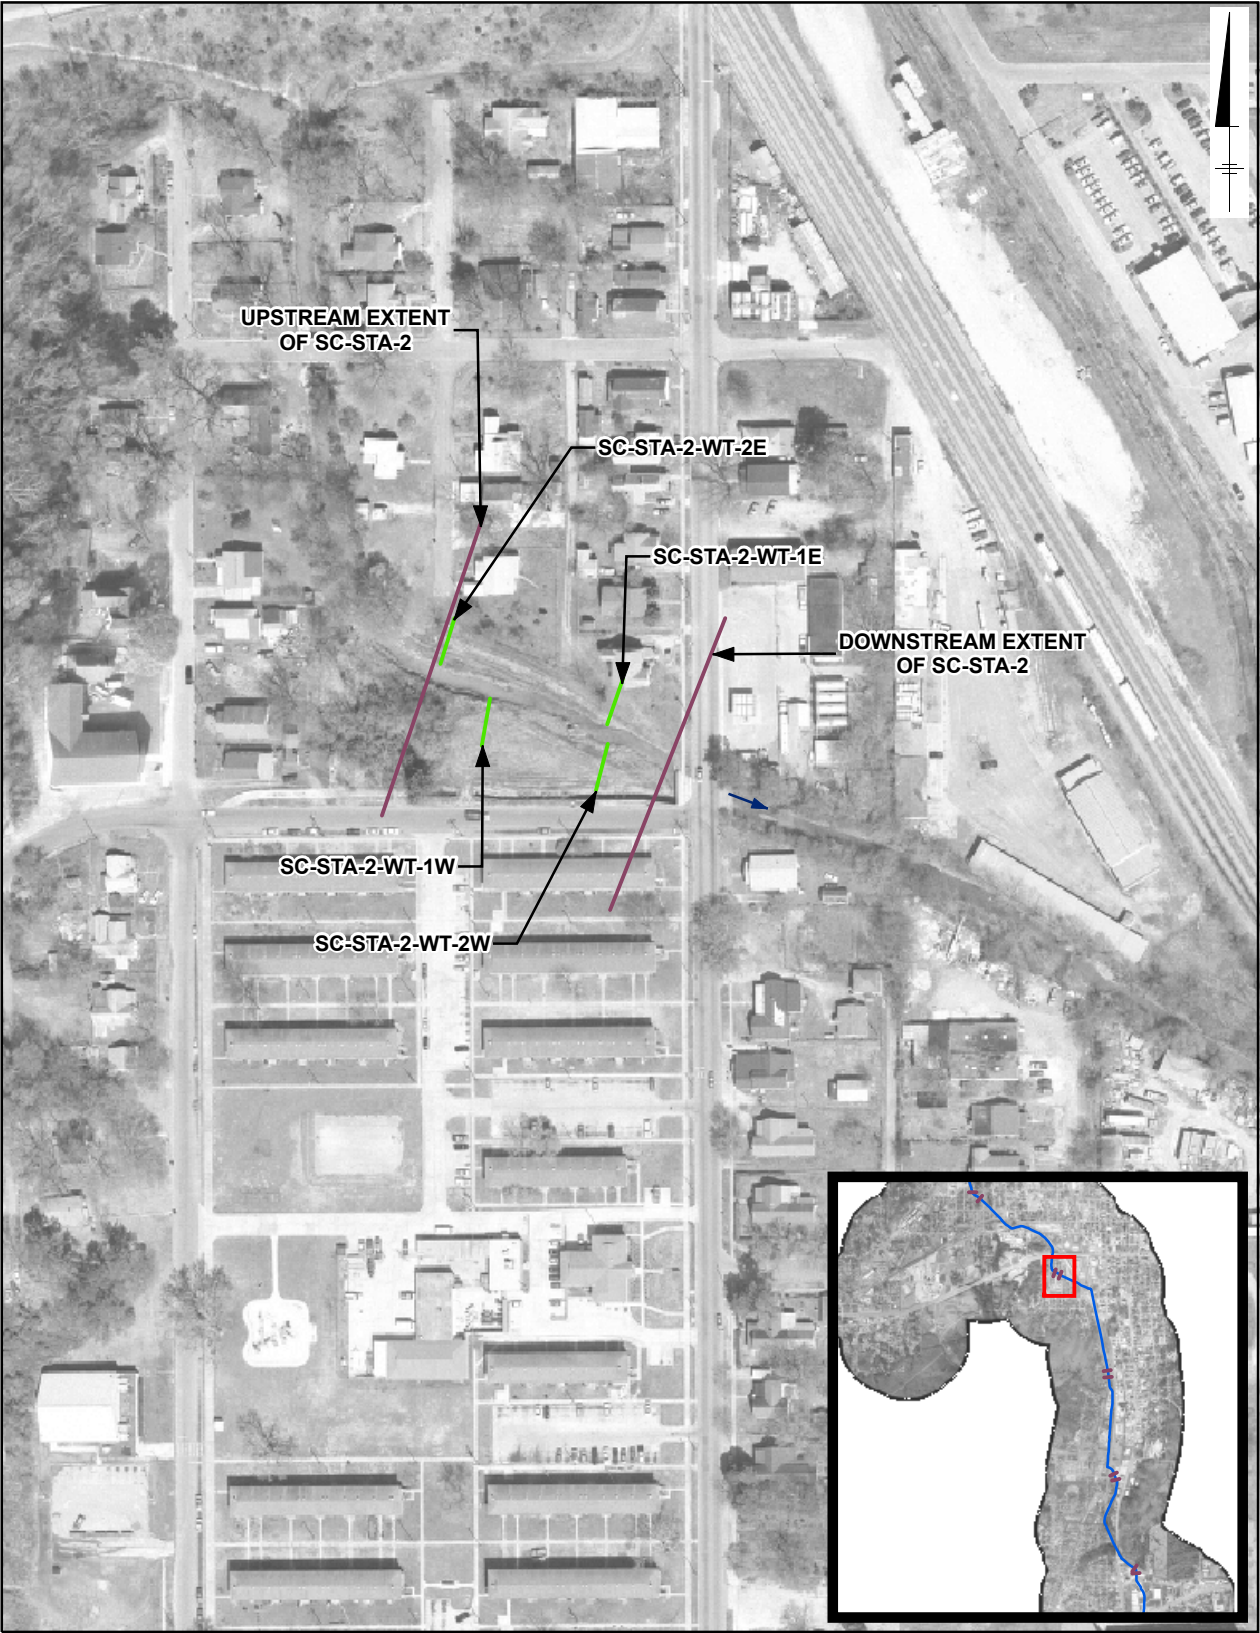
FIGURE
29

Habitat Evaluation Summary					
Habitat Parameters - Low Gradient Streams Reaches	Condition Category & Score				
	Optimal (20 - 16) --- Suboptimal (15 - 11) --- Marginal (10 - 6) --- Poor (5 - 0)				
	SC-STA-1	SC-STA-2	SC-STA-3	SC-STA-4	SC-STA-5
Epifaunal Substrate/Available Cover	8	11	17	12	17
Pool Substrate Characterization	14	8	7	8	4
Pool Variability	3	4	8	11	15
Sediment Deposition	14	12	17	14	17
Channel Flow Status	17	17	17	17	18
Channel Alteration	14	17	18	18	9
Channel Sinuosity	5	6	3	4	6
Bank Stability	Right Bank (10 - 0)	9	9	7	10
	Left Bank (10 - 0)	9	9	10	10
Vegetative Protection	Right Bank (10 - 0)	9	9	7	10
	Left Bank (10 - 0)	8	8	10	9
Riparian Vegetative Zone Width	Right Bank (10 - 0)	6	6	1	5
	Left Bank (10 - 0)	6	5	2	2
TOTAL SCORE	122	121	124	130	125

Fish Community Survey Summary						
Species Observed	Count by Location					Total Fish
	SC-STA-1	SC-STA-2	SC-STA-3	SC-STA-4	SC-STA-5	
Largescale Stoneroller (<i>Campostoma oligolepis</i>)	15	21	2	70	91	199
Eastern Mosquitofish (<i>Gambusia holbrooki</i>)	110	2		7		119
Unknown Shiner #2 (<i>Notropis</i> spp.)		5	8	62	3	78
Unknown Shiner #1 (<i>Notropis</i> spp.)		12	3	23	4	42
Bluespotted Sunfish (<i>Enneacanthus gloriosus</i>)	2	18	1	5	1	27
Unknown Shiner #3 (<i>Notropis</i> spp.)			7			7
Bluegill (<i>Lepomis macrochirus</i>)				6		6
Unknown Shiner (<i>Cyprinella</i> sp.)				3	1	4
Creek Chub (<i>Semotilus atromaculatus</i>)			1			1
Suckermouth minnow (<i>Phenacobius mirabilis</i>)				1		1
Longear Sunfish (<i>Lepomis megalotis</i>)					1	1
Black Redhorse (<i>Moxostoma duquesnei</i>)					1	1
Yellow Bullhead (<i>Ameiurus natalis</i>)					1	1
Total Fish	127	58	22	177	103	487
Species Richness	3	5	6	8	8	13
Total Shock Time (seconds)	2,386	2,146	1,468	1,678	2,322	10,000

Benthic Macroinvertebrate Summary Metrics							
Metric	Expected Response	STA-1	STA-2	STA-3	STA-4	STA-5	RP-1
Total Number of Specimens	Decrease	97	106	16	28	16	331
Species Richness	Decrease	19	13	5	7	4	31
Percent EPT	Decrease	0	42	19	14	63	37
Percent Diptera	Increase	23	45	69	82	31	10

BIOSURVEY RESULTS FOR STA-2

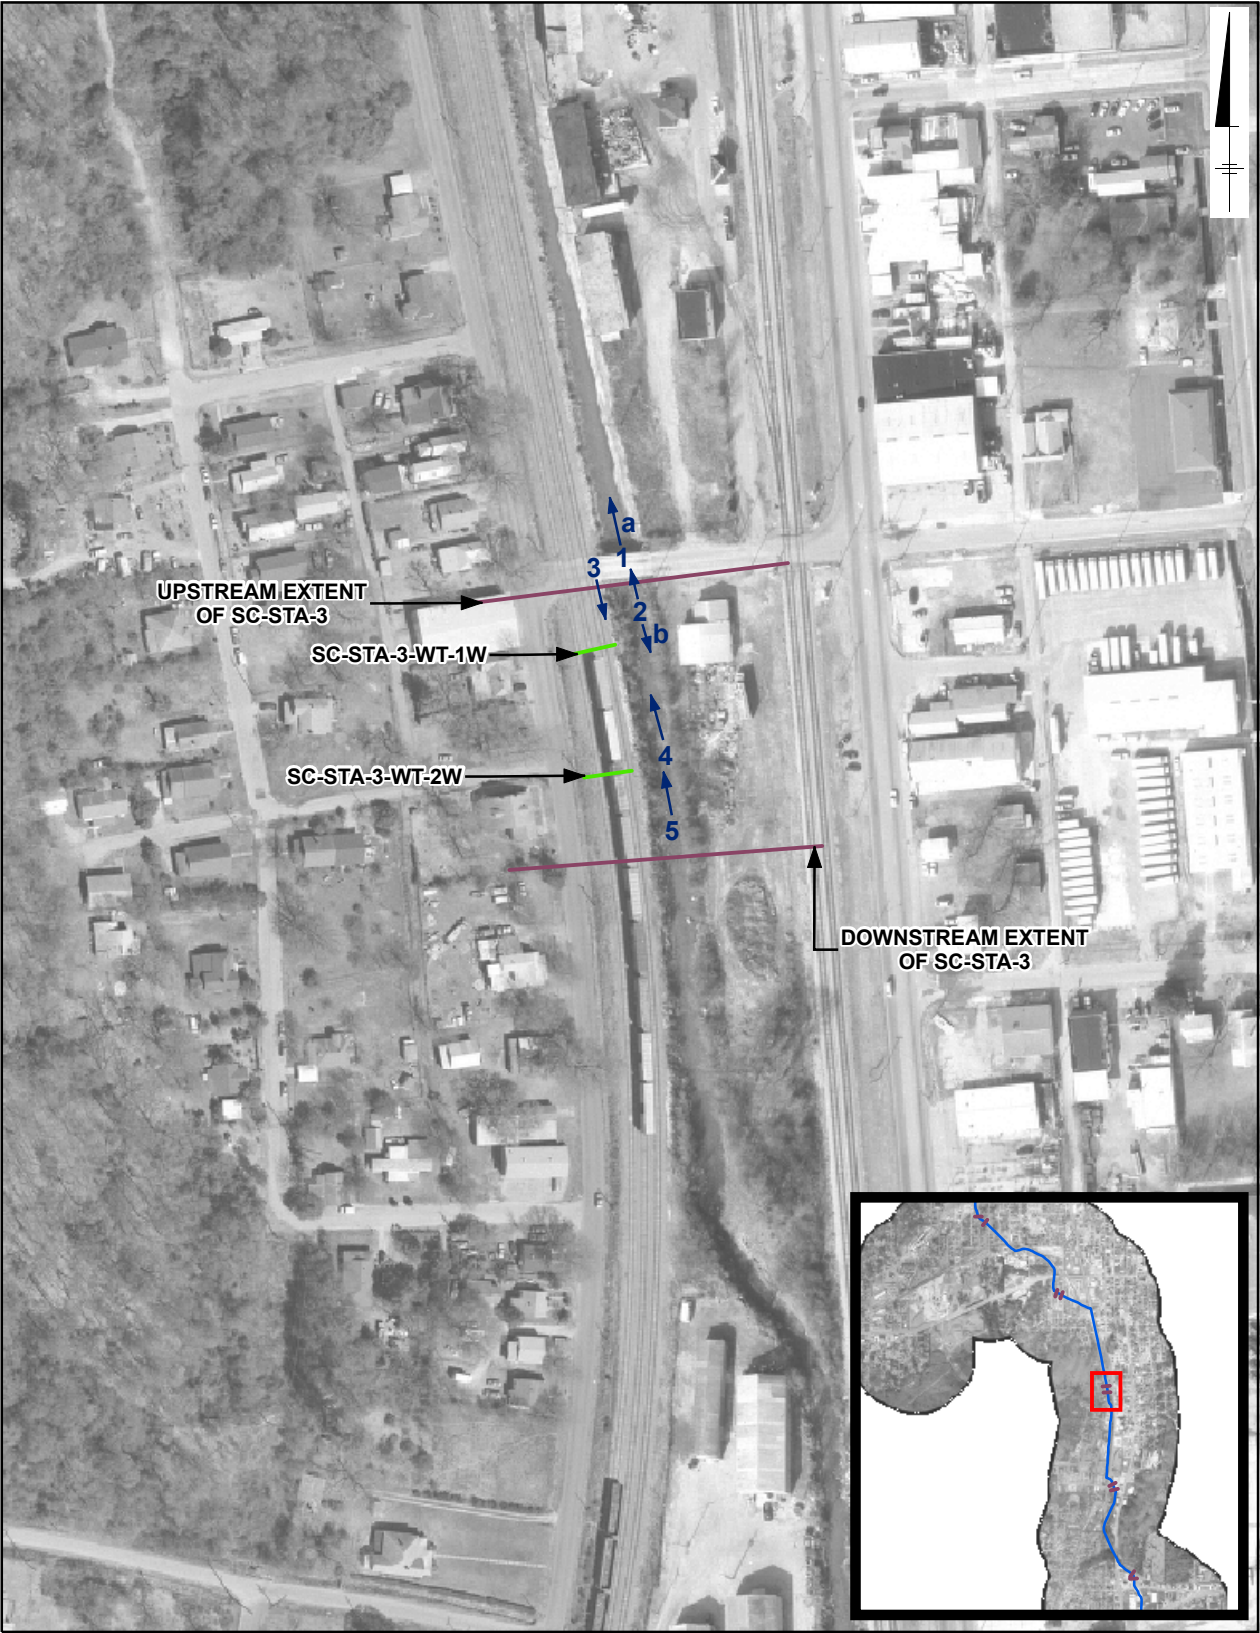
FIGURE
30

BIOSURVEY LOCATIONS ON
SNOW CREEK: STA-3

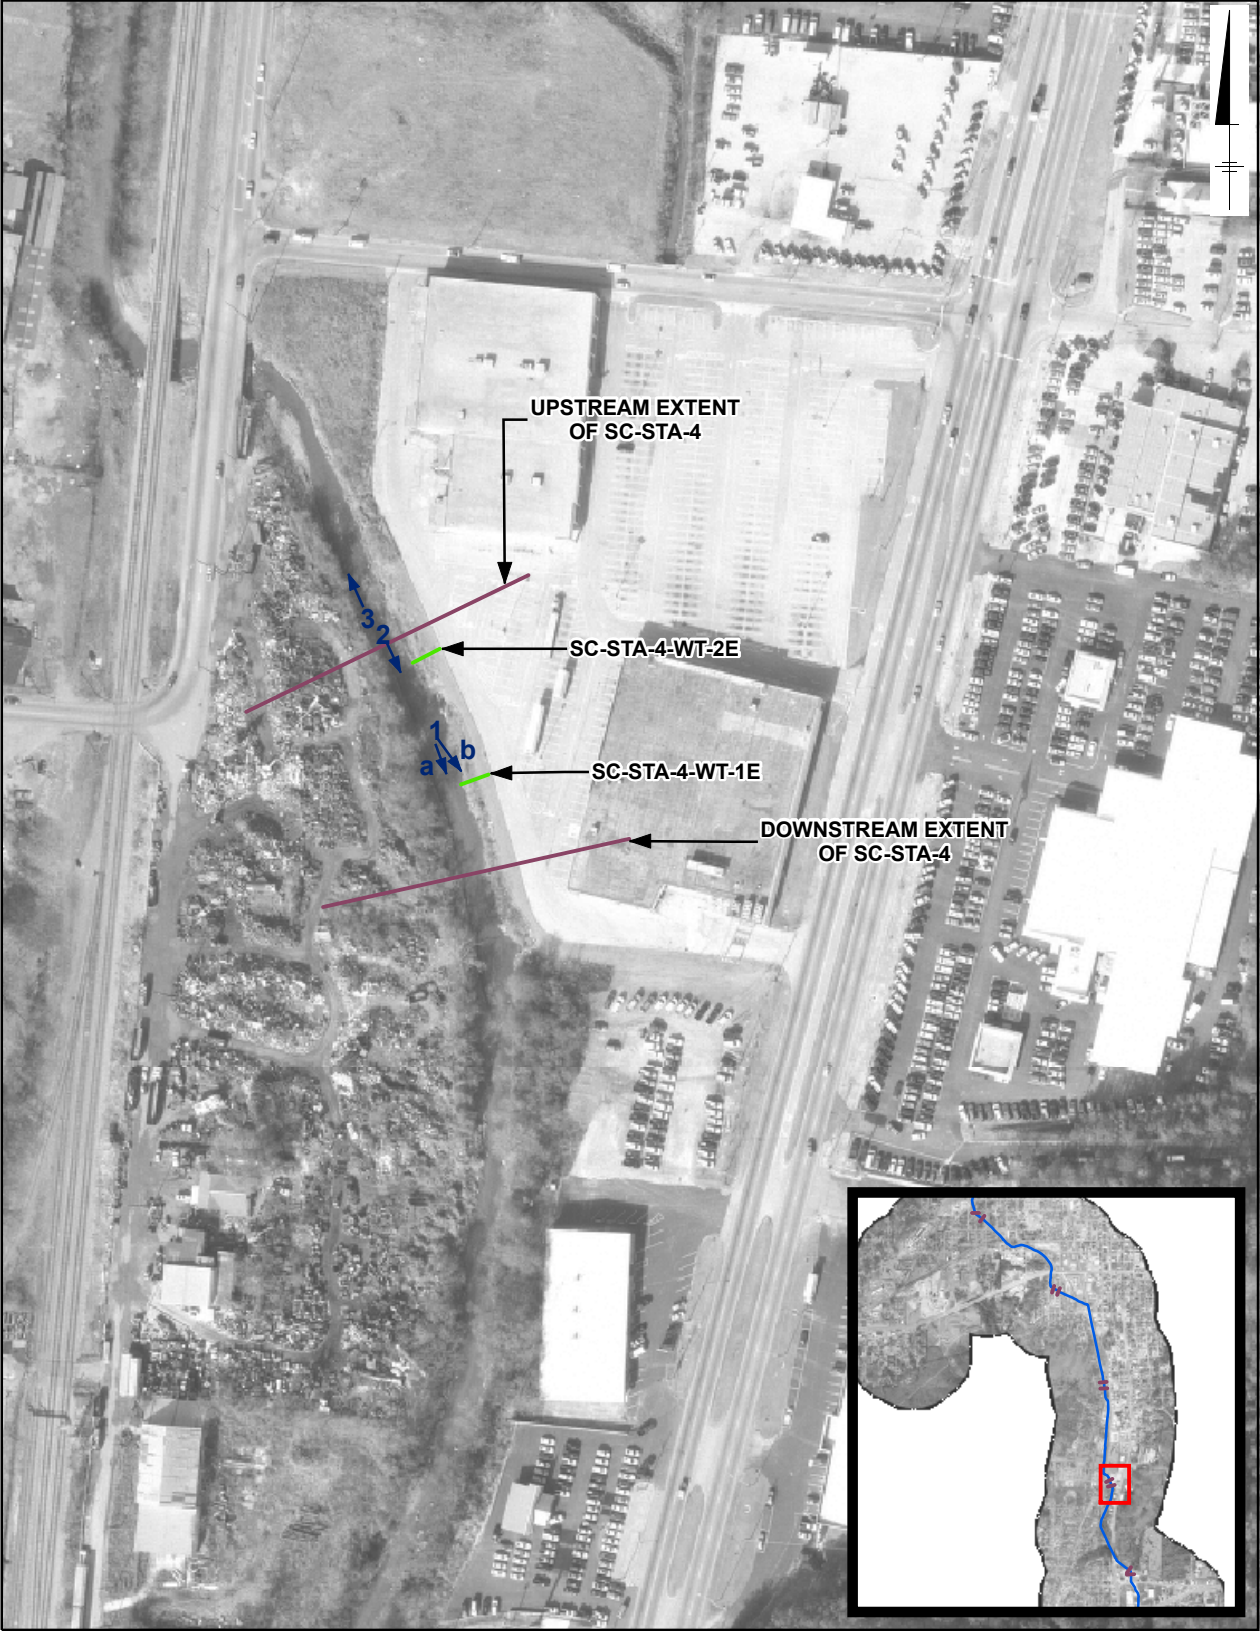
FIGURE
32

**BIOSURVEY LOCATIONS ON
 SNOW CREEK: STA-4**

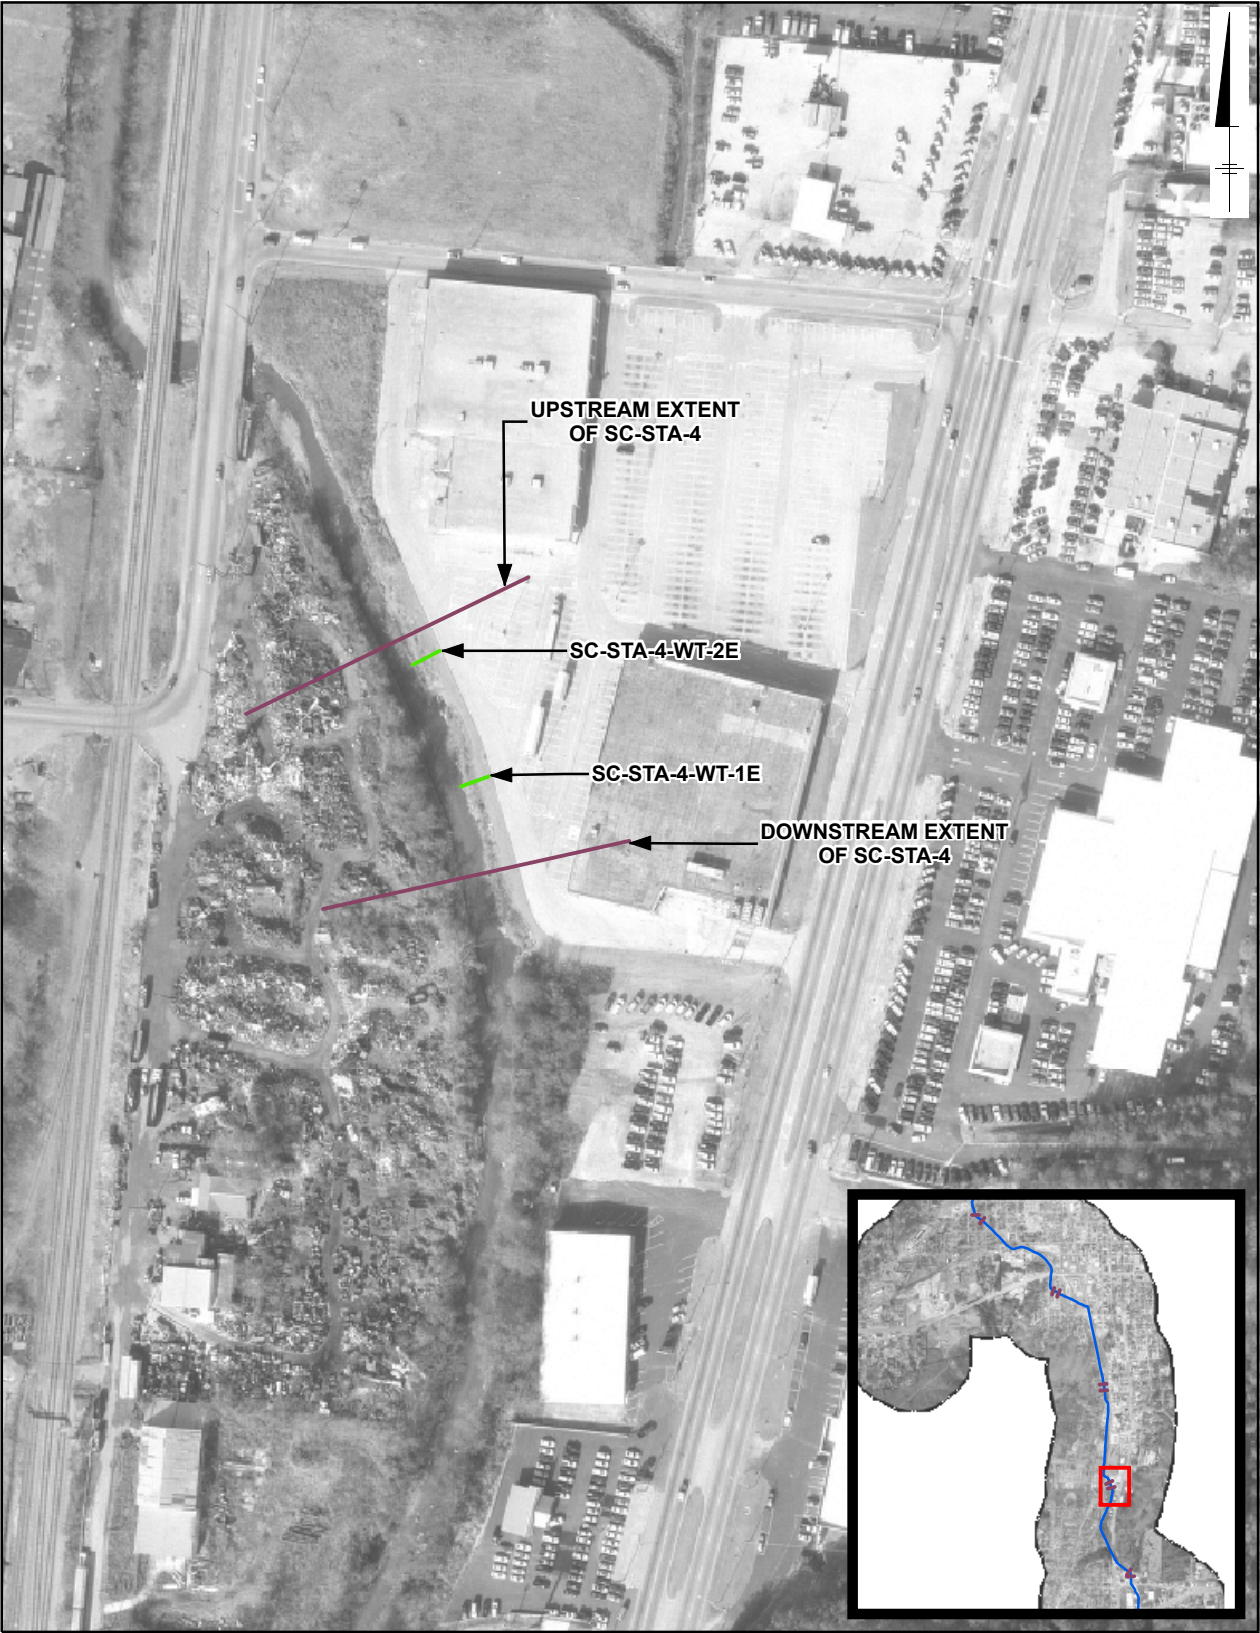
FIGURE
33

Habitat Evaluation Summary						
Habitat Parameters - Low Gradient Streams Reaches		Condition Category & Score				
		Optimal (20 - 16) --- Suboptimal (15 - 11) --- Marginal (10 - 6) --- Poor (5 - 0)				
		SC-STA-1	SC-STA-2	SC-STA-3	SC-STA-4	SC-STA-5
Epifaunal Substrate/Available Cover		8	11	17	12	17
Pool Substrate Characterization		14	8	7	8	4
Pool Variability		3	4	8	11	15
Sediment Deposition		14	12	17	14	17
Channel Flow Status		17	17	17	17	18
Channel Alteration		14	17	18	18	9
Channel Sinuosity		5	6	3	4	6
Bank Stability	Right Bank (10 - 0)	9	9	7	10	10
	Left Bank (10 - 0)	9	9	10	10	10
Vegetative Protection	Right Bank (10 - 0)	9	9	7	10	9
	Left Bank (10 - 0)	8	8	10	9	7
Riparian Vegetative Zone Width	Right Bank (10 - 0)	6	6	1	5	2
	Left Bank (10 - 0)	6	5	2	2	1
TOTAL SCORE		122	121	124	130	125

Fish Community Survey Summary						
Species Observed	Count by Location					Total Fish
	SC-STA-1	SC-STA-2	SC-STA-3	SC-STA-4	SC-STA-5	
Largescale Stoneroller (<i>Campostoma oligolepis</i>)	15	21	2	70	91	199
Eastern Mosquitofish (<i>Gambusia holbrooki</i>)	110	2		7		119
Unknown Shiner #2 (<i>Notropis</i> spp.)		5	8	62	3	78
Unknown Shiner #1 (<i>Notropis</i> spp.)		12	3	23	4	42
Bluespotted Sunfish (<i>Enneacanthus gloriosus</i>)	2	18	1	5	1	27
Unknown Shiner #3 (<i>Notropis</i> spp.)			7			7
Bluegill (<i>Lepomis macrochirus</i>)				6		6
Unknown Shiner (<i>Cyprinella</i> sp.)				3	1	4
Creek Chub (<i>Semotilus atromaculatus</i>)			1			1
Suckermouth minnow (<i>Phenacobius mirabilis</i>)				1		1
Longear Sunfish (<i>Lepomis megalotis</i>)					1	1
Black Redhorse (<i>Moxostoma duquesnei</i>)					1	1
Yellow Bullhead (<i>Ameiurus natalis</i>)					1	1
Total Fish	127	58	22	177	103	487
Species Richness	3	5	6	8	8	13
Total Shock Time (seconds)	2,386	2,146	1,468	1,678	2,322	10,000

Benthic Macroinvertebrate Summary Metrics							
Metric	Expected Response	STA-1	STA-2	STA-3	STA-4	STA-5	RP-1
Total Number of Specimens	Decrease	97	106	16	28	16	331
Species Richness	Decrease	19	13	5	7	4	31
Percent EPT	Decrease	0	42	19	14	63	37
Percent Diptera	Increase	23	45	69	82	31	10

BIOSURVEY RESULTS FOR STA-4

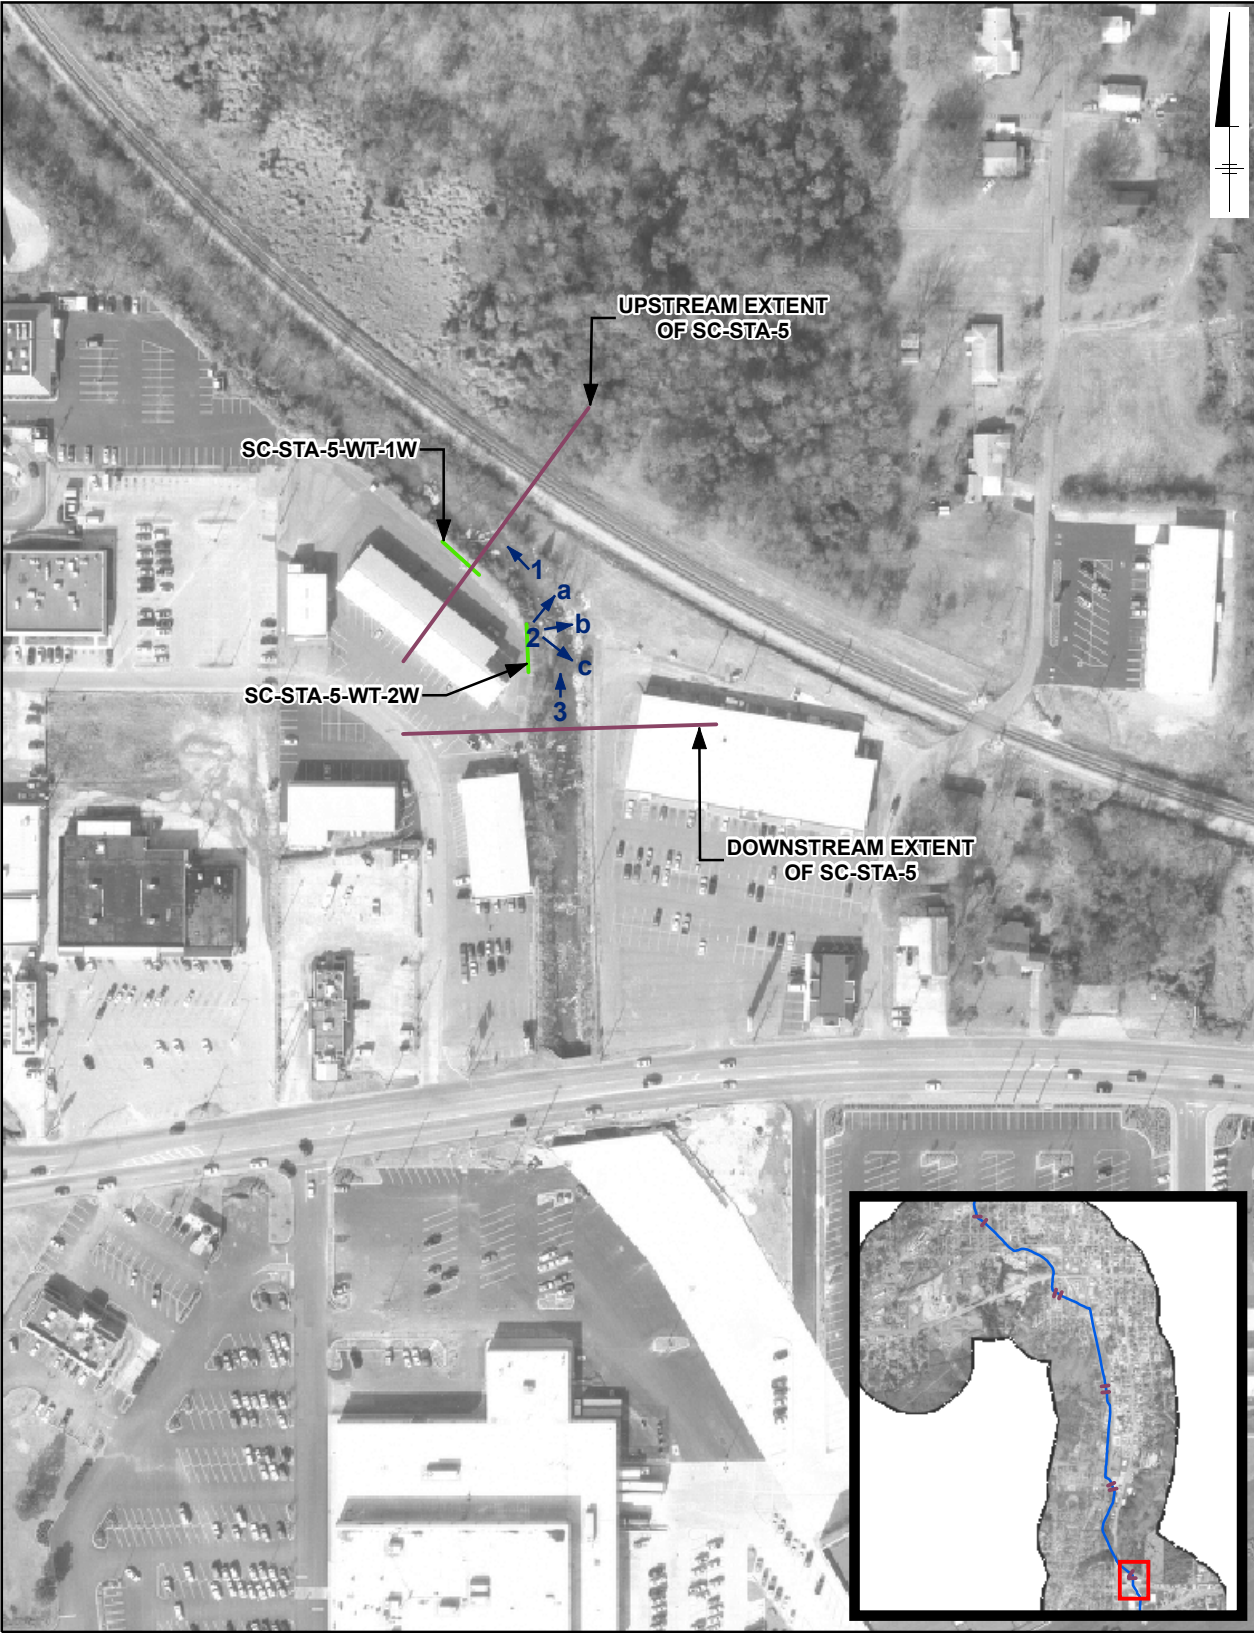
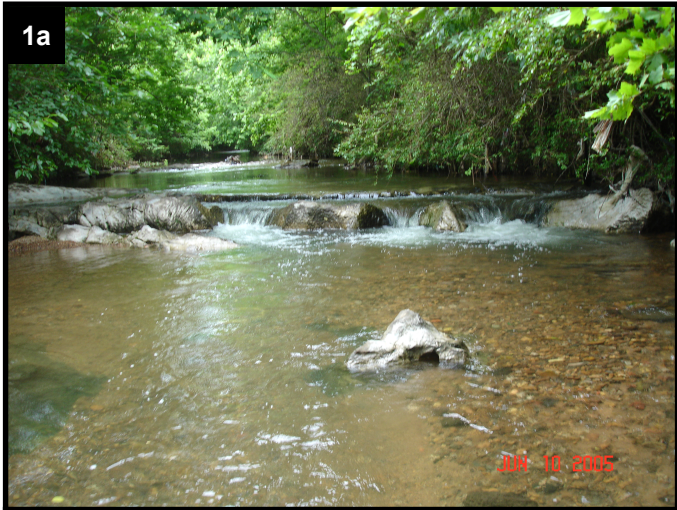
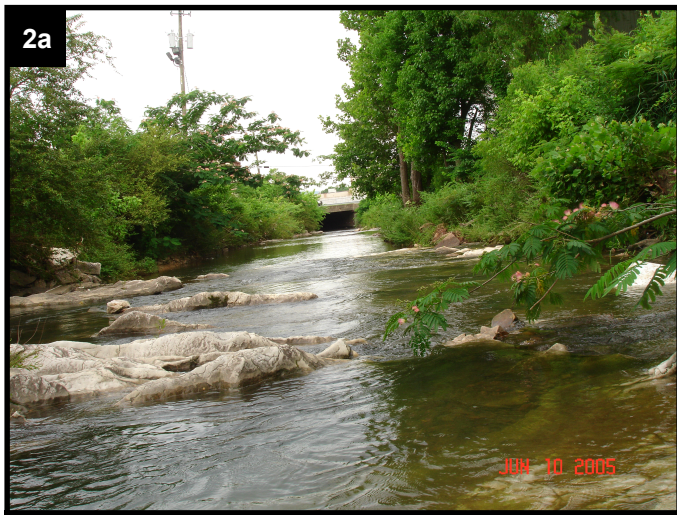
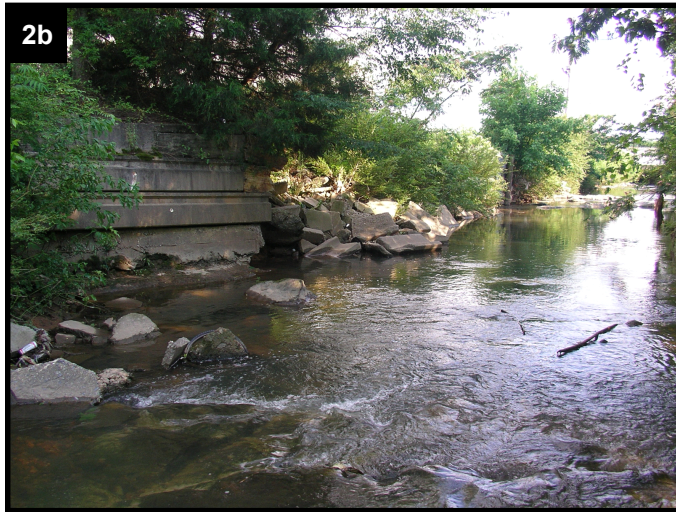
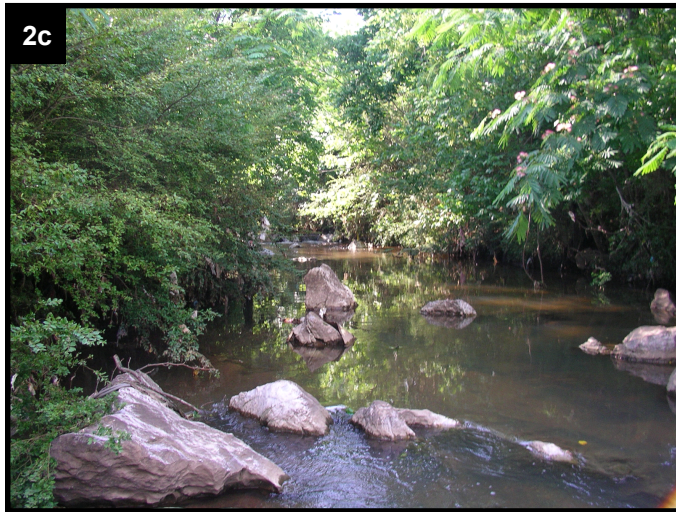
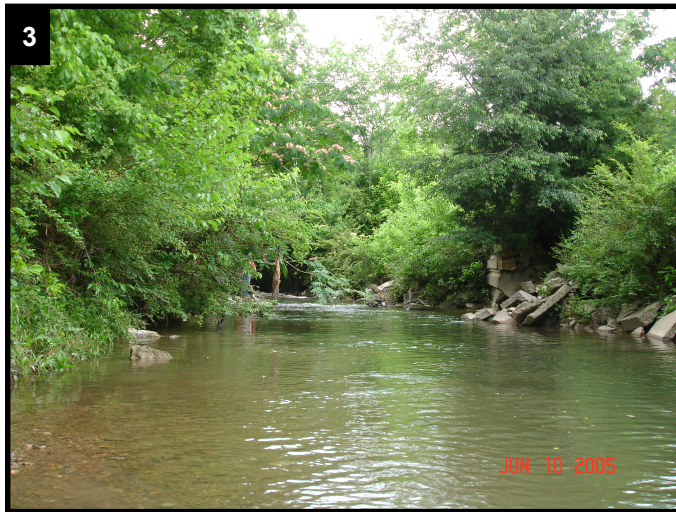
FIGURE
34

1. ALL BENTHOS AND FISH SAMPLING ACTIVITIES CONDUCTED WITHIN REACH BOUNDARIES.
2. WILDLIFE TRANSECTS WERE CONDUCTED BY WALKING THE VEGETATED SLOPE PARALLEL TO SNOW CREEK DUE TO CLOSE PROXIMITY OF ASPHALT PARKING LOTS AND BUILDINGS TO THE EDGE OF THE CREEK.

BIOSURVEY LOCATIONS ON
 SNOW CREEK: STA-5

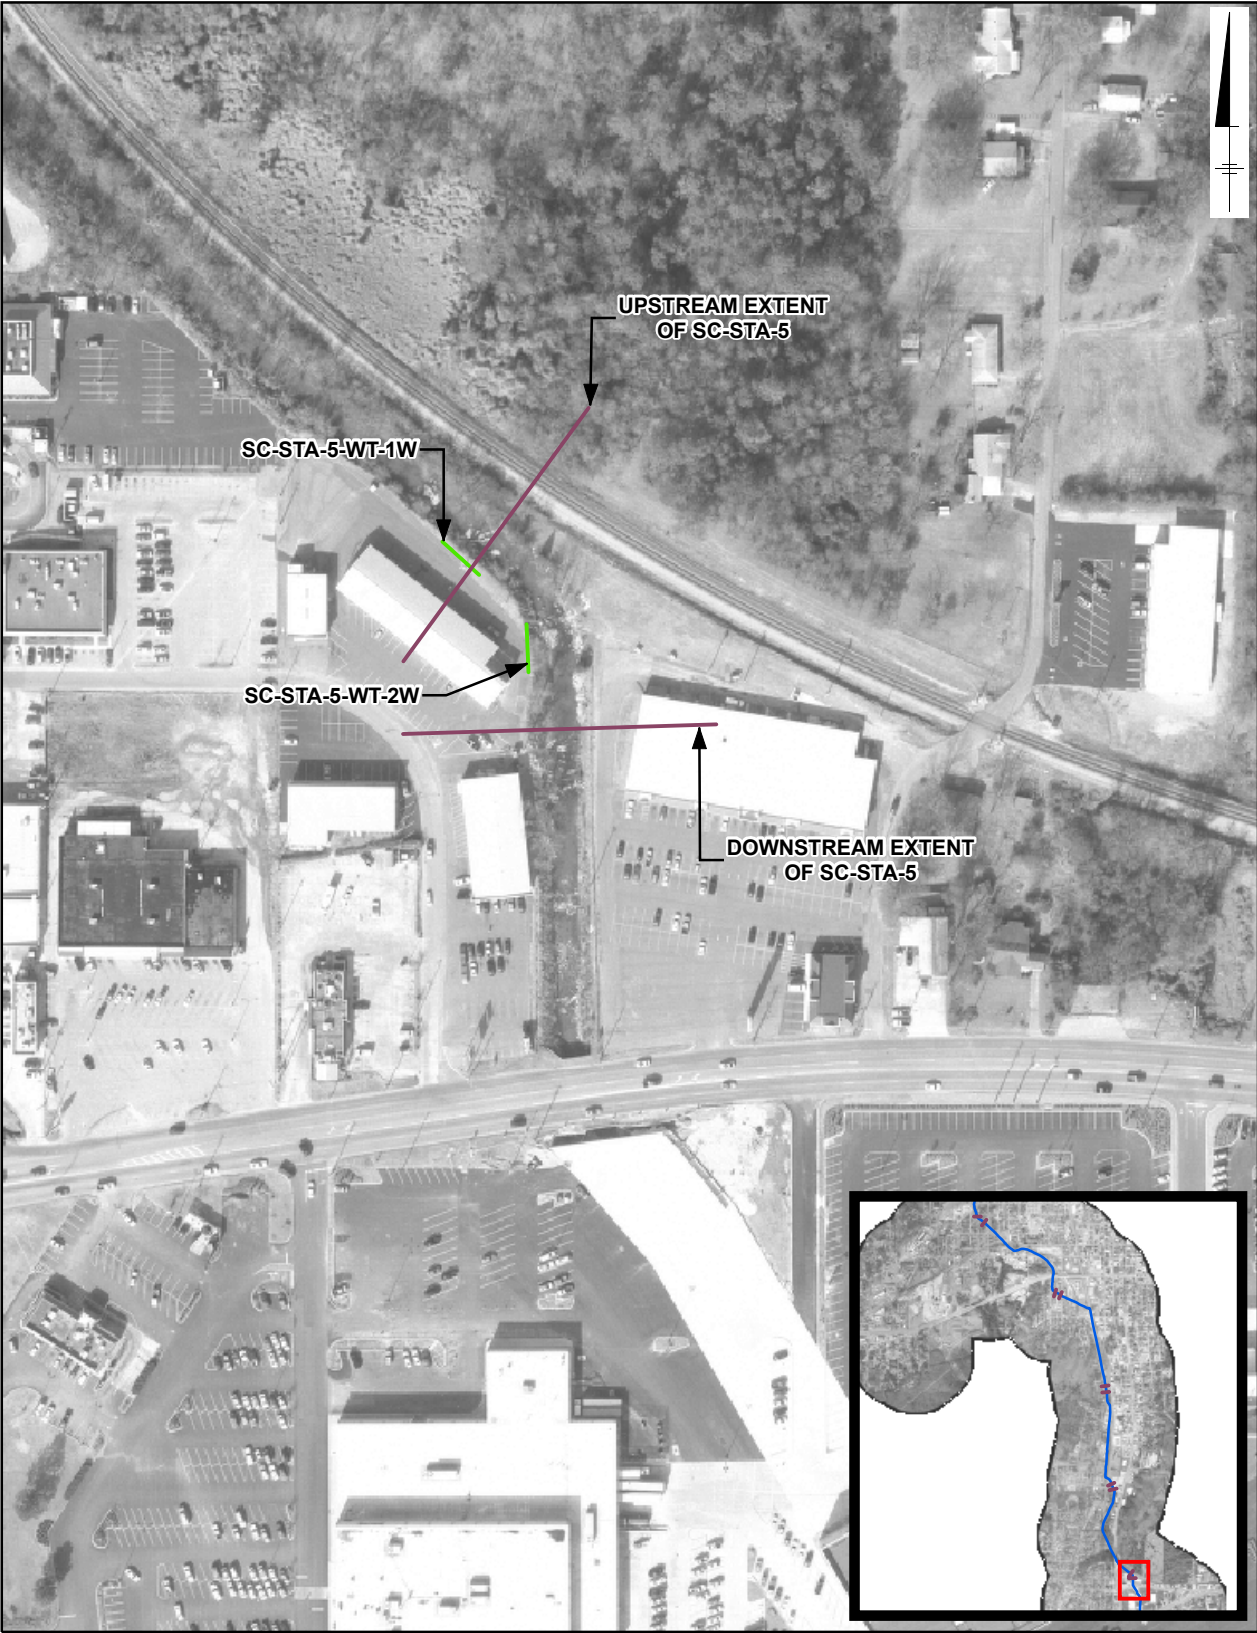
FIGURE
35

Habitat Evaluation Summary					
Habitat Parameters - Low Gradient Streams Reaches	Condition Category & Score				
	Optimal (20 - 16) --- Suboptimal (15 - 11) --- Marginal (10 - 6) --- Poor (5 - 0)				
	SC-STA-1	SC-STA-2	SC-STA-3	SC-STA-4	SC-STA-5
Epifaunal Substrate/Available Cover	8	11	17	12	17
Pool Substrate Characterization	14	8	7	8	4
Pool Variability	3	4	8	11	15
Sediment Deposition	14	12	17	14	17
Channel Flow Status	17	17	17	17	18
Channel Alteration	14	17	18	18	9
Channel Sinuosity	5	6	3	4	6
Bank Stability	Right Bank (10 - 0)	9	9	7	10
	Left Bank (10 - 0)	9	9	10	10
Vegetative Protection	Right Bank (10 - 0)	9	9	7	9
	Left Bank (10 - 0)	8	8	10	7
Riparian Vegetative Zone Width	Right Bank (10 - 0)	6	6	1	5
	Left Bank (10 - 0)	6	5	2	2
TOTAL SCORE	122	121	124	130	125

Fish Community Survey Summary						
Species Observed	Count by Location					Total Fish
	SC-STA-1	SC-STA-2	SC-STA-3	SC-STA-4	SC-STA-5	
Largescale Stoneroller (<i>Campostoma oligolepis</i>)	15	21	2	70	91	199
Eastern Mosquitofish (<i>Gambusia holbrooki</i>)	110	2		7		119
Unknown Shiner #2 (<i>Notropis</i> spp.)		5	8	62	3	78
Unknown Shiner #1 (<i>Notropis</i> spp.)		12	3	23	4	42
Bluespotted Sunfish (<i>Enneacanthus gloriosus</i>)	2	18	1	5	1	27
Unknown Shiner #3 (<i>Notropis</i> spp.)			7			7
Bluegill (<i>Lepomis macrochirus</i>)				6		6
Unknown Shiner (<i>Cyprinella</i> sp.)				3	1	4
Creek Chub (<i>Semotilus atromaculatus</i>)			1			1
Suckermouth minnow (<i>Phenacobius mirabilis</i>)				1		1
Longear Sunfish (<i>Lepomis megalotis</i>)					1	1
Black Redhorse (<i>Moxostoma duquesnei</i>)					1	1
Yellow Bullhead (<i>Ameiurus natalis</i>)					1	1
Total Fish	127	58	22	177	103	487
Species Richness	3	5	6	8	8	13
Total Shock Time (seconds)	2,386	2,146	1,468	1,678	2,322	10,000

Benthic Macroinvertebrate Summary Metrics							
Metric	Expected Response	STA-1	STA-2	STA-3	STA-4	STA-5	RP-1
Total Number of Specimens	Decrease	97	106	16	28	16	331
Species Richness	Decrease	19	13	5	7	4	31
Percent EPT	Decrease	0	42	19	14	63	37
Percent Diptera	Increase	23	45	69	82	31	10

BIOSURVEY RESULTS FOR STA-5
