ANNISTON PCB SITE ANNISTON, ALABAMA SCREENING LEVEL ECOLOGICAL RISK ASSESSMENT FOR OPERABLE UNITS 1, 2, AND 3	
OPERABLE UNITS 1, 2, AND 3	
  BLASLAND, BOUCK & LEE, INC. engineers, scientists, economists	FIGURE 1

ANNISTON PCB SITE
ANNISTON, ALABAMA
SCREENING LEVEL ECOLOGICAL RISK
ASSESSMENT FOR OPERABLE UNITS 1, 2, AND 3

**SCREENING LEVEL ECOLOGICAL RISK ASSESSMENT
FOR OPERABLE UNITS 1, 2, AND 3**

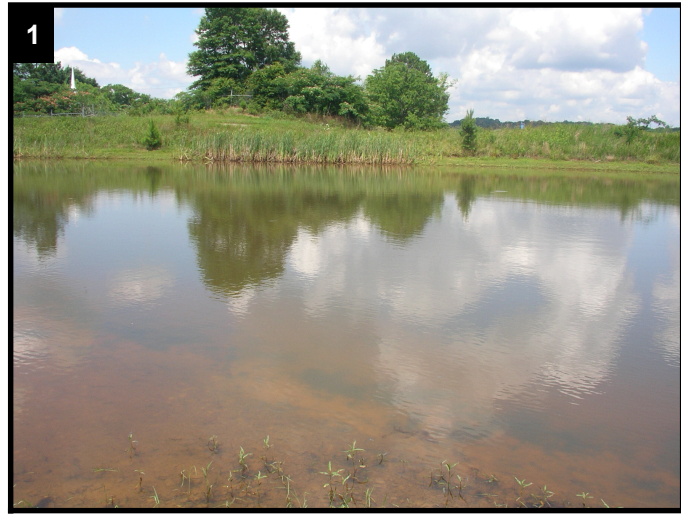
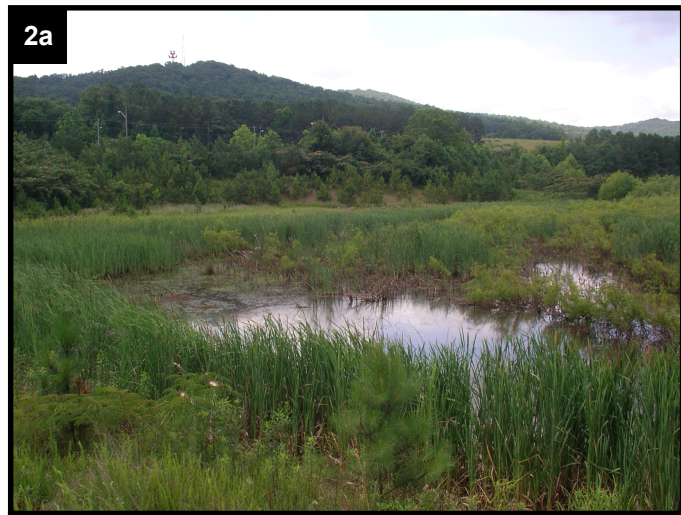
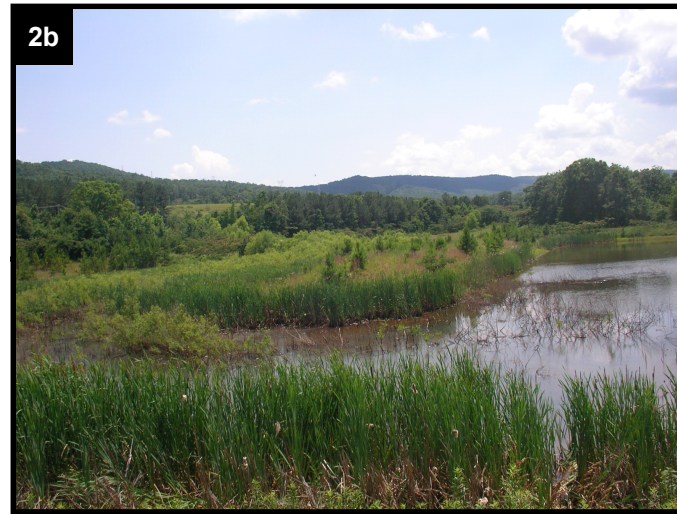
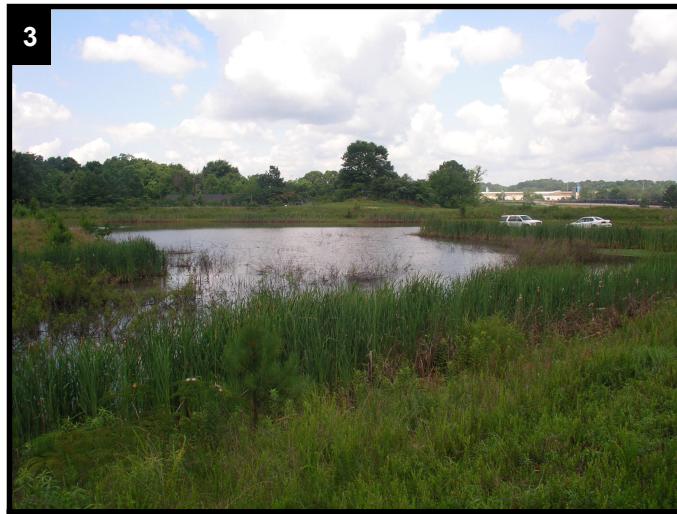
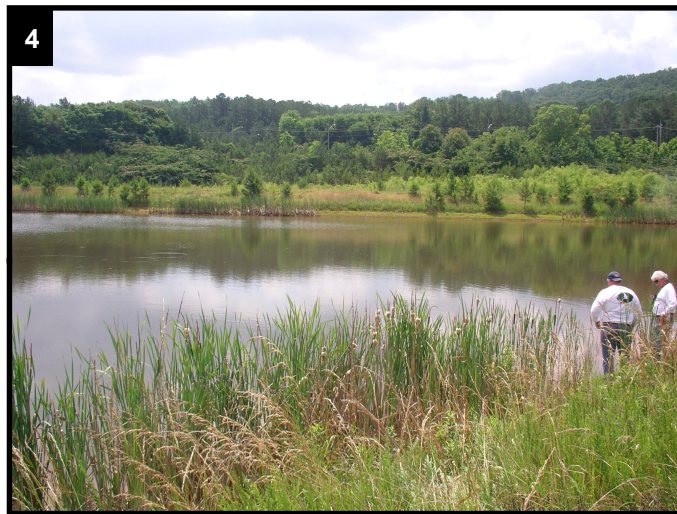
FIGURE
36

LEGEND:
 WILDLIFE OBSERVATION TRANSECT
 FISH SAMPLING AREA
 BENTHIC AND FISH SAMPLING AREA
 PHOTO ID AND CAMERA DIRECTION

**BIOSURVEY LOCATIONS FOR
STORMWATER RETENTION STRUCTURE**

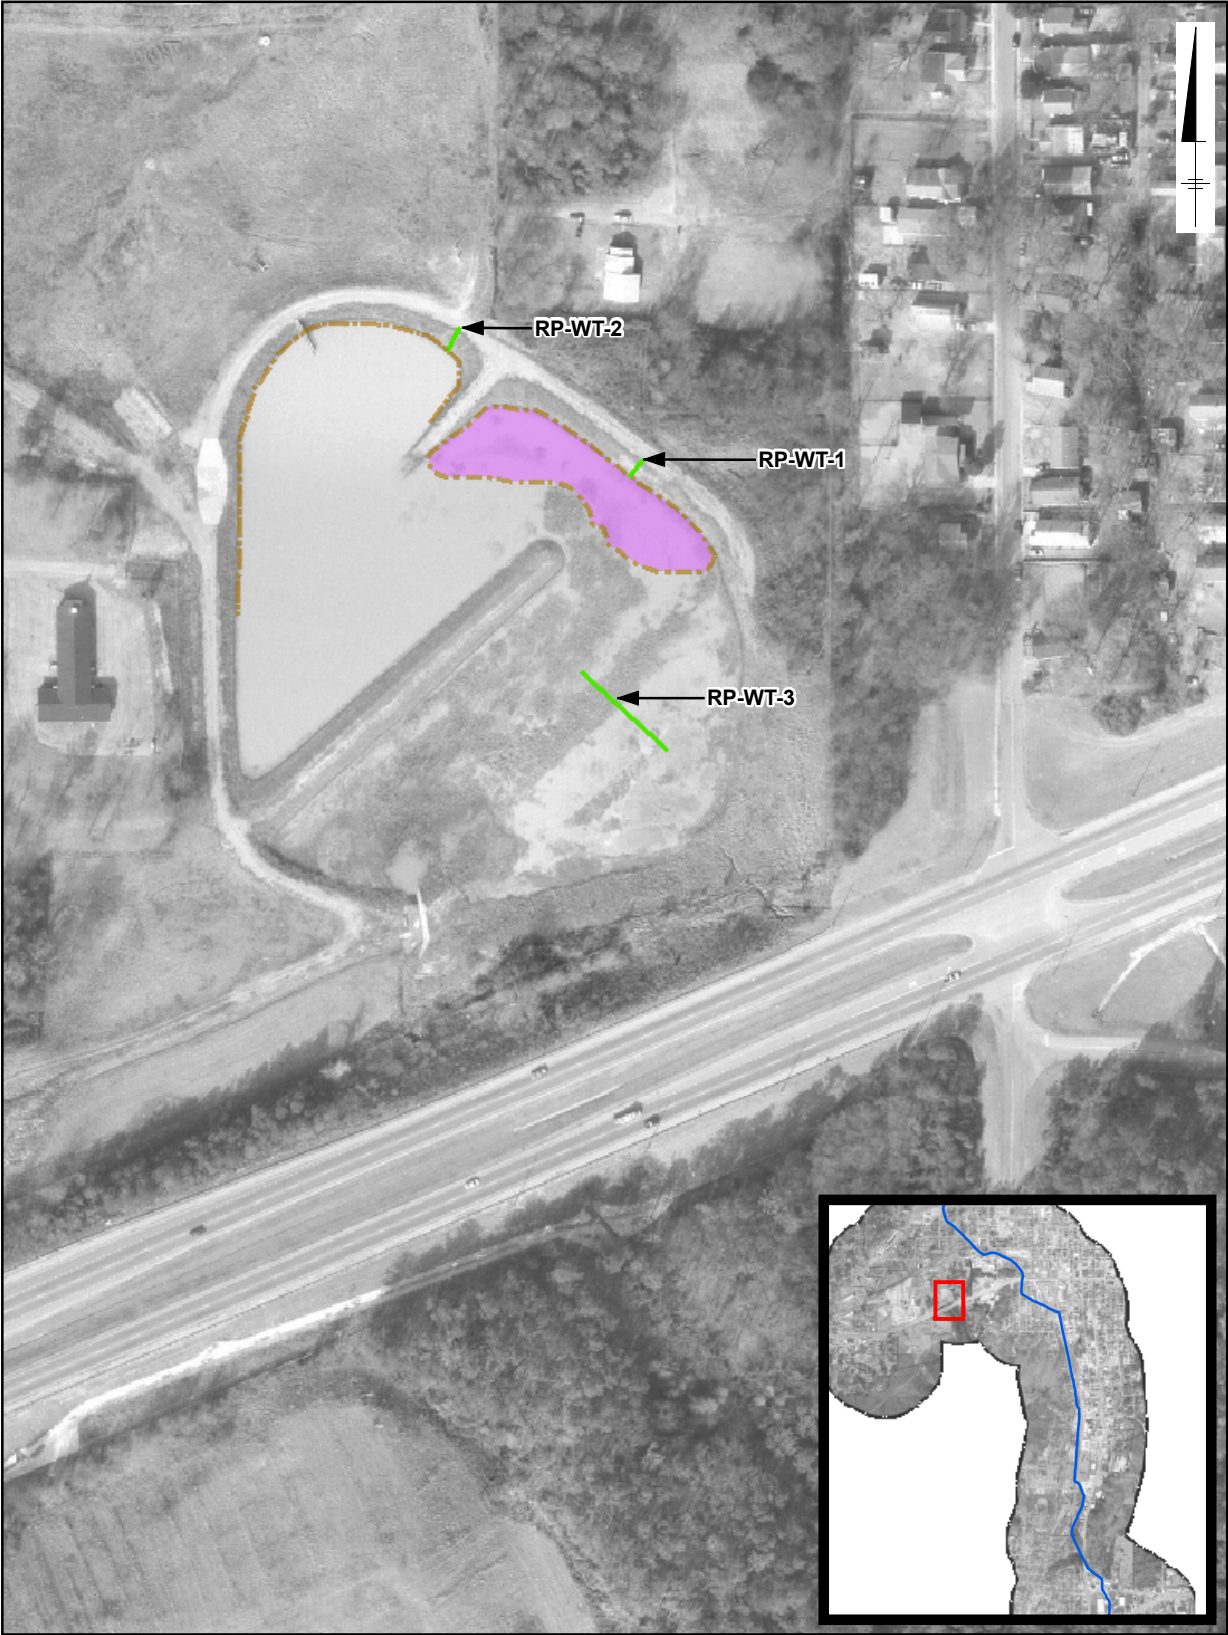
Note: 1,853 seconds of shocking in the stormwater containment structure yielded no fish

BIOSURVEY RESULTS FOR
STORMWATER RETENTION STRUCTURE

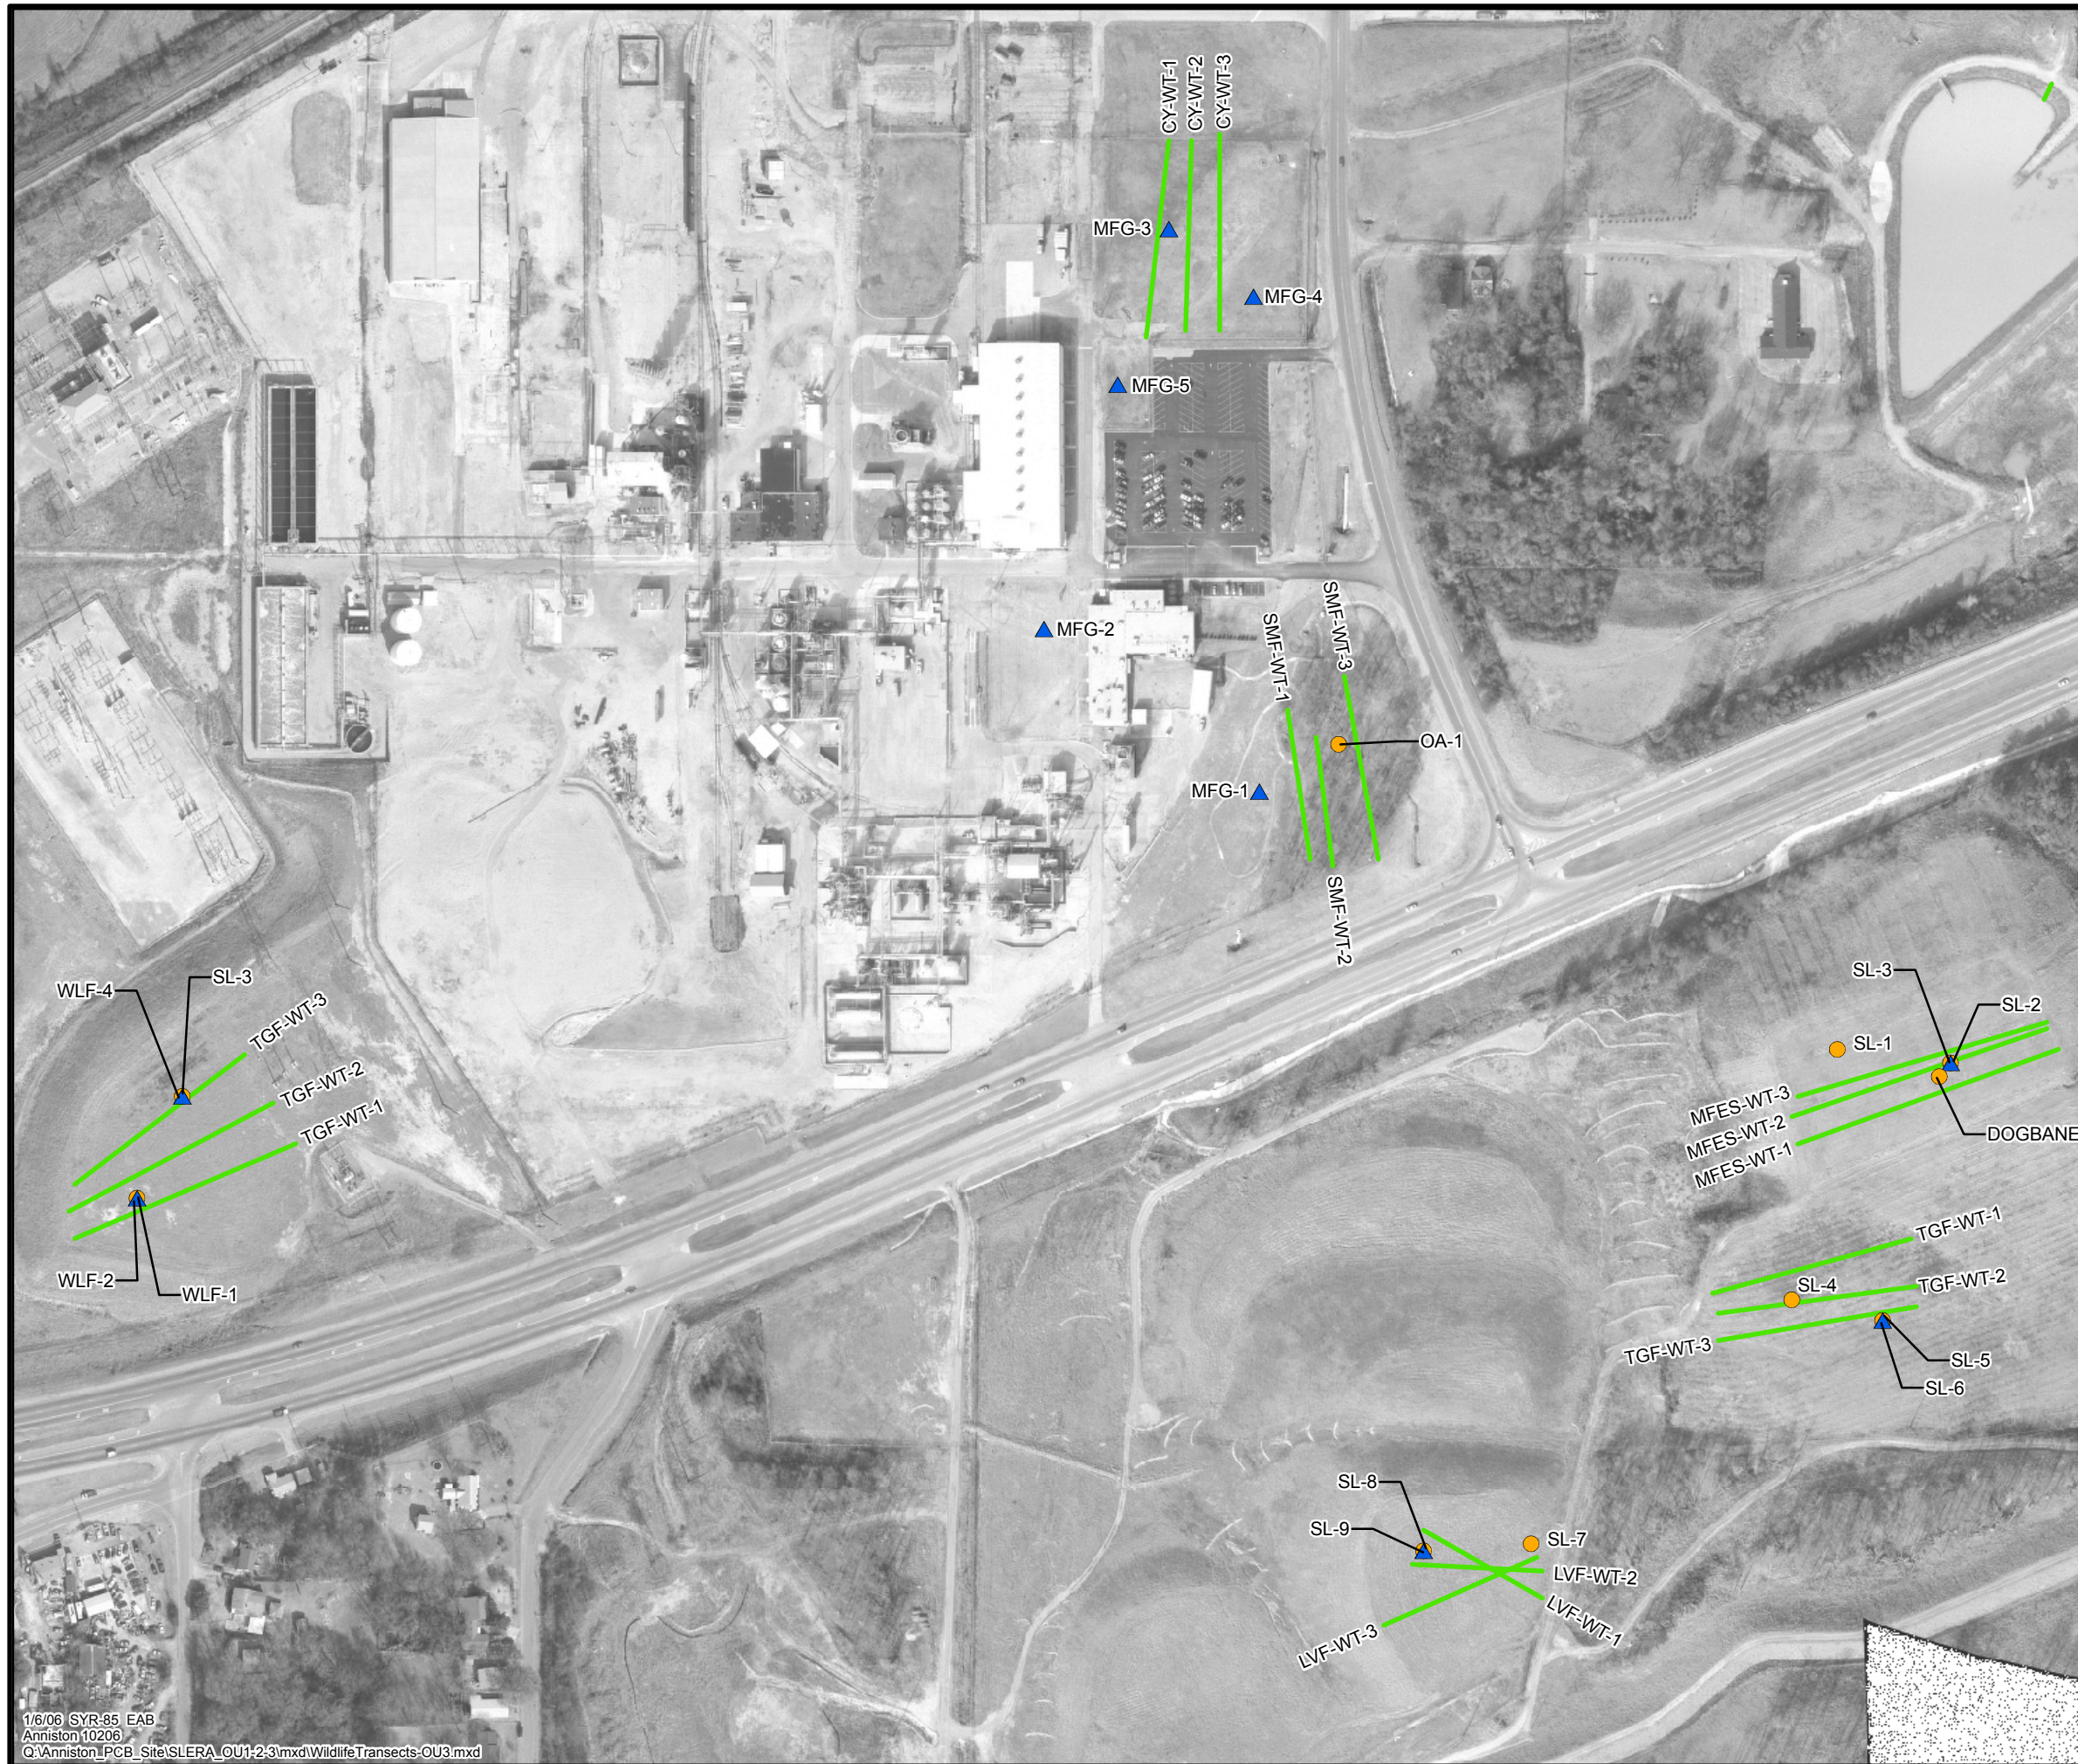
FIGURE
38

- WILDLIFE OBSERVATION LOCATION - 1 MINUTE SWEEP
- ▲ WILDLIFE OBSERVATION LOCATION - SOIL CORE
- WILDLIFE OBSERVATION TRANSECT

**WILDLIFE TRANSECT AND
SAMPLE LOCATIONS: OU-3**

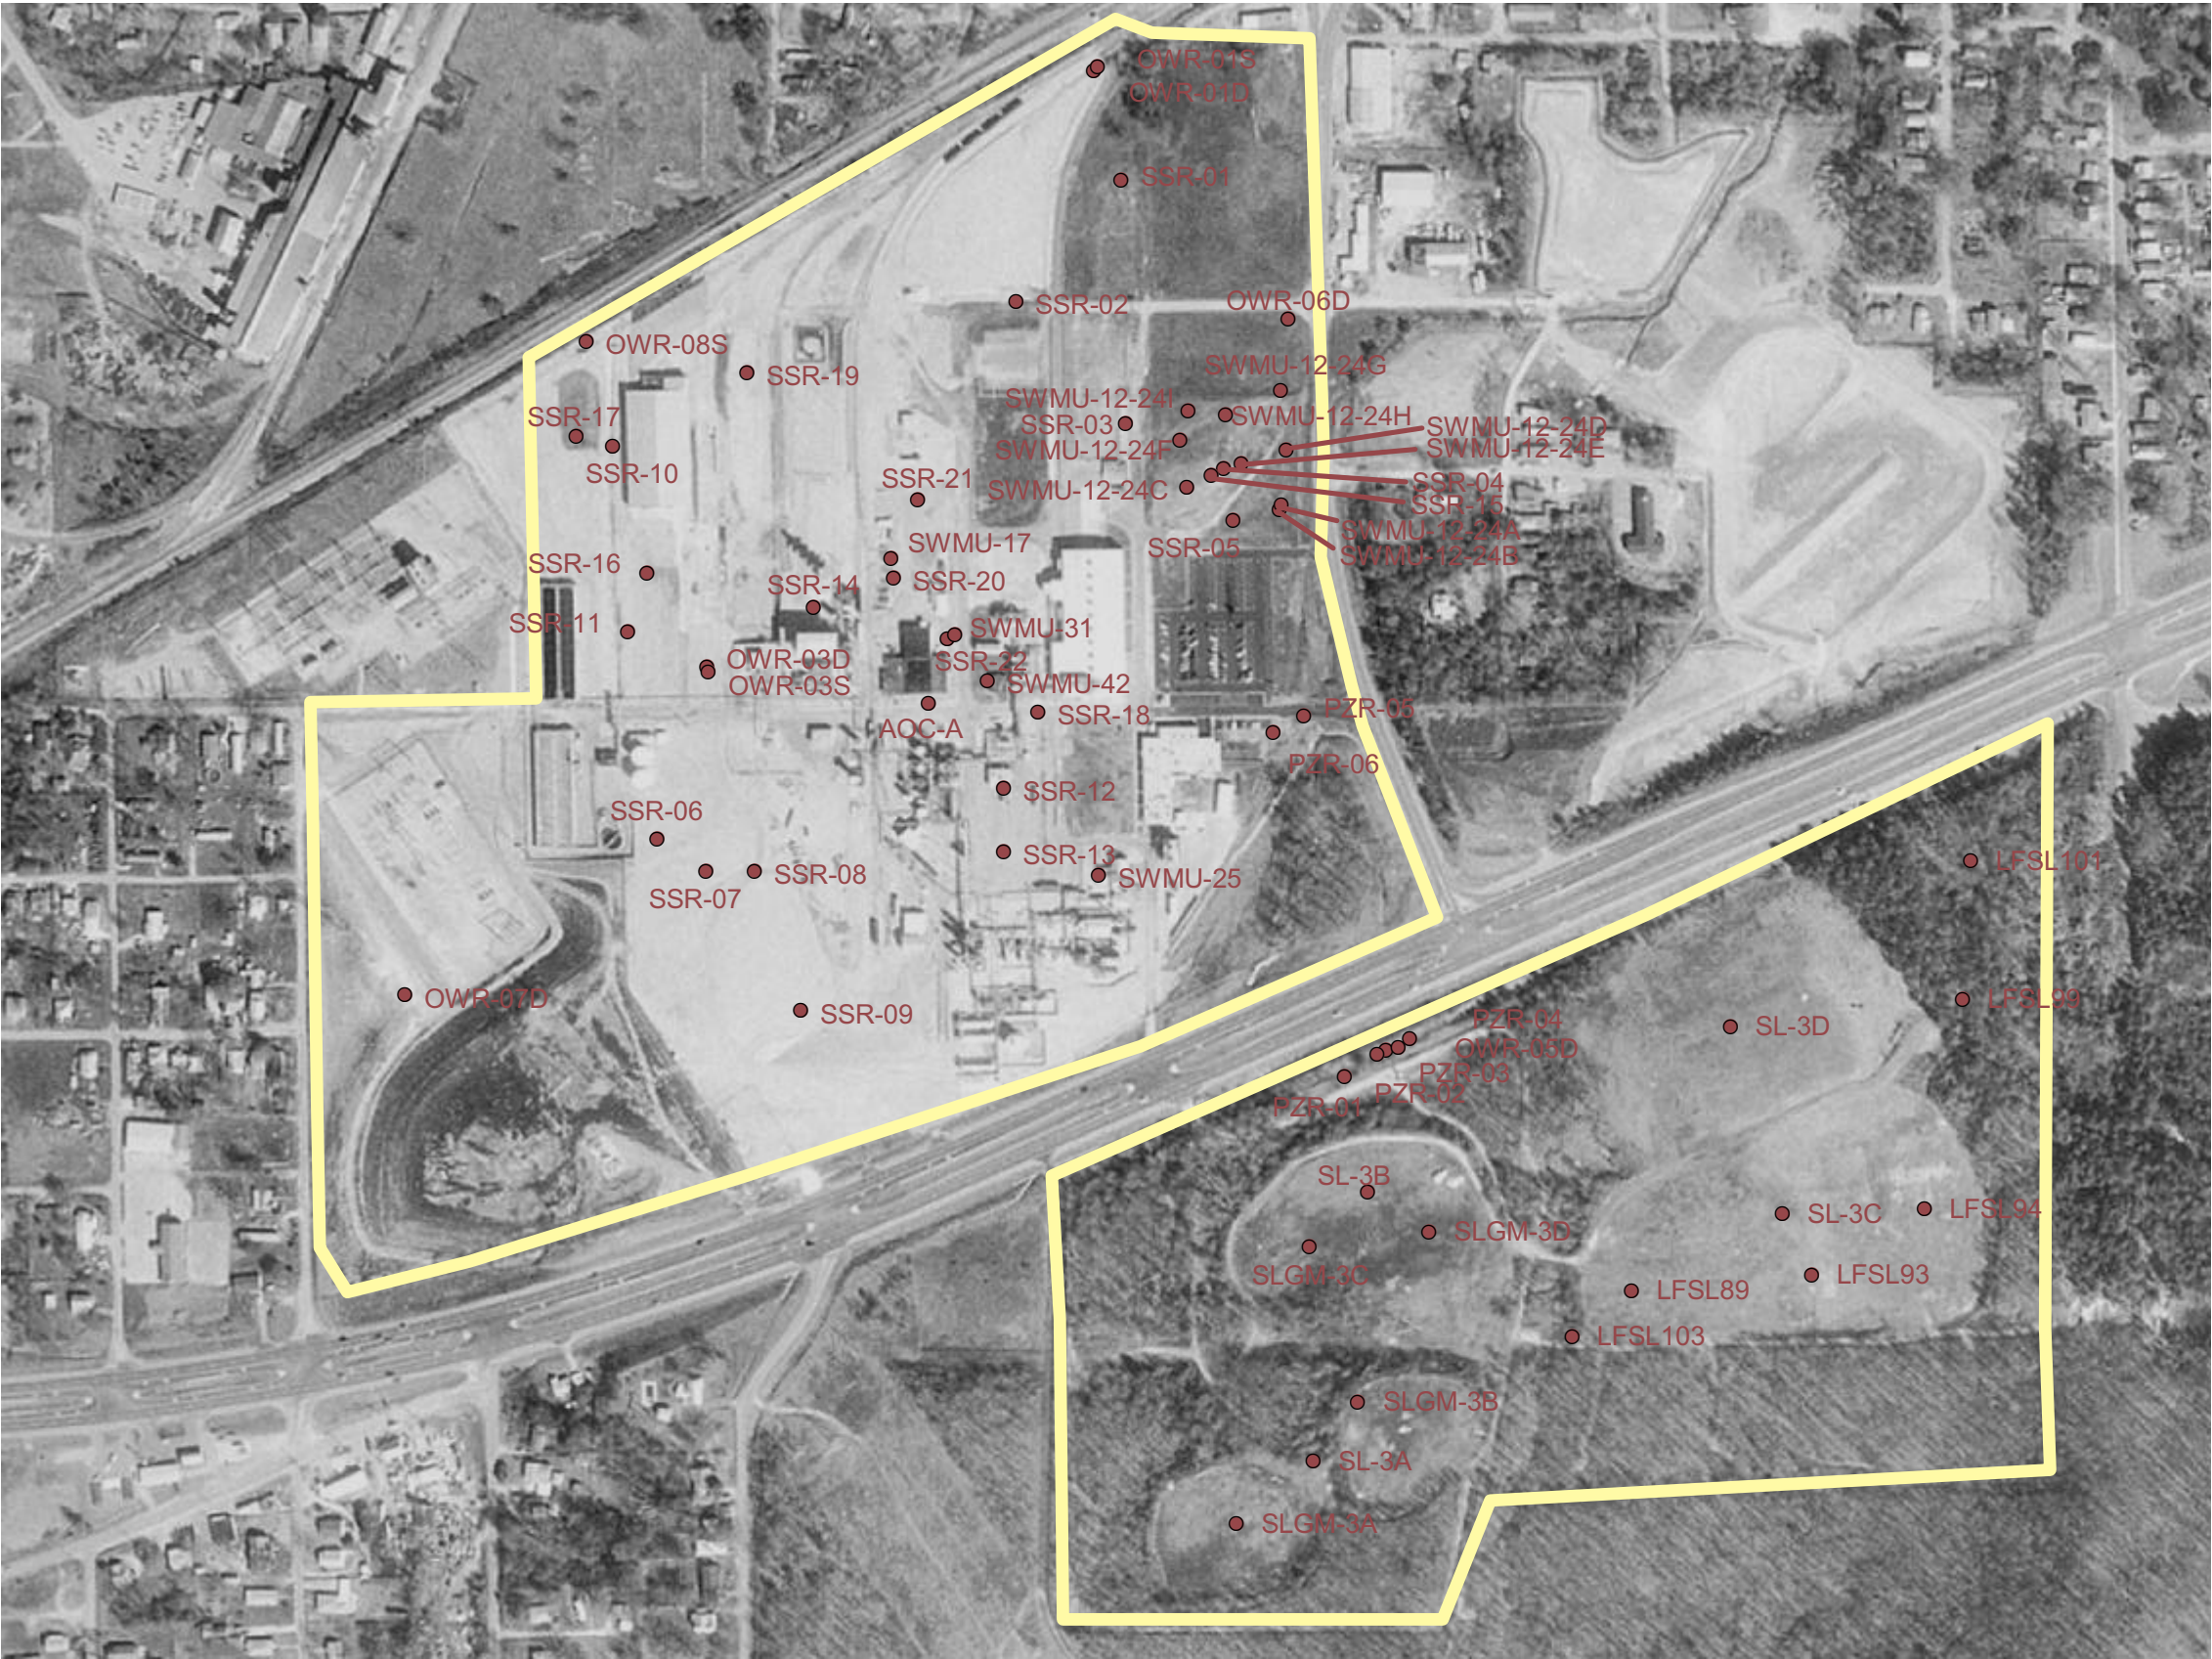
- OU-3 Sample Locations
- OU-3

**OU-3 SURFACE SOIL
SAMPLING LOCATIONS**
