**THERMINOL**

## Hello, Therminol. Goodbye, mineral oil sludge.

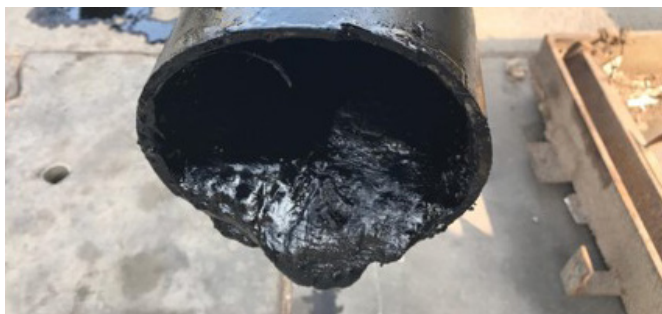
The results of the in-service test sample indicated the mineral oil was extensively thermally stressed. The mineral oil displayed elevated acidity, high viscosity, and insoluble solids. On further inspection, loose carbon particles were found settling in low-lying areas of the heat exchangers, causing the sludge that created inefficient heat exchange.

*With mineral oil, loose carbon particles gathered in low-lying areas, causing sludge.*

To clean out the sludge and restore system efficiency, the TLC team recommended Therminol FF flushing fluid. To minimize downtime, the Therminol team provided hands-on assistance with lowering the operating temperature and properly mixing Therminol FF into the existing mineral oil. This loosened and entrained the degradation solids within the flushing fluid and helped clean the system without disrupting operations.
