Re: *Dredge Spoil Area Evaluation Report*  
Solutia Inc. Anniston, AL Facility  
EPA ID No. ALD 004 019 048

**DREDGE SPOIL AREA EVALUATION REPORT  
SNOW CREEK AND CHOCCOLOCCO CREEK  
CALHOUN AND TALLADEGA COUNTIES, ALABAMA**

**October 15, 1998**

**ROUX ASSOCIATES, INC.  
1110 Nasa Road One, Suite 207  
Houston, Texas 77058  
(281) 335-4000**

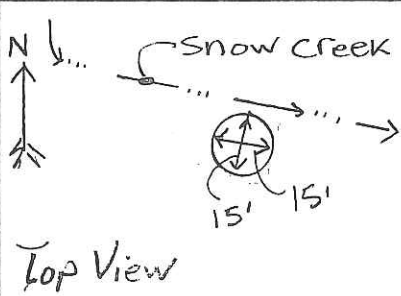
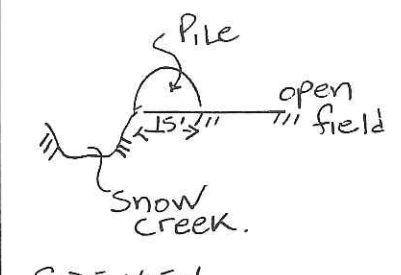
Dredge spoil Area Nos. 3 through 6 extend to the Creek bank and exhibit average slopes of 1:1 (H:V). Vegetation is well established at each area; however, each area exhibits some evidence of minor slumping. In order to prevent further slumping of these areas, it is recommended that permanent turf reinforcement mats be installed and seeded. Preparation of these areas will require the removal of large rocks, soil clods and existing vegetation to ground level to ensure intimate contact between the mats and subgrade. A turf reinforcement mat would then be installed, and the areas would be hydro-seeded to establish a good stand of grass. The turf reinforcement mats will stimulate rapid vegetative growth and provide permanent resistance to elevated hydraulic forces. The mats will permanently anchor the vegetative cover to the soil surface and provide twice the erosion protection of unreinforced vegetation. Typical specifications for turf reinforcement mats are provided in Appendix B. The mats are composed of a dense, three-dimensional web of polypropylene fibers, placed between two high strength nets and stitched together. The mats are installed in overlapping rolls and secured with ground-anchoring devices.

PHYSICAL DESCRIPTION	(#13)	(#14)	(#15)	(#16)	(#17)		(#18)
	Length (ft)	Width (ft)	Height (ft)	Soil Type in Area	Cover Type and Description		Is Vegetation Well Estab. ?
	15	15	5	Sand Silt Gravel	Weeds, brush		Yes
AREA SLOPE DATA	(#19)	(#20)	(#21)	(#22)	(#23)	(#24)	
	Average Slope Along Length (H) : (V)	Slope Length (Along Length) (ft)	Average Slope Along Width (H) : (V)	Slope Length (Along Width) (ft)	Steepest Slope (H) : (V)	Is There Evidence of Slump, Erosion or Area Stability Problem(s) ?	
	uneven, 1 : 1	4	uneven, 1 : 1	4	Portions near vertical	Some minor slumping	
SKETCH OF AREA			AREA PHOTOGRAPH

SIDE VIEW			Photo Caption:    Area 6, view to the east.

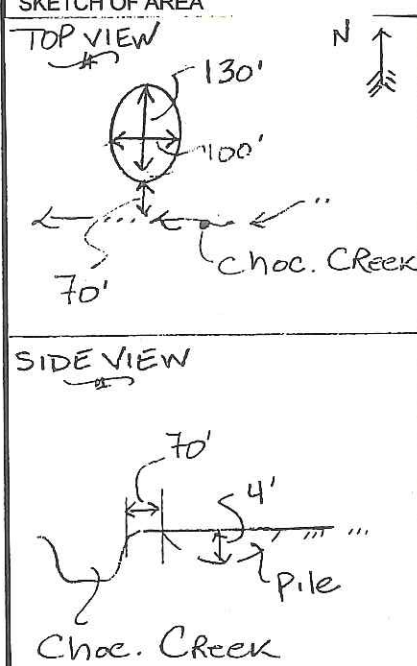
PHYSICAL DESCRIPTION	(#13) Length (ft)  130	(#14) Width (ft)  100	(#15) Height (ft)  -NA- Depth = 4 per NRCS	(#16) Soil Type in Area  Sand Silt	(#17) Cover Type and Description  Grass and tall weeds		(#18) Is Vegetation Well Estab. ?  Yes	
AREA SLOPE DATA	(#19) Average Slope Along Length (H) : (V)	(#20) Slope Length (Along Length) (ft)	(#21) Average Slope Along Width (H) : (V)	(#22) Slope Length (Along Width) (ft)	(#23) Steepest Slope (H) : (V)	(#24) Is There Evidence of Slump, Erosion or Area Stability Problem(s) ?		
	Flat	-NA-	Flat	-NA-	Flat	No		
SKETCH OF AREA
