Injection molding
Troubleshooting guide

Eastman™ copolyesters

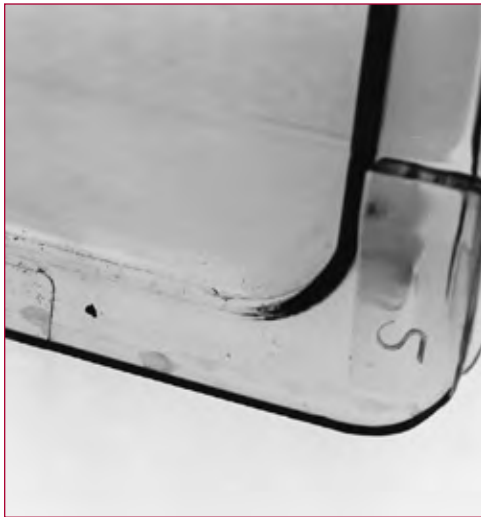
Black specks

Possible cause	Corrective action
Previous material(s) in the screw, check ring, hot runner, etc.	Purge machine with Eastman™ copolyesters or commercial purge compounds. If necessary, remove screw and manually clean the screw and barrel. Take the nozzle and hot runner apart and clean out previous materials.
Regrind contamination	Shut off regrind and mold virgin to test source of specks. Allow sufficient time to clear the screw, barrel, check ring, and hot runner.
Raw material contamination	Ensure any open boxes are covered while in use. Examine pellets for possible contamination.

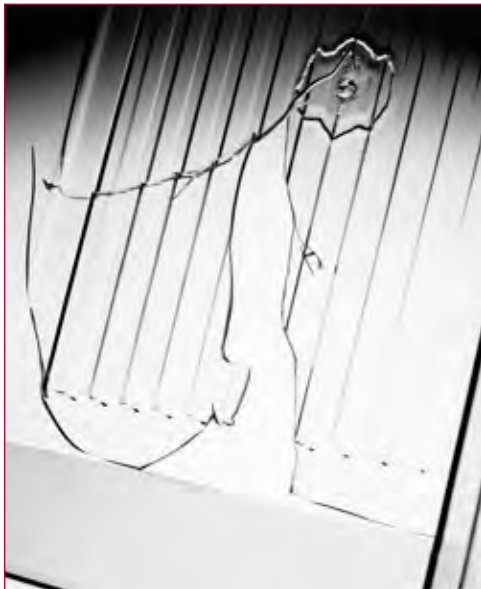
Brittleness

Possible cause	Corrective action
Poor drying	See processing guidelines for your copolyester formulations.
Excessive residence time	Calculate melt residence time by formula in molding guides. If >5 minutes, use smaller shot machine or reduce cycle time.
Melt temperature too high	Measure and reduce melt temperature.
Cracking when mold opens <ul style="list-style-type: none"> • Overpacking • Hot mold • Poor drying • Breakaway too fast • Needs vacuum break 	<ul style="list-style-type: none"> • Reduce either packing pressure or time. • Lower mold temperature or improve cooling uniformity. • See processing guidelines for your copolyester formulations. • Reduce mold-opening speed. • Install air poppet/vacuum break.

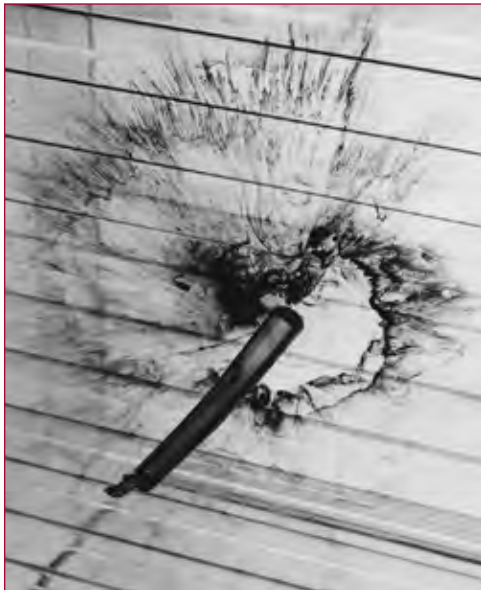
Discoloration

Possible cause	Corrective action
Overdrying	Follow recommended drying temperatures and times outlined on the product specification. If deviations are necessary, consult your Sales/Technical Representative.
Long melt residence time	If melt residence time (holdup time) is >5 minutes, purge machine before restarting, reduce cycle time, or use a smaller barrel capacity.
Contamination	Same as for haziness (see page 7).

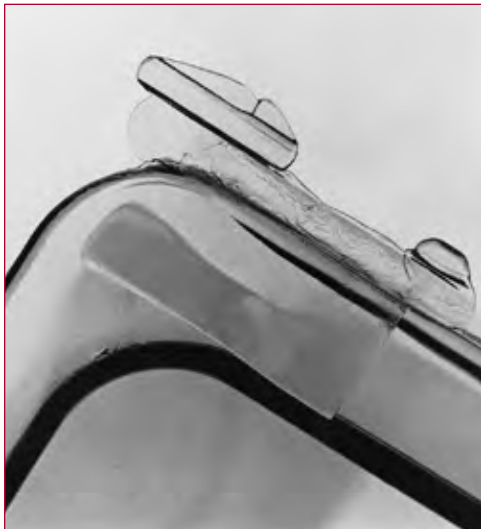
Flashing

Possible cause	Corrective action
Poor mold spot	Spot mold to ensure fit and vent depths at ~0.025 mm (0.001 in.).
Injection pressures too high	Reduce pressure. This may require higher melt temperature or lower injection speed.
Boost time too long	Shorten boost time, lower boost pressure, or move transfer to an earlier position.
Insufficient clamp tonnage	Increase clamp pressure or move to machine with more tonnage.

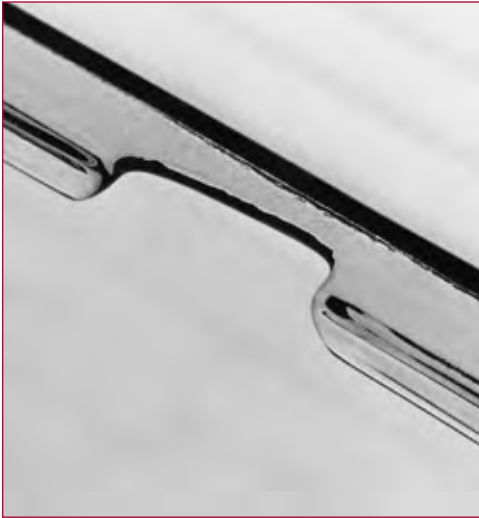
Flash and short shot in different shots

Possible cause	Corrective action
Check ring inconsistent; worn barrel	Check and replace assembly ring. Replace/reline barrel as needed.

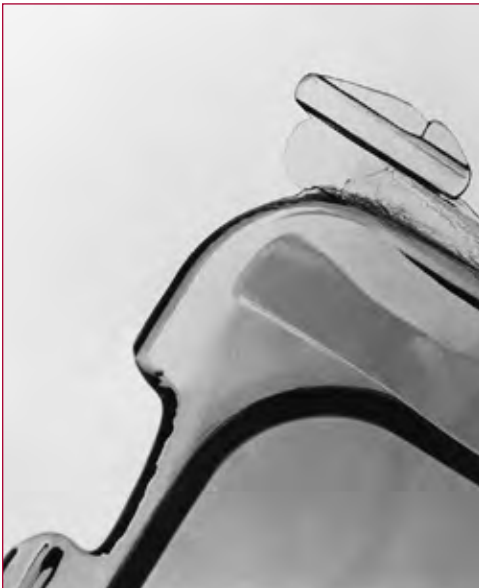
Flash and short shot in the same shot

Possible cause	Corrective action
Core shift	Check wall thickness for core shift. Investigate for sources of core shift and repair mold.
Inadequate clamp tonnage	Increase clamp pressure or move to machine with more tonnage.
Fill speed or pressure too high	Reduce speed or fill pressure.
Melt temperature too low	Check and raise melt temperature if needed.
Sprue too long or too small, "0" dimension	Install correct size sprue.

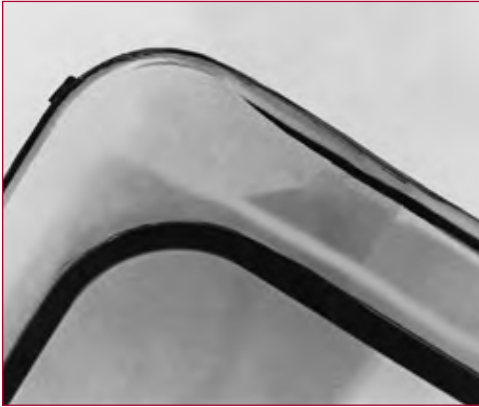
Jetting

Possible cause	Corrective action
Plastic flow into the part channels or "snake flows"	Raise or lower fill speed to change filling pattern. Change the part or gate so that flow spreads evenly as the part is filled.

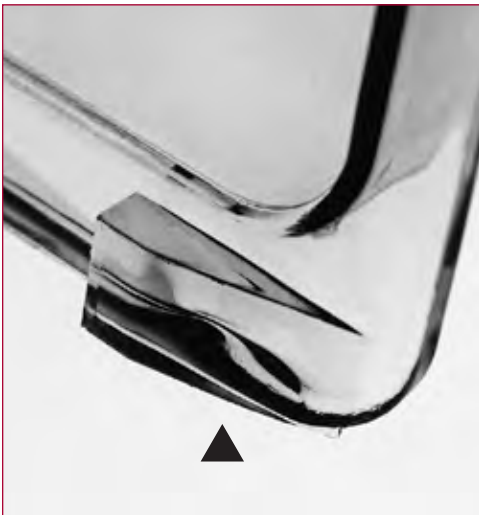
Sinks and voids

Possible cause	Corrective action
Insufficient packing	Increase packing time and/or pressure. Check gate, sprue, and tip dimensions to make sure size is adequate. Check part dimensions (packing thick sections through thin walls).
Walls, etc., too thick	Reduce thickness if possible.
Hot spots in mold	Improve cooling.
Injection speed too fast	Reduce speed to allow more uniform fill and pack.
Melt temperature too low	Check and adjust temperature upward if needed.

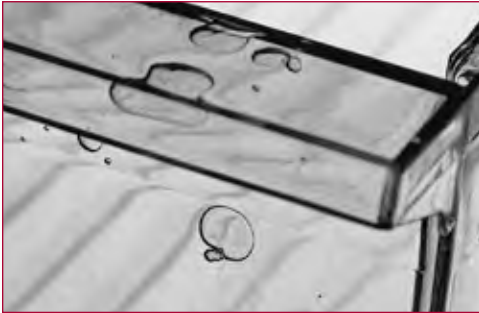
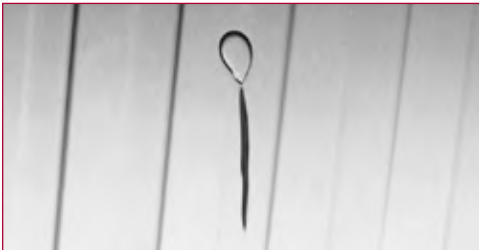
Air splay and decompression splay

Possible cause	Corrective action
Trapped air on screws	Decrease screw rpm. Increase back pressure. Check to ensure uniform recovery time; if not, decrease screw rpm or try reverse temperature profile. Review screw design with Eastman Technical Representative.
Trapped air in nozzle	Reduce decompression (suck back) or sprue break.
Trapped air in tool (foamy tail on bubbles)	Investigate (possibly using series of short shots) sources of air in tool such as weld line formation, inadequate venting, unusual shapes of pins where air remains after the flow passes, etc.

Splay is defined here to include any defects that appear as smeared material or bubbles on the part surface, usually oriented in the flow direction. Appearance alone cannot tell you which type of splay is present. To decide on the likely cause(s), test each to prove/disprove whether it is causing the splay, then take the corrective action indicated.

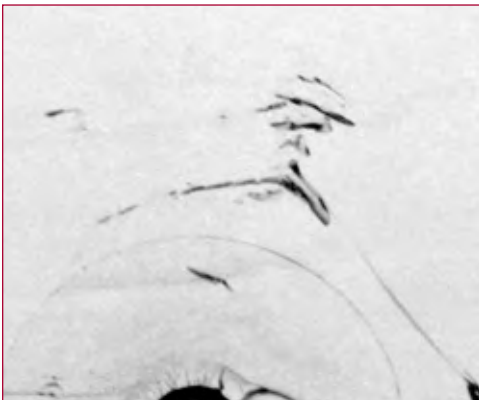
Contamination splay

Possible cause	Corrective action
Incompatible resins or thermally unstable contamination	Find and eliminate source (regrind, etc.).

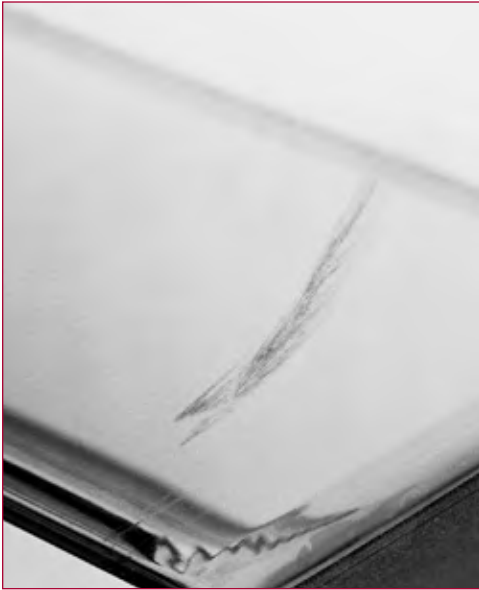
Heat splay

Possible cause	Corrective action
Hot spots in barrel, nozzle, or hot runner	Check actual melt temperature. Check actual barrel, nozzle, and hot runner temperatures. Check heater bands, thermocouples, and controllers.
Residence time too long	Ensure shot size 25%–75% of barrel capacity. Maintain melt residence time at <5 minutes. Check for dead spots in hot runners and nozzles.

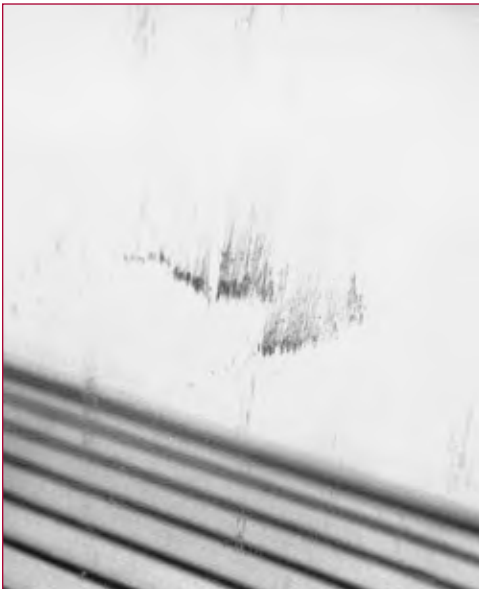
Possible cause	Corrective action
Improperly dried material (Note: Moisture splay is visible only when material is <i>extremely</i> wet.)	Ensure good drying. See processing guidelines for your copolyester formulations.

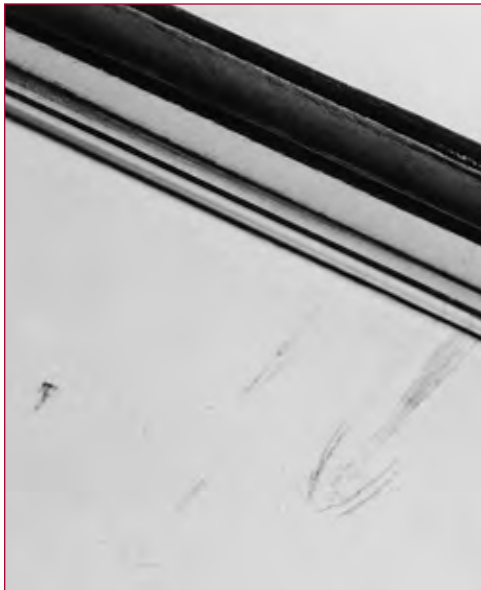
Shear splay

Possible cause	Corrective action
Gate design	<p>Increase gate size.</p> <p>Change gate geometry such as using a fan gate.</p> <p>Radius sharp edges.</p> <p>If hot runner, consult hot runner supplier.</p>
Screw speed too fast (either rpm or inject speed)	Reduce speed or profile as needed.
Screw slipping/spinning <ul style="list-style-type: none"> Screw design Worn barrel 	<ul style="list-style-type: none"> Reduce screw rpm. Measure compression ratio, flight depth, and zone lengths (typical range: 3:1 compression or more). Consult your Eastman Sales/ Technical Representative for suggestions. Replace or reline barrel.
Part design	<p>Radius sharp corners.</p> <p>Eliminate flow restrictions.</p> <p>Run series of short shots to determine flow pattern.</p> <p>Run mold filling analysis.</p>

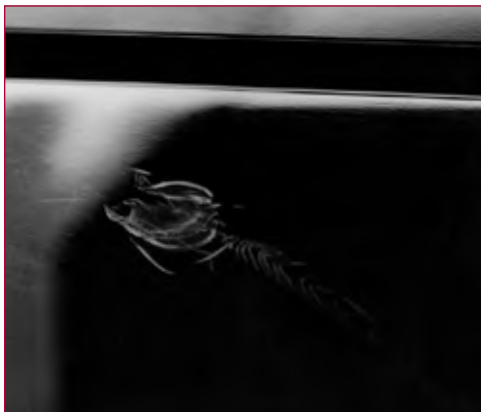
Other splay

Possible cause	Corrective action
Leaking check ring or high shear check ring or ball check	Repair or change check ring. Check for barrel wear.
Temperature differences in melt stream	Look for temperatures from check ring forward (cold slugs, nozzle drool, nonuniform nozzle temperature, hot runner internal temperature differences, etc.).
Cold slugs	Check nozzle, hot drop, and hot runner areas. Insulate or raise temperatures as appropriate.

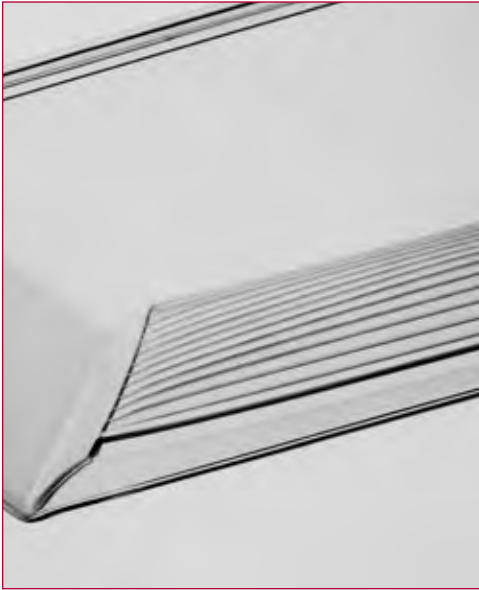
Warped or distorted parts as ejected from the mold

Possible cause	Corrective action
Hot spots or sticking during ejection	Locate hot spots (by pyrometer, etc.) and eliminate them by added cooling.
Undercuts	Locate undercuts (by finding part scratches or distortions) and eliminate them.
Insufficient ejector pins or lifters	Investigate part as it ejects to locate areas of weak ejection support and add ejectors.
Part overpacked	Reduce packing time/pressure.
Thick wall sections	Revise part wall thickness to be more uniform.

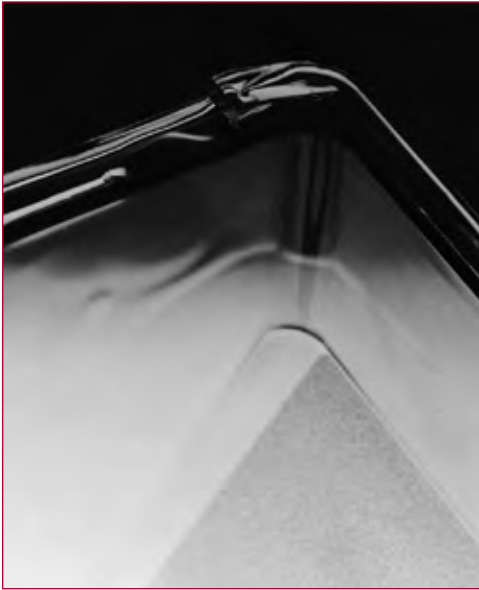
Wavy appearance

Possible cause	Corrective action
Mold surface too hot	Find hot (near the T_g of the plastic) areas and increase cooling.
Underpacking	Near the gate, increase packing time. Far from the gate, increase packing pressure.
